New Properties 2000 Plus Example Residential Building Survey

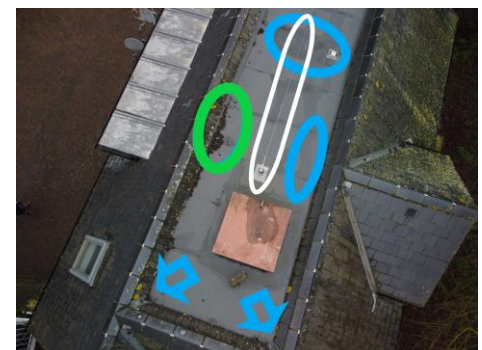
1. Does it have a good drainage point? It will need to be viewed when it is raining heavily.
2. Does it have a problem with the flashing detail due to the coping stones being both mortared and mechanically fixed?
3. The overall condition of the roof, in this case we would say it is starting to deteriorate due to the ponding/water patterns that we could see.

Green – blocked gutter

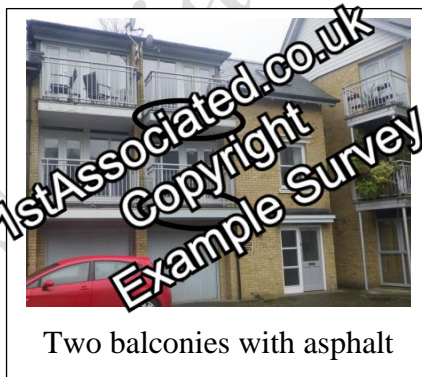
The balconies have an asphalt finish which we believe is one of the best finishes, in this case it is starting to deteriorate and looks to have failed completely on the second/top floor balcony in one area.

Two balconies with asphalt

ACTION REQUIRED: Repair asphalt.

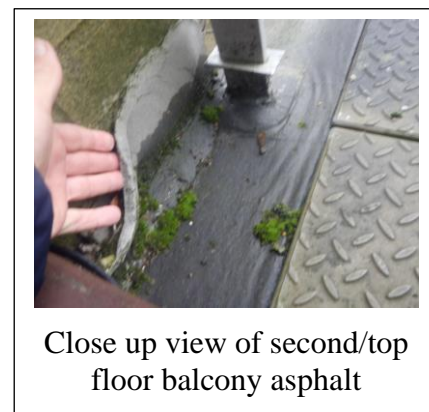
Close up view of second/top floor balcony asphalt

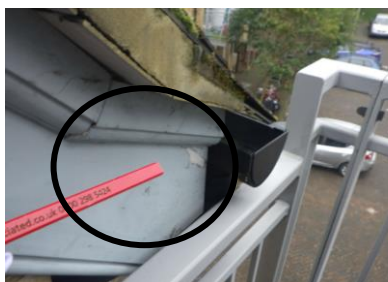
The exterior of the property has timber fascia boards and soffits. These are in below average condition and some deterioration is visible to the fascia boards and we believe this is also likely to the soffit boards as some of them have an unusual corbel style detail. You should also check the vents are clear when looking at the soffits.

Fascias board starting to deteriorate

ANTICIPATED COST: Budget for both repair and redecoration of the rear windows. The rear fascia board looks to be a grained plastic (or other manmade material) which generally will not perish however it does need periodic cleaning from our experience typically every three to five years depending upon location to traffic, trees, etc. We have also seen this get a mould covering as well. Please obtain quotations before legally committing to purchase the property.

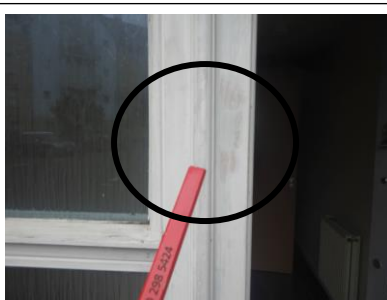
Entrance door paintwork starting to deteriorate

ACTION REQUIRED: If painting is your responsibility we would recommend this is carried out the sooner the better ideally in the warmer months/summer of XXX. If you are not in charge of it and you have to pay into a service charge of some sort such as a sinking fund you need to check and confirm the sinking fund is up to date and payments are in order to carry out the work. We have enclosed in the Appendices a ten year plan that we would typically expect to see where it is a lease; we appreciate this is not a lease but it may be applicable to the shared areas.

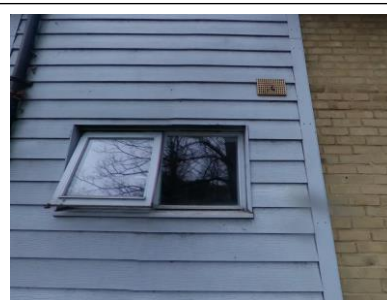
Mastic on kitchen window and feather edge boarding

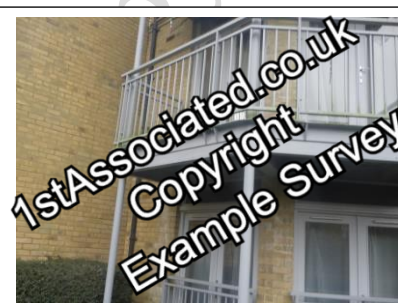
We would also draw your attention to the balcony areas that can get green mould as can be seen on the photograph of a nearby balcony (not your balcony) which is deteriorating.

Nearby balcony (Not your property)

We would recommend repainting using a rust inhibitor paint such as hammerite or similar and redecorate. Generally, our advice on metalwork is to clean and paint early before rust occurs.

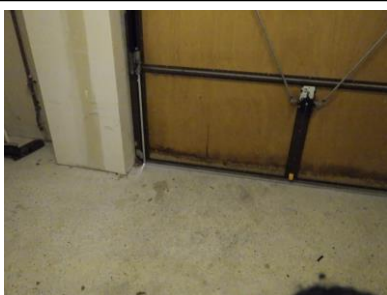
Damp staining to rear of garage door

If you are using the garage as a secure store for something expensive then maybe a running gully in front of the garage would help stop the water getting underneath it.

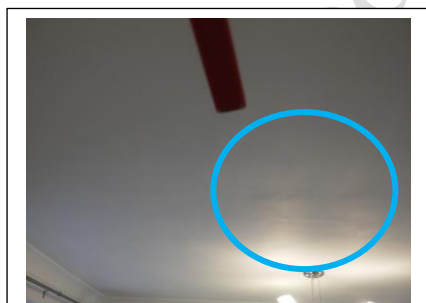
There are marks to some of the ceilings which looked to have been repaired. These cracks and undulations may relate to water coming through from the bathroom and/or the shower room above or even general spillages of water in the bedroom areas on the top floor. Although the vendor rented out the property they did advise that there was a leak under the shower screen in the bathroom which may have caused the marks to the ceiling although they did not specify when. In our experience often in rented properties things can happen that the landlord never gets to know about as they get repaired by the tenants.

Marks to living room ceiling

ACTION REQUIRED: In some instances there may be leaks in shower rooms or bathrooms with showers when someone stands on them and it displaces the joints slightly on the waste water and this sort of leak can appear from time to time (we have not tested for this!) and you do need to be aware of it. Your legal advisor to specifically ask the owners when the leaks occurred and provide feedback to us.

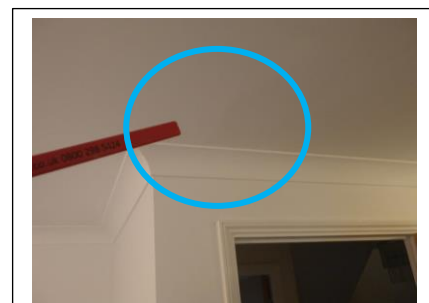
Close up view near entrance door to living room

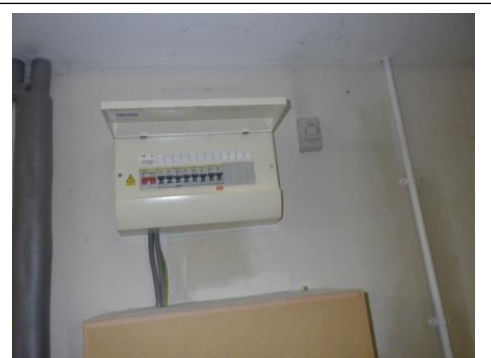
Dated fuse board in garage

ACTION REQUIRED: We recommend a new fuse board with a metal casing; modern standards require half hour to one hour fire resistant casing around a fuse board.

We recommend a test and report and we would also advise as the property is changing occupancy the Institution of Engineering and Technology (IET) also recommend a test and report and any recommendations should be carried out by a NICEIC registered, or equivalent, approved electrical contractor or similarly approved.

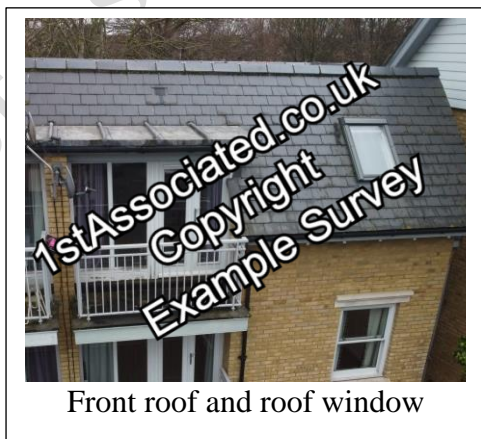
The roof is pitched and clad with modern manmade slate and, from ground level, this looks in average condition considering the roof's age, type and style. The main roof has a hidden flat roof.

Front roof and roof window

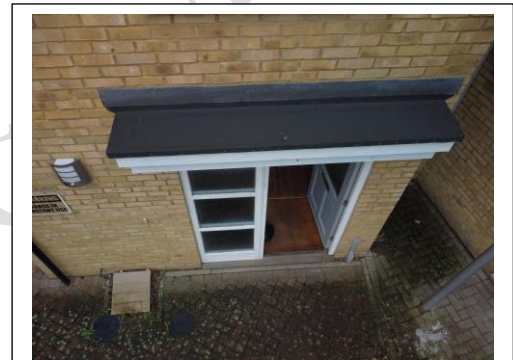
This roof is a flat roof with felt tacked on. We would comment it is in average condition for its age, type and style.

Front entrance roof

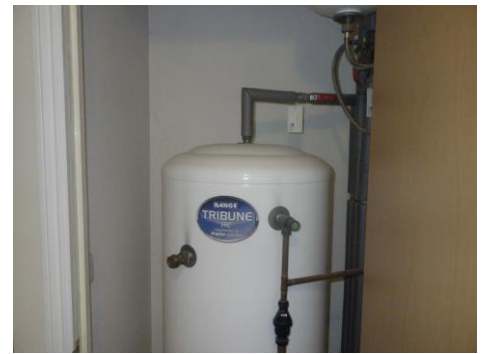
The EPC recommends it has an insulation jacket added which does seem unusual; this needs to be double checked with the person who carried out the EPC.

Hot water cylinder on top floor

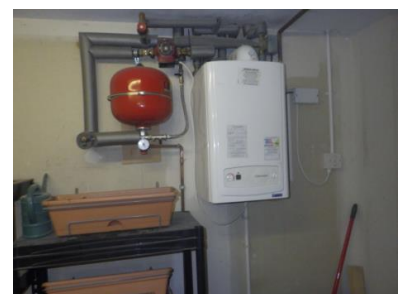
Boiler in garage

ACTION REQUIRED: Your Legal Advisor to check and confirm that the boiler has been regularly serviced (not just a landlords check although our questionnaire advises it was last serviced in XXX) and start to budget for a replacement boiler in the next few years.
