# RESIDENTIAL BUILDING SURVEY

Mid 1800s Detached Property

**GEM Associates Limited**

INDEPENDENT CHARTERED SURVEYORS

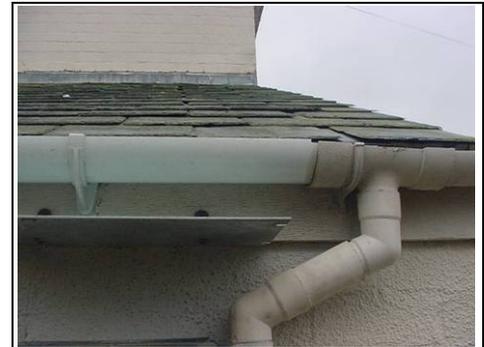
From the condition of the render we are not absolutely certain that the gutters are catching the rain. Unfortunately it did not rain whilst we were at the property and this would be the only way to check.

Gutters and downpipes

**ACTION REQUIRED:** Next time it rains heavily you need to stand outside the property and ascertain if the gutters are catching the rain water and / or leaking and amend as appropriate.

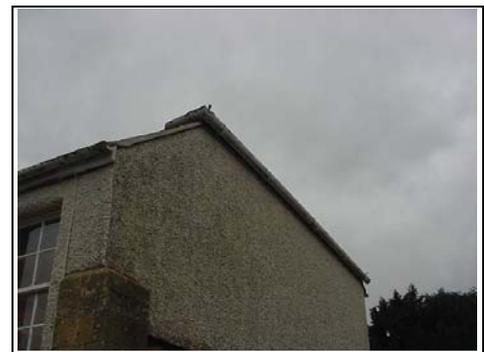
Discolouring render

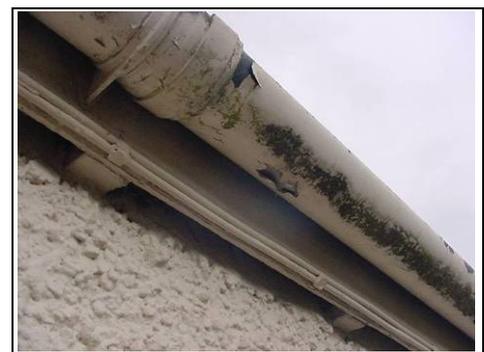
Timber fascia board behind the guttering

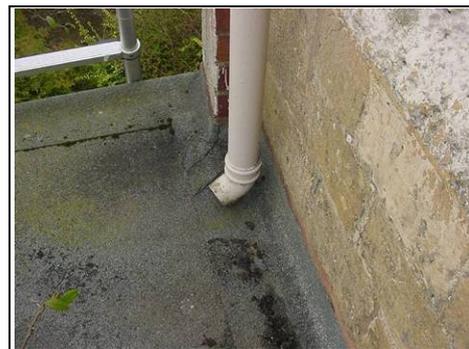
## 2) Flat Roof

The flat roof is covered with felt; whilst the felt is in reasonable condition it is poorly detailed being predominately flat.

**ANTICIPATED COSTS:** The patch repairs will probably help the roof to last for 3 – 10 years before renewal is required.

**ACTION REQUIRED:** You will need to patch repair the roof. Ultimately when you come to re-roof it we suggest you add a fall.

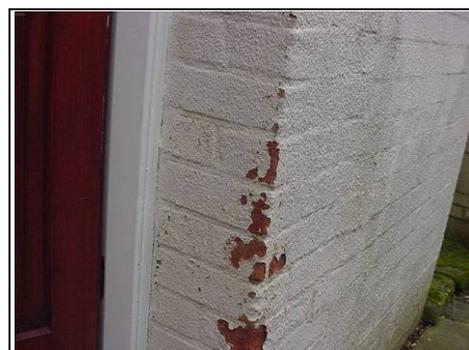
The property has had a modern plastic based paint applied. In our experience these do not work particularly well, as they don't allow the property to breathe and a brick property of this age needs to have an element of breathability to dissipate the damp. We could see areas where it is starting to come away.

**ACTION REQUIRED:** The paint should be removed and replaced with microporous paint, however in our experience this is very difficult / almost impossible to remove. You can encourage the paint to come off by using a soft brush. Ideally we would suggest you let it naturally come away and then redecorate, but this would make the property look in very poor condition and certainly wouldn't be very attractive.

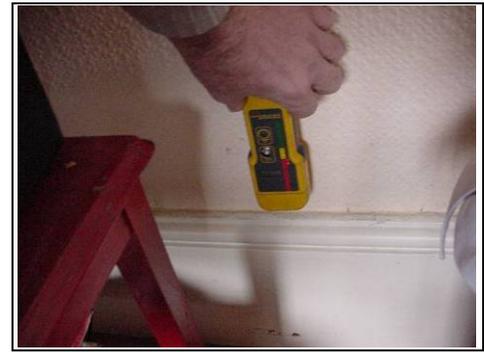
We found rising damp to the property, particularly to the rear wall. We think this could be due to either the gutters not catching the rainwater (that we have already mentioned) or a high ground level. Unfortunately we didn't actually access this rear wall as it is in your adjoining neighbour's garden and they were out at the time of our inspection.

Checking for dampness and finding it

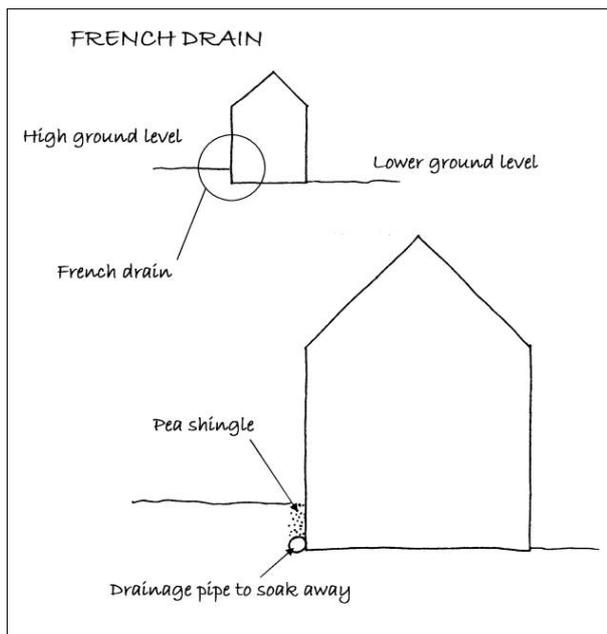
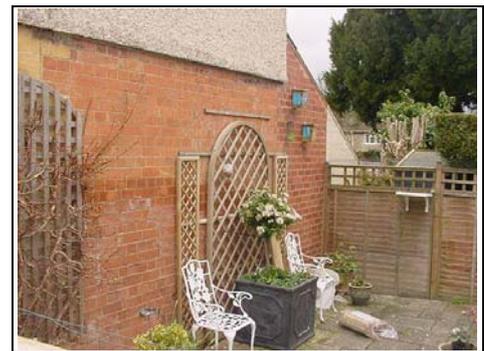
We did have access to one of the gardens and were able to take photos, but from the photo it is very difficult to tell how the ground levels lie; however, we can see that there is paving which does tend to carry rainwater rather than absorb it (as the ground would), and it may be discharging onto your property's walls.

Your neighbour's side of your rear wall.

**ACTION REQUIRED:** We would recommend you go round and see the neighbours and if this is the case then a French drain along the wall would be the solution.

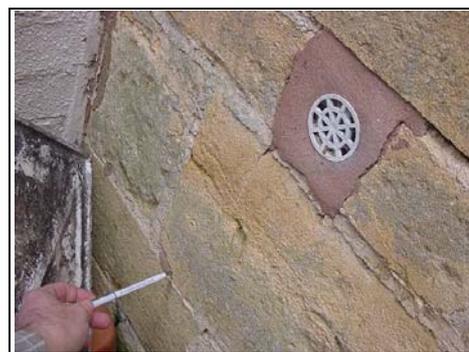
We would draw your attention to the green moss to the right hand side of the property which indicates that little light is being gained in this area, which will add to the dampness. We could see that in the past several attempts at adding a damp proof course have been made. We would make several comments:

The pen indicates the inserted damp proof course and at the top we have a vent that is often used.

We don't generally believe in rising damp being stoppable with an inserted damp proof course and much more commonly we find the problem to relate to difference in the ground level outside and the floor level inside, and/or cement repointing, and/or leaking gutters.

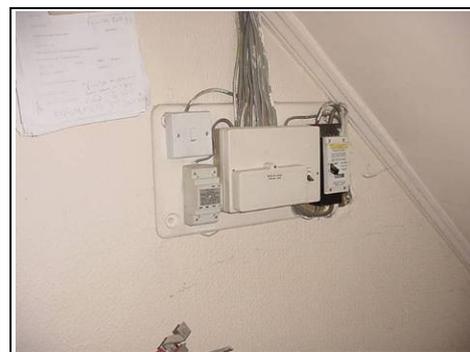
Dated fuse board

**ACTION REQUIRED:** NICEIC (or equivalent) electrical test and report. Replace the fuse board as soon as possible.

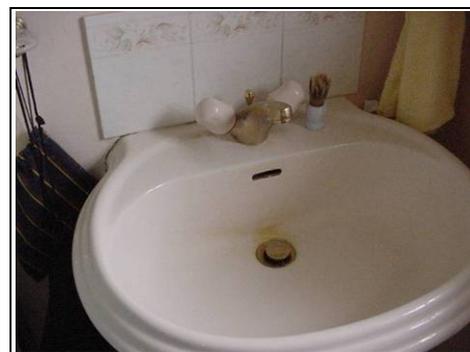
When we carried out our water pressure test by running the water we found the pressure to be low and upstairs the tap in the bathroom did not work at. This may simply be furred up pipes or it may be low pressure.

The sink tap that didn't work

Low pressure can be a problem with a shower (we did not try the shower). You may wish to look into installing a pump shower.

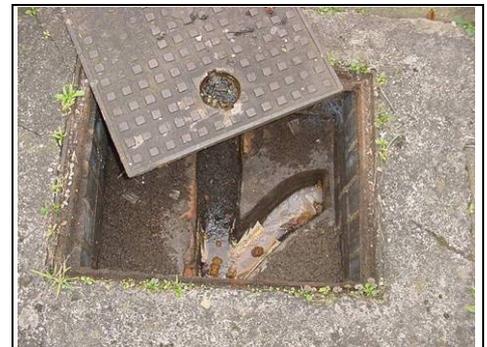
Shallow drainage run

**ACTION REQUIRED:** There is very little you can do about this other than obtain a set of drainage rods or get to know someone who will carry out this job.

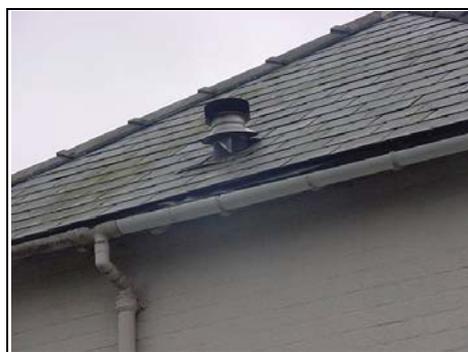
The flue is to the centre of the higher roof.

**ACTION REQUIRED:** Confirm with the existing owner if the chimney works properly.

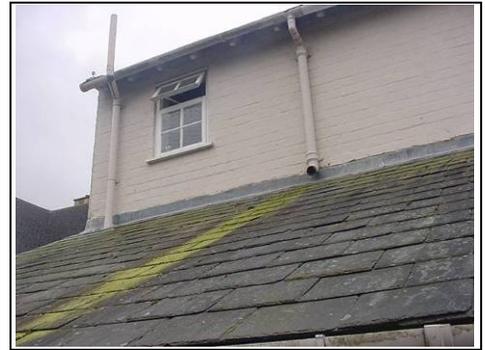
This roof is a pitched and clad in slate, as previously described. There is some pattern staining where the downpipe discharges on to this roof and also at the top which we believe is due to a lack of light getting to the area generally.

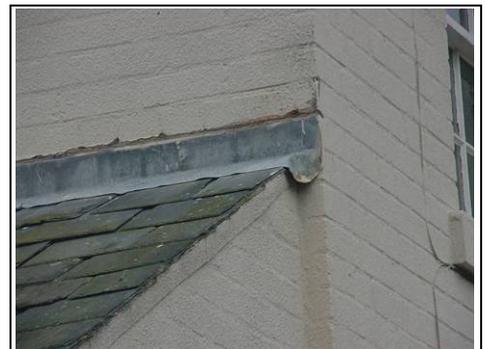
Where the roof meets the main building there is a lead flashing which looks to have been added, amended or repaired.

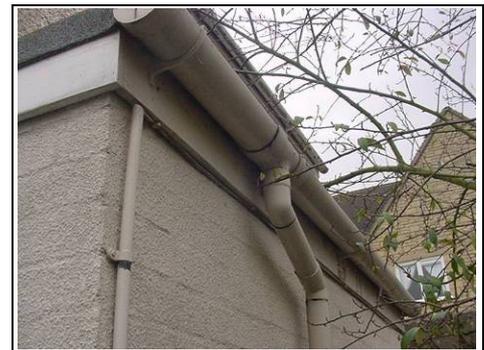
From ground level the gutters and downpipes looked to be plastic and appeared in average condition.

The plastic used is the older style with is affected by sun light and loses its colour slightly and does become brittle over the years.

Please see our comments in the Executive Summary about the rainwater possibly missing and not being caught by the gutters to the rear in particular. We can only think that this is the reason why the property has been painted overall because dampness was getting in.

**ACTION REQUIRED:** We would always recommend that the gutters and downpipes are cleaned out, the joints are checked and the alignment checked to ensure that the gutters fall towards the downpipes.

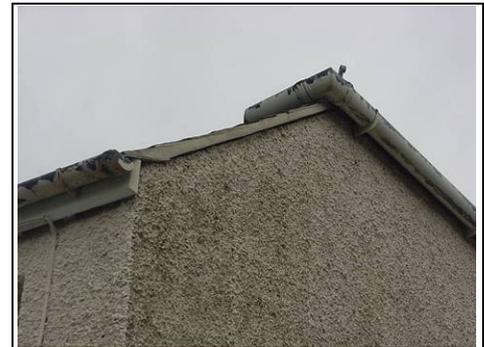
The walls at high level to this property are finished in a pebble dash painted render. We would normally carry out a tap test to the render to try to establish if there are any hollow areas, however we have not done this in this instance as the render is at high level. With this age of render repairs will increase over the years.

Painted pebbledash render

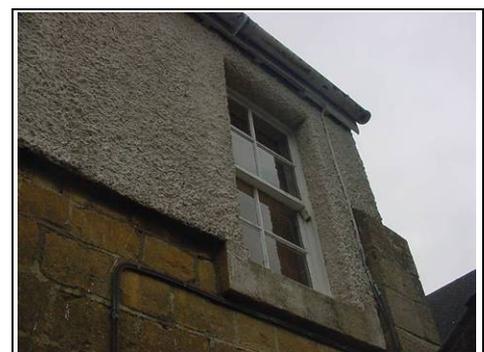
The rendering is from the cheaper end of the market and there is no render detailing around the windows or to the base. We would literally need to see the render when it is raining to establish if it is affecting the property, but we certainly think it is contributing to dampness getting in.

Render and stonework to right hand end

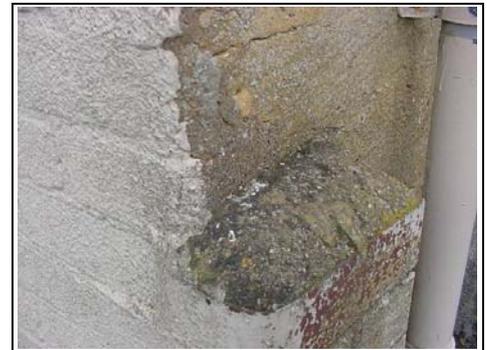
We noted a ridge in the stonework. Water can sit on this ridge and come into the property.

Ridge in stonework

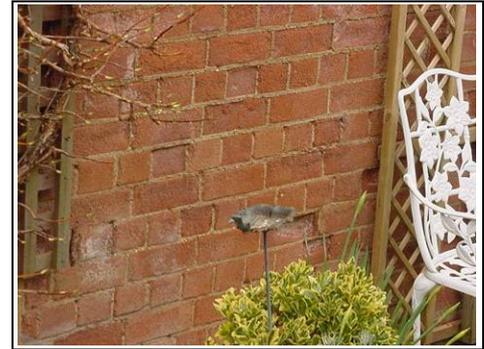
The brickwork we can see is Flemish bond which was originally pointed in a lime mortar but has been repointed in a cement mortar, which is starting to have quite bad consequences to the rear of the wall. We suggest that access is gained to the neighbouring property.

Brickwork to the rear

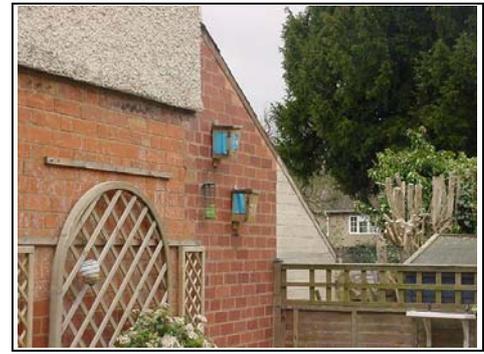
Unfortunately the brick is quite a soft red brick and is therefore starting to spall. It looks to have been repaired in the past using a cement mortar which unfortunately is making it worse and continuing the allowance of dampness into the property.

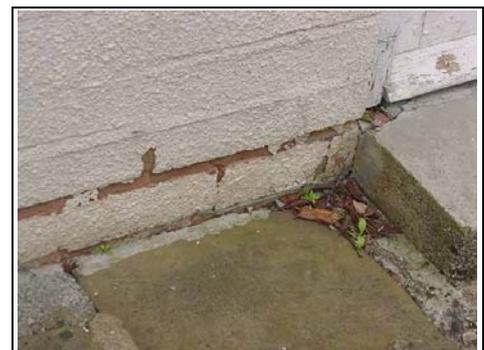
With the paint on the bricks it is difficult to see their condition, however we would take an educated guess that what has happened here is the original brickwork has started to allow in water, it has then been repointed in a cement mortar which has made the problem worse and it has then been painted over with a plastic based paint. So, the property has been moved from having a breathable wall to having one that is smothered.

Painted brickwork

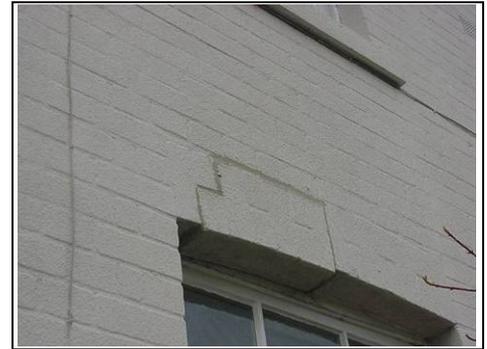
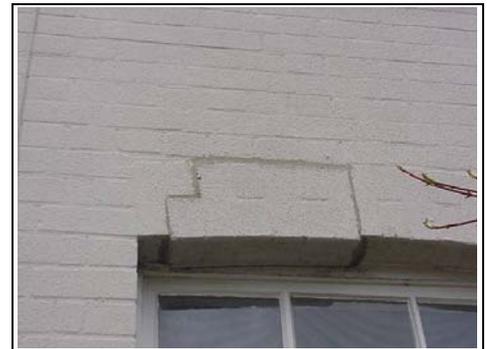
There is movement visible over the large sliding sash window. However, there are a relatively high number of openings in the property and we feel this is therefore acceptable movement. We are just concerned about the way it has been repaired. Normally we have seen repairs to brick soldier courses over windows that have had a slate wedged in to pack them together; in this case it just looks like the cracking has been filled in, therefore the brickwork could still literally fall out.

**ACTION REQUIRED:** Have a proper repair carried out with packing involved.

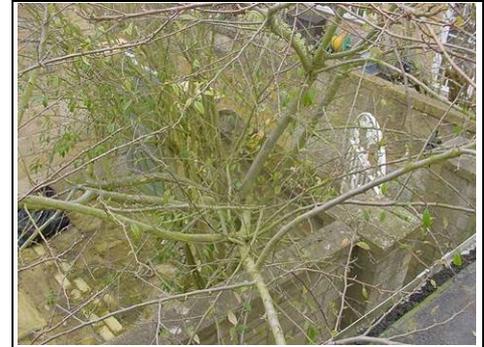
Next door's trees are very close to the building on the right hand side and need maintenance; we recommend you speak to the next door neighbours about the trees to ensure they are happy to maintain them. Damage to foundations and underground services can be caused by trees and shrubs.

Next door's trees

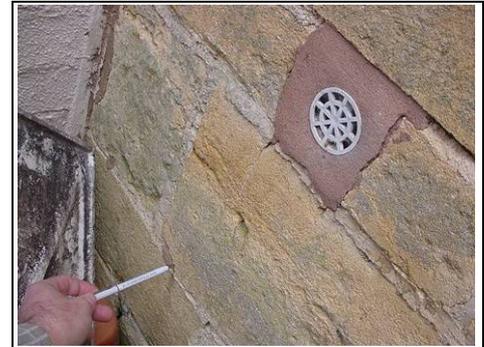
Two damp proof courses have been inserted

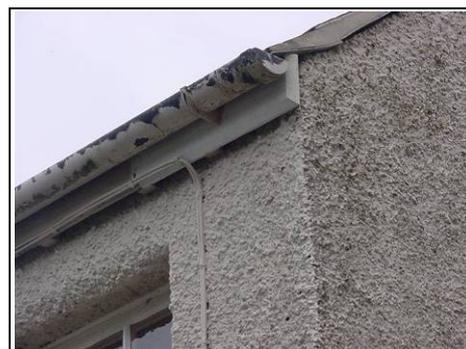
The fascia is hidden behind the guttering in this instance and we could not see it very well. We could see that the paintwork to the gutters is coming off, therefore indicating that they are leaking, which in turn will probably mean that there is some wet rot in the fascias.

Fascia hidden behind the guttering

**ACTION REQUIRED:** Repair and redecorate.

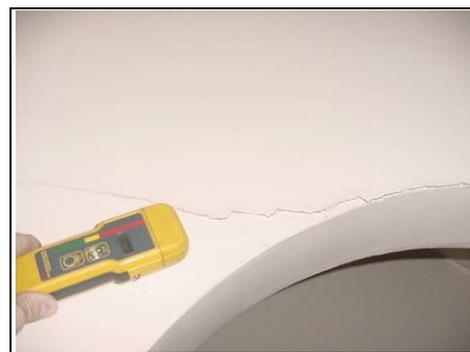
Cracking over archway on first floor

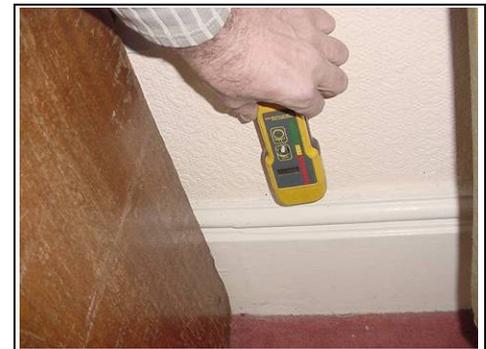
We carried out tests with a damp meter to a random selection of areas and we found damp.

Checking for dampness

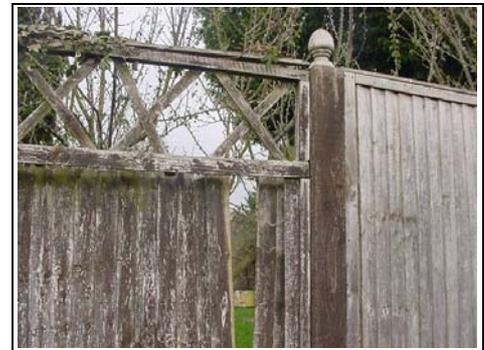
We would suggest you have a meeting with the adjoining owner to see how the land lies with regard to this fence; it certainly did not look in the best of conditions.
