RESIDENTIAL BUILDING SURVEY

Three Storey Georgian Property in Devon

Mrs Georgian

GEM Associates Limited

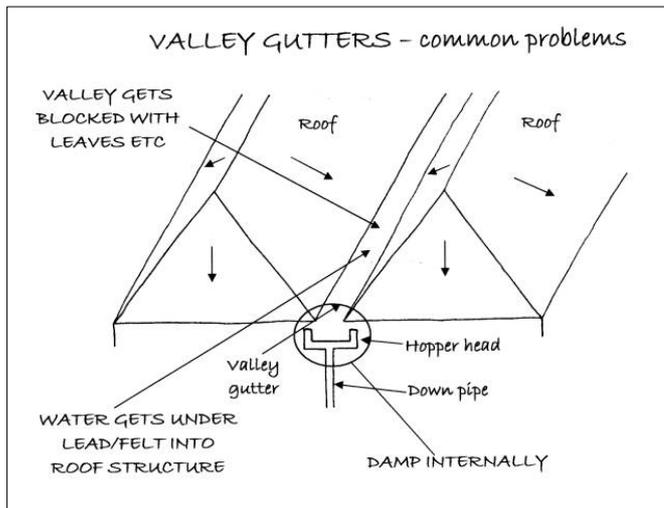
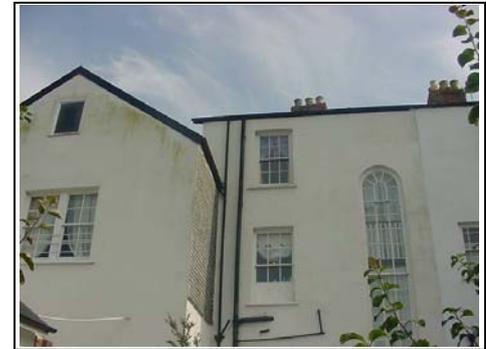
Between the main roof and the right hand roof extension there is a hidden valley gutter. This explains why we have the vertical tiling on the property, as the amount of water that has been collected in this area may sometimes be excessive and discharge down the side of the property.

Between the main roof on the right hand side of the photo and the left hand roof there is a hidden valley gutter.

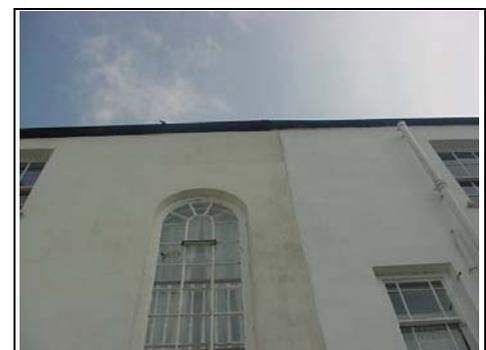
Rear view of the property. You can see that your paintwork requires painting.

ANTICIPATED COST: We would recommend that you paint an elevation at a time, initially making sure all the repairs to the render work are carried out. We would suggest that you budget in the region of £2,500 - £5,000 per elevation, assuming you will use your own tower scaffolding for part of the work.

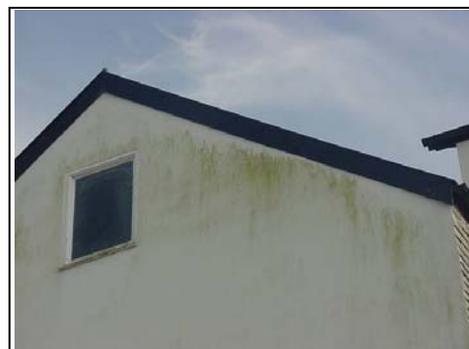
The paintwork acts as a protective coat and any hairline cracks within the render need to be filled as quickly as possible. We would expect you to redecorate almost on a continuous cycle. We also noted moss to the render, which is always bound to be a problem where you are surrounded by trees.

Moss to the render

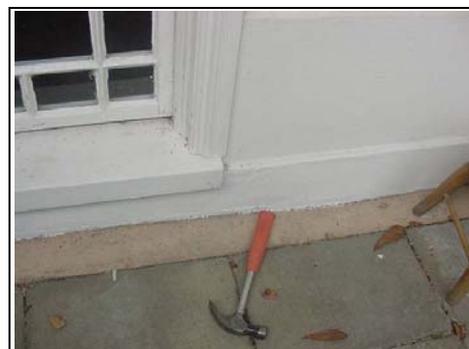
We would recommend that the detailing to the base of the render has what is known as a bell-mouth detail. This will help stop the blotting paper effect where the render is drawing up rainwater into the property and making it damp.

ACTION REQUIRED: Add a bell-mouth detail to the base of the render and add drip details above the windows.

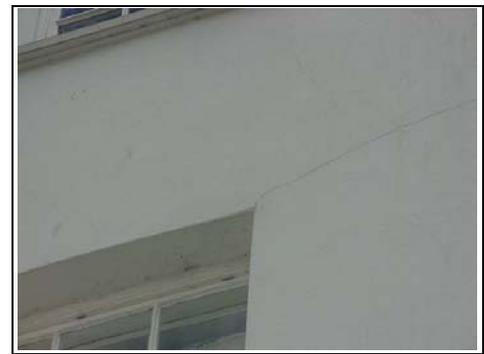
You should also look at providing a drip detail above the windows.

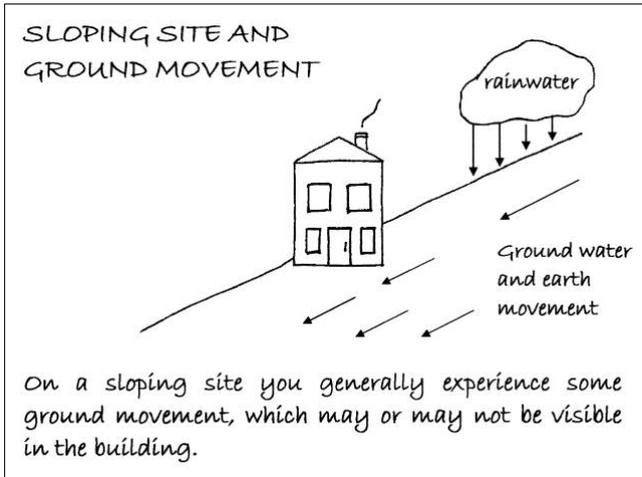
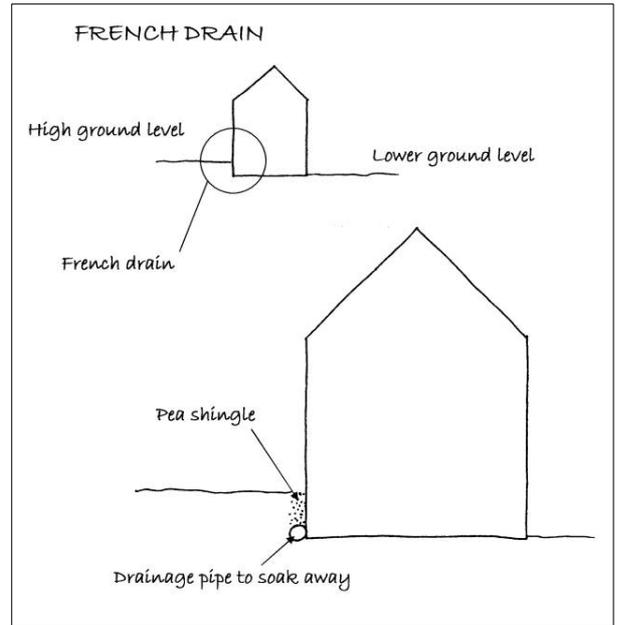
Dampness in the garden

ACTION REQUIRED: We would suggest that you stand outside the property next time it rains heavily and see where the water really goes and then work with nature and help the water to get from the top of the site to the bottom. We would suggest you add a French gully to the front of the property and slates on edge to the bottom garage area (if you recall there is a yellowing patch to the paintwork where it looks like all the rainwater goes).

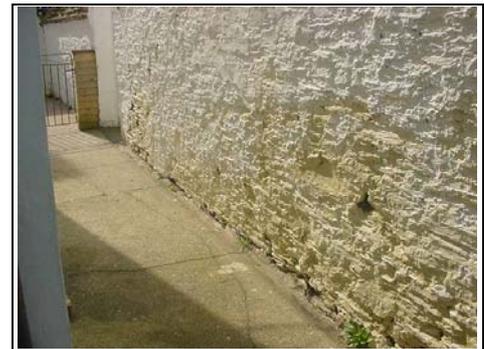
Yellow patch to garage wall.

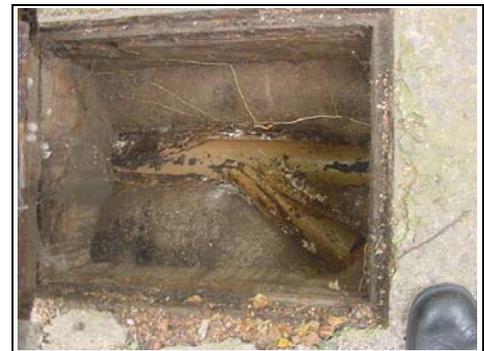
Roots in the drains

ACTION REQUIRED: A Close Circuit TV Camera Report to be carried out on the drains.

Call an arboriculturist (not a tree surgeon, as they just cut down trees) or wise old man to advise you on the trees and kill the roots within the drains.

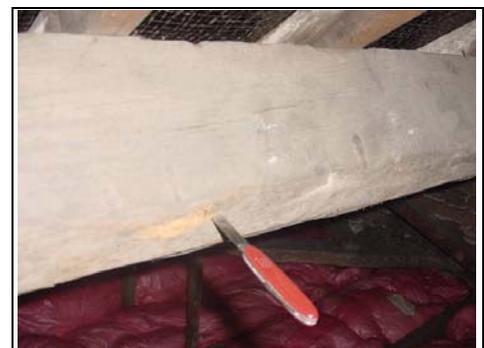
As we would expect with a property of this age you do have woodworm. The question is whether the woodworm is active. From what we could see it is not active; however you can only really tell during the breeding season in the spring.

ACTION REQUIRED: We recommend that you ask the present owners whether they have had woodworm treatment carried out. If not then get a quotation from a BWPDA (British Wood Preserving and Damp Proofing Association) approved contractor. If the work in the roof is to be carried out properly then all the insulation has to be removed and spraying carried out; if the insulation is not removed then it is unlikely to be successful.

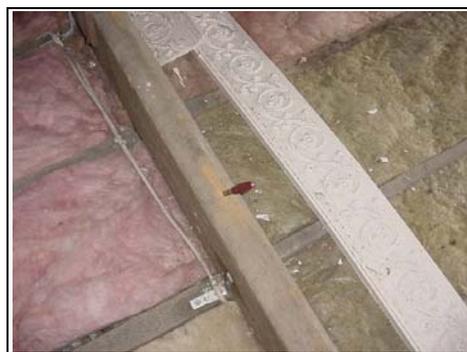
We have decided to bring this specifically to your attention; having given this due thought and consideration both roofs have common rafters that are thinner than we would normally expect. In addition to this both have dampness and woodworm and the main roof has had problems in the past, which is why it is propped. You do need to budget for possible repair and replacement of this roof in years to come. Please contact us to discuss this issue further.

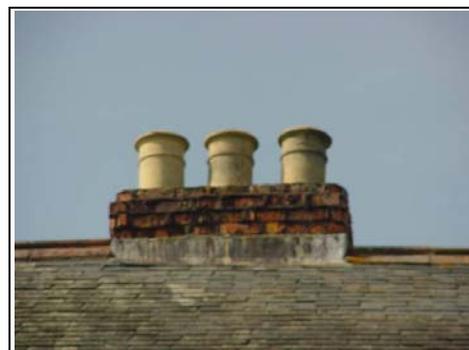
This chimney is brick finished with a metal flashing, we believe it to be lead, with three chimney pots. Where we could see deterioration the chimney needs repair / repointing. Unfortunately we were unable to see the very top of the chimney known as the flaunching, we therefore cannot comment upon it.

ACTION REQUIRED: Please see our comments in the Executive Summary.

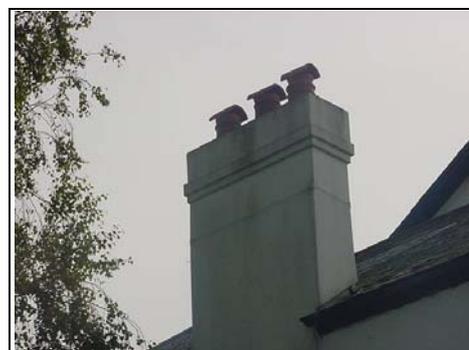
This is a large chimney with a painted render finish and a metal flashing that we believe to be lead. There are three chimney pots. From ground level the chimney looks to be in a reasonable state of repair. Again, unfortunately, we were unable to see the very top of the chimney known as the flaunching, so we are unable to comment upon it.

ACTION REQUIRED: Please see our comments in the Executive Summary and check the condition of the chimney when carrying out high level repairs to other areas.

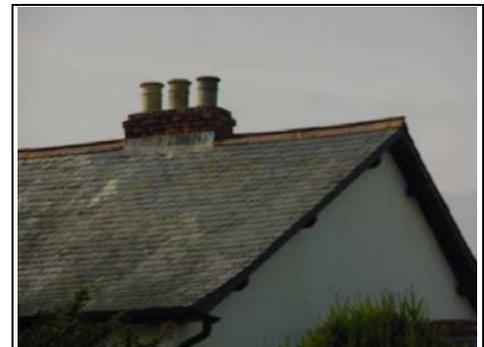
The left hand side roof is pitched and clad with quarried tiles. The slates sit fairly true and are generally in average condition considering the property's age, type and style.

We believe this roof to have been re-roofed post war, probably around the 1960s; this is based upon the protective underlayer we could see.

ACTION REQUIRED: As with most roofs of this age this roof will need some general day-to-day maintenance. We could see some slipped and missing slates and we could also see that some parts of the ridge need re-bedding. This is all part of the general maintenance that is required on this age of property.

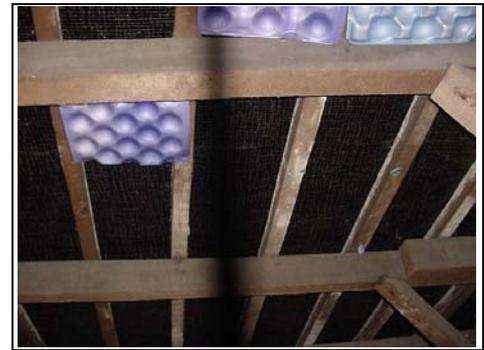
When we inspected the loft space we found a Hessian base Bitumen membrane. This type of membrane has been used since the 1960s. We generally found it to be in average condition, although it is damaged in a few places but this is not unusual considering its age.

This photo shows the common rafters (the ones that form the pitch of the roof) and the dark area between is the underlayer. The purple items in the photo are egg boxes which have been used, we assume, for additional insulation; we would however recommend removing them as they can cause condensation.

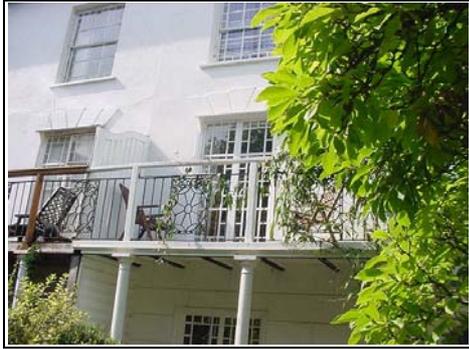
Balcony

As you can see from the photos below some work is required to the balcony. The leak you can see in the corner may be a leak that you will never get rid of as you can tend to chase such leaks around. Having had a balcony myself I am well aware that sometimes you just have to accept that there will be a minor amount of leaks to it.

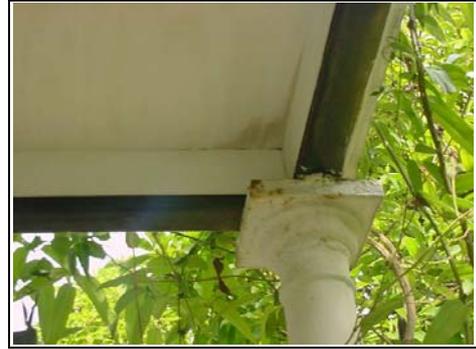
If you look closely you can see a damp patch in the corner and you can also see rusting to the cast iron supports.

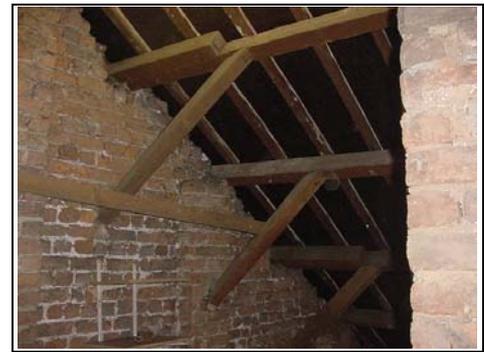
We would also add that quite unusually there are props in the roof at the side. If you look at the adjoining photo you can see props to the right hand side wall. This type of addition would have been added due to dipping in the main roof as a 'belt and braces' measure. We think the main issue here is the thinner common rafters which will be very difficult to replace without completely re-roofing the property.

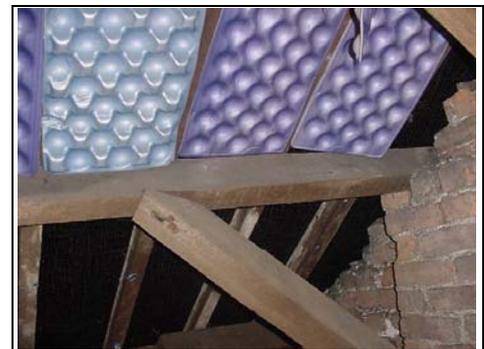
Our examination was limited by the general configuration of the roof, the pink bagged insulation and some stored items. As mentioned above we found the roof in what we would term as below average condition with dampness and woodworm. Sorry to repeat ourselves but the woodworm is an issue even when taking into consideration the roof structure's age; we could see flight holes and the timber was generally soft from the woodworm.

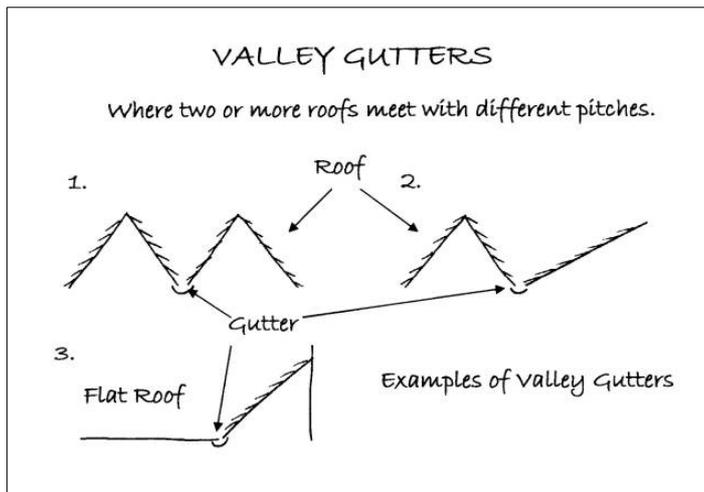
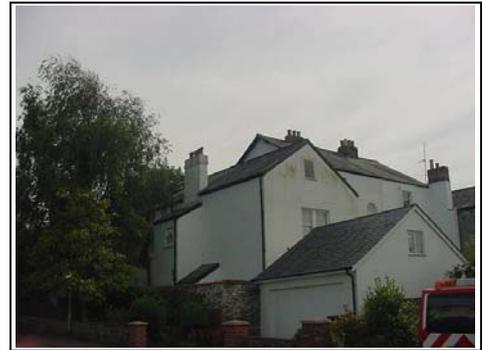
Valley gutters are renowned for causing problems which is why dampness is getting into the base of the timbers.

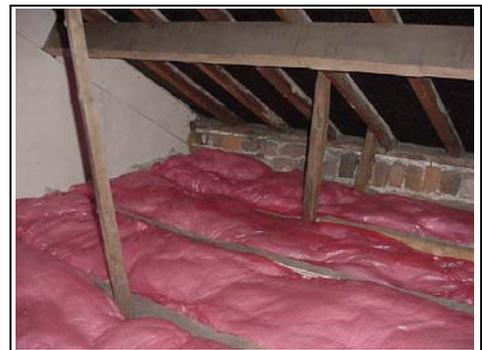
Here you can see the timber fire wall to the left hand side; you can also see the dampness getting into the timbers and some more props.

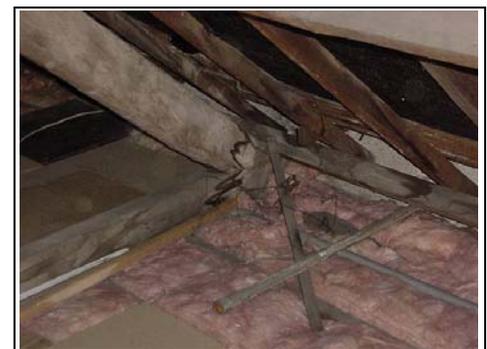
Side View

Again, our examination was limited by the general configuration of the roof and the insulation, this roof was remarkable free of stored items. Again, we would classify the roof as being in below average condition; we found dampness and woodworm. Please see our comments in the Executive Summary.

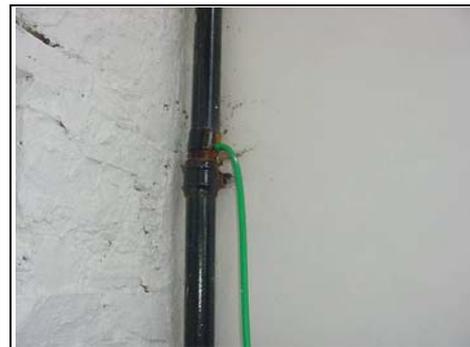
The property has a mixture of the original cast iron gutters and downpipes and the more modern plastic gutters and downpipes. What we found was generally in slightly below average condition, all things considered, and we could see areas where the gutters and downpipes are rusting and damaged.

Rusting cast iron downpipe

ACTION REQUIRED: Next time it rains hard you need to watch the gutters and downpipes for leaks, make a note and repair them. This process will need to be repeated many times.

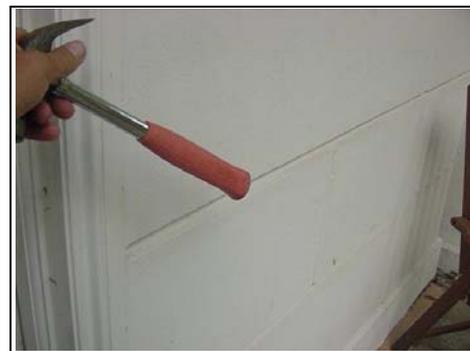
Hammer test to render

We have carried out a tap test to the render at low level (literally hitting the render with the back of a hammer) to try to establish if there are any hollow areas. We have found the render to be average for this age of property. No doubt you will have to carry out render repairs over the years and will come to expect it.

ACTION REQUIRED: You need to keep the render and paintwork in good condition and check the condition of the render at high level. We have suggested earlier in the report that you purchase your own tower scaffolding and you should also look at carrying out repairs to the building on an elevation by elevation each year as a constant repair process.

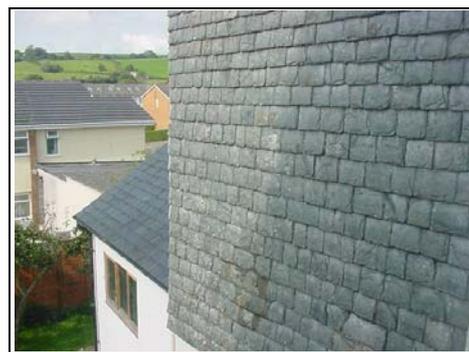
At high level, where the main roof meets the right hand roof, there is a hidden valley gutter (please see our comments on this elsewhere in this report); this means that water from the right hand roof is collected and then carried to the rear of the property, in fact to the gutter directly above the vertical tiling that you can see in this photo. This, we assume, overflows and has done for many years and rather than dealing with the 'cause' of the problem, which is to add a larger hopper head gutter, as is often the case the 'effect' of the problem has been dealt with, which no doubt was the water running down the render, this has been dealt with by adding vertical tiling.

ACTION REQUIRED: We believe you will need to add a larger gutter to the rear of the property.

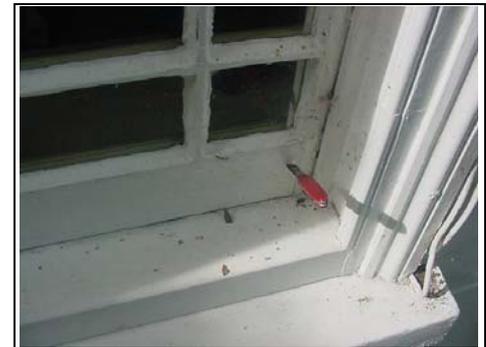
Knife test showing minor wet rot

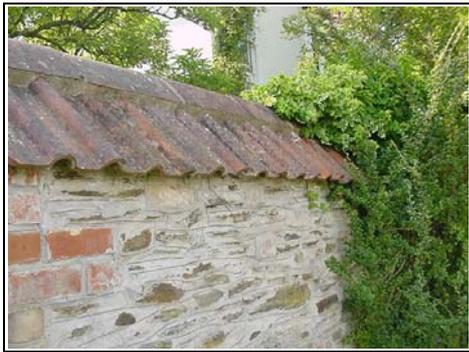
Poorly repaired garden wall with Roman tiles to the top

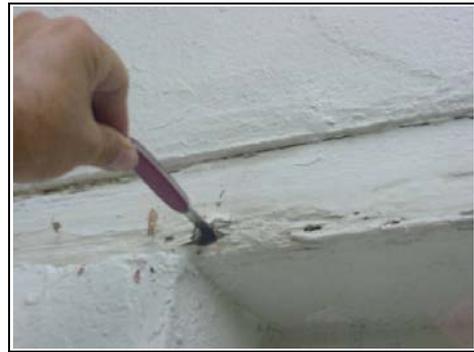
Rotting timber lintel to garden wall
