RESIDENTIAL BUILDING SURVEY

Semi Detached Victorian Property in London

GEM Associates Limited

INDEPENDENT CHARTERED SURVEYORS

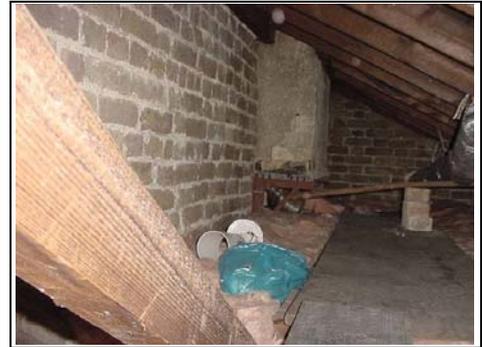
The rear chimney at the property has been removed. If you recall we showed you this within the roof space. This should have had Building Regulation approval although in many cases we find that it hasn't. It has stood the test of time and there is no obvious stress cracking to areas around it; having said that the property is, of course, newly painted, and was still in the process of being painted when we carried out the survey.

Chimney being supported within the roof space

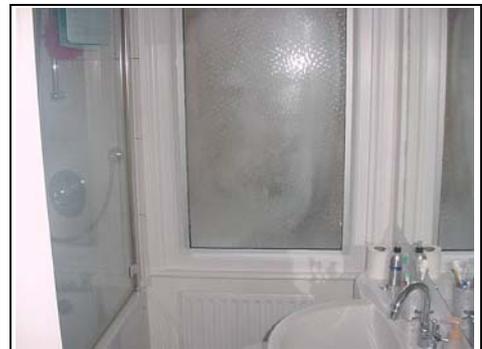
We noted that the double glazing to the bathroom was misting over indicating that the seals have gone, which will need replacement in due course. However, as this is a frosted window it may not be of much importance, although it may indicate what is to come with deterioration to other double glazed windows.

ACTION REQUIRED: You need to establish if there are guarantees available on the existing double glazing.

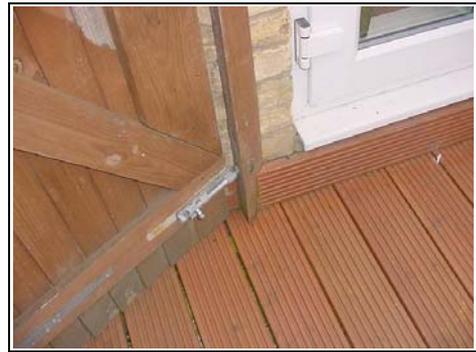
Decking, possibly blocking airbricks

We noted airbricks at the front of the property, but there should also be airbricks to the rear of this property to get an air flow. There may be some to the rear covered by the decking.

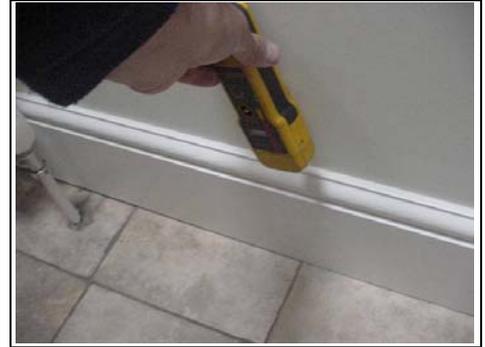
Dampness was found to the right hand side (all directions given as if you face the property from the front) approximately two thirds of the way along the property.

We believe this either relates to a leaking gutter, unfortunately you are going to have to stand outside when it next rains to see if it is overflowing down the wall in this area, or alternatively a break in the damp proof course could also be causing the dampness where the extension has been added and it could be that it is travelling to this area.

Checking for dampness

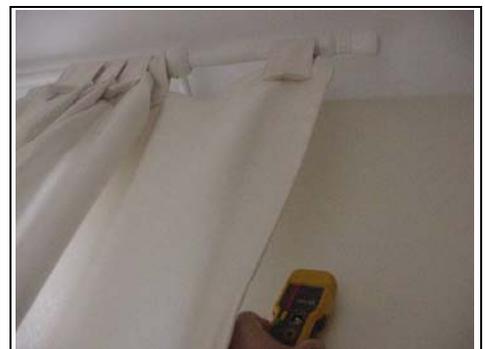
We would advise that there is a possibility of some lateral dampness that is relatively common in this age of property. We mention this because we did get minor readings of dampness in the rear bedroom which could, of course, relate to the alterations to the chimney or in fact slight dampness and drying out in the paint.

Lateral Dampness

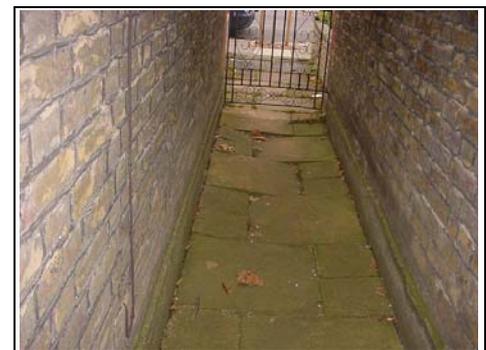
The drains run between this house and the adjoining property on the right hand side and are directly below an uneven footpath. The uneven footpath indicates to us that there has been some leakage in this area, which is not uncommon in this age of property but it is the extent of the leaks that can be the problem.

Uneven path

ACTION REQUIRED: Close circuit TV camera report to check the condition of the drainage run. Please see our comments in the Executive Summary.

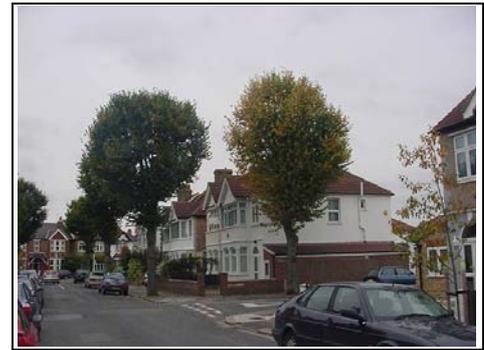
We would also add that there is a sapling tree to the end of the property which looks to have been newly replaced. There could have been problems relating to this.

Nearby Trees

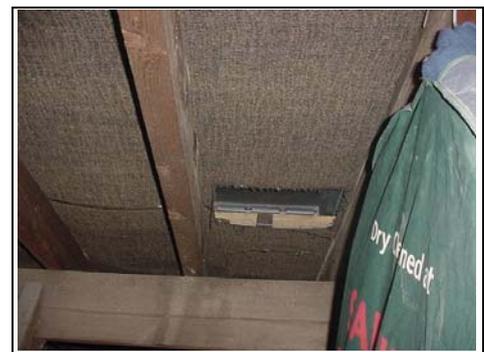
We have mentioned this especially due to our discussions. The current Building Regulations recommend a roof insulation of 270mm – 300mm, however it is important with an older property that it is suitably ventilated to avoid condensation; we noted that there are vents in the roof space.

Ventilation in the roof space

ACTION REQUIRED: If you do add insulation you do need to ensure that the ventilation is sufficient to not cause condensation.

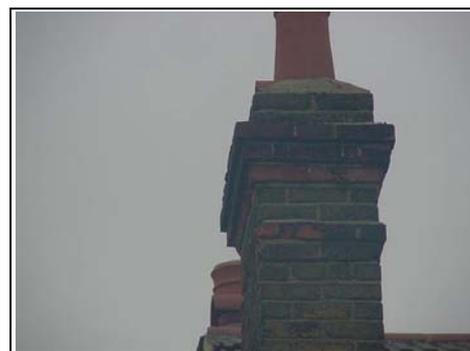
Chimney Two – Located to the Rear Roof

Our view of this chimney was very limited; we could see it was brick built and we know from our further investigations that it has been removed at first floor and ground floor level and is supported. Often we find with alterations to a chimney that there is some dampness coming in around them, which normally raises its head during the winter months.

ACTION REQUIRED: As discussed an option would be to remove the chimney completely although you do need to get Party Wall agreement (more about this at the end of this section).

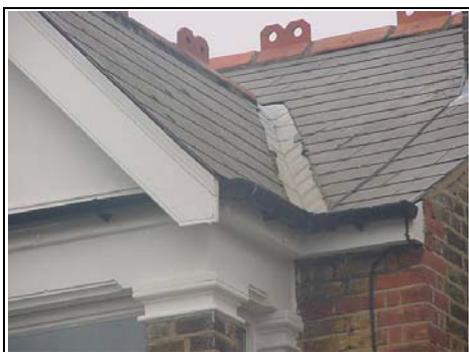
The valley gutters are finished in lead, which looks in reasonable condition. We could see some moss to the sides of it and we could see that some minor dampness was getting in within the roof, but presently we feel this is at an acceptable level.

Valley Gutter

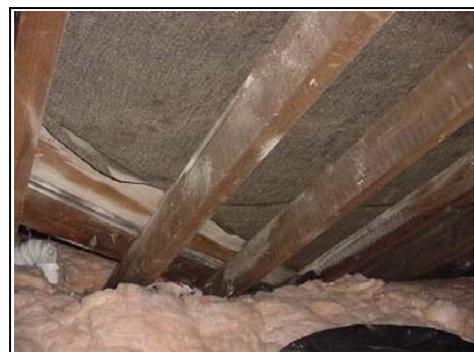
Minor dampness in the roof space

Our examination was limited by the general configuration of the roof, the insulation and stored items. As mentioned what we could see was generally found to be in an average condition with some minor dampness coming in via the valley gutters. It is, however, feasible that there are problems in the roof that are hidden.

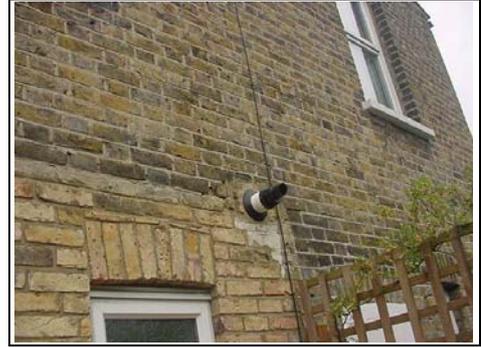
Different Coloured Bricks to the Rear

To the rear there are different coloured bricks which could either be because the area has been re-built or there was some sort of lean-to structure to the rear of the property.

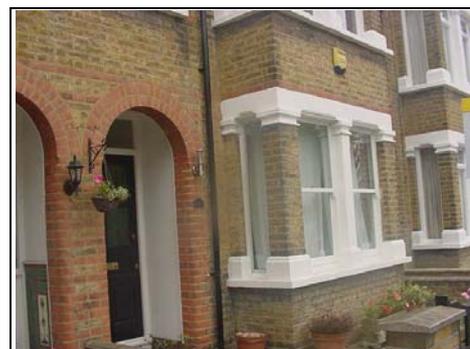
This property predominantly has sliding sash windows, which are double glazed and have a painted timber finish and are in reasonable condition considering their age, type and style. We would specifically comment that they are double glazed. The double glazing to the front windows is quite thin, as is often the case where it is added to sliding sash windows; this, as we discussed, is to allow weights in the side of the sliding sash to balance.

ACTION REQUIRED: Please see our comments in the Executive Summary. As is common the windows will need some easing and adjusting by a carpenter who is used to dealing with this type of work.

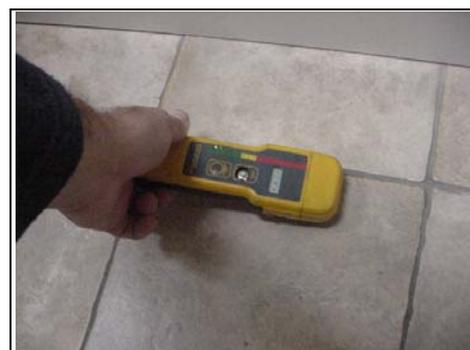
We have carried out tests with an electronic damp meter to a random selection of areas and we found rising damp.

Checking for dampness

ACTION REQUIRED: Please see our comments in the Executive Summary.
