SPECIFIC DEFECTS REPORT

Relating to Cracking to the Plasterwork

12 Claremont Grove, Woodford Green, Essex IG8 7HS

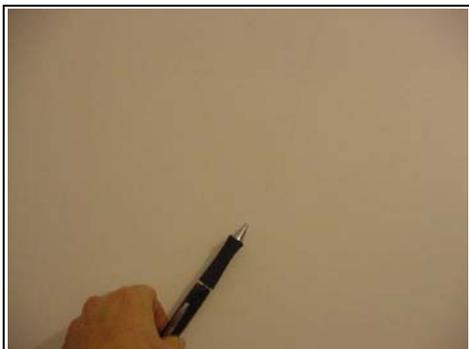
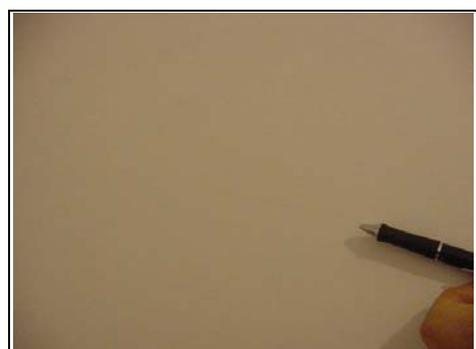
An example of the hairline cracking

From our discussions with yourself and general visual investigations, we believe that the original lime based plaster has had a skim coat of modern gypsum plaster, and then we would term it as being “painted to sell”, albeit that the redecoration leaves a lot to be desired in some areas! These two materials (lime plaster and gypsum plaster) have very different characteristics and they contribute towards the differential movement in the property.

Unfortunately the cracking to the plaster will be a feature of this property until the gypsum plaster is removed (not that we are suggesting that this is carried out as it is a very difficult task although not an impossible task).

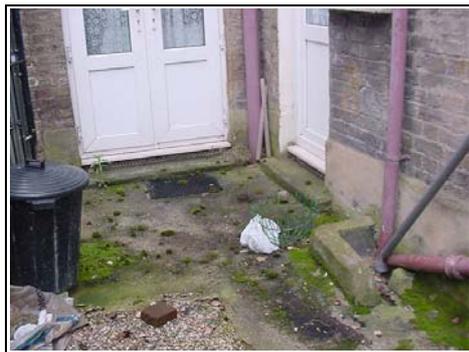
Your home sits on a sloping site. Therefore any rain water will run from the top of your garden to the bottom of your garden. You can however aid how the rainwater travels from the top to the bottom of your garden by adding a French gully (also sometimes knows as a land drain). Presently we can see moss to the rear area of the garden which does indicate that a fair amount of water is sitting in the area.

Moss to the rear area of the garden

We would recommend that the next time it rains, you stand out in the rear garden and check exactly how much rain water comes down and passes your property.

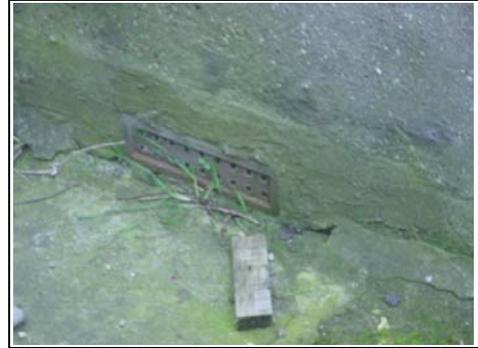
We have already touched upon this point with the adding of a French gully around the property. We would also add that some of your air bricks are effectively adding as gullies due to their location at outside ground level. You could add a temporary protection using brickwork around the gully (as the one in the bottom photograph).

Air vent acting as a gully

We would recommend you check the timber flooring found particularly around the gully points. We also found rising damp in this area, which we think has been caused partly by the rainwater travelling from the top of your garden to the bottom. We have also discussed how your property sits on a sloping site and we need to help the water travel around the property rather than down the side of it. Also in this case water appears to be travelling through your property! We have already touched upon this point by adding a French gully around the property.

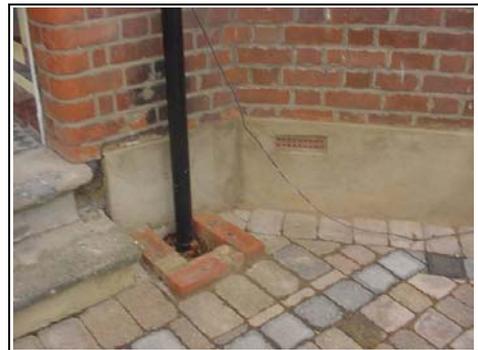
Brick around the gully

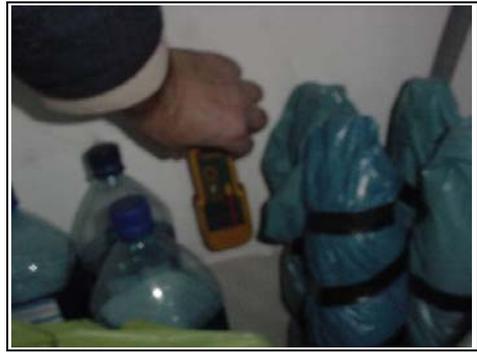
We also checked the property for rising damp using a damp meter and believe the dampness that we discovered which was predominantly to the right hand side of the property (and no doubt could also get to the rear of it) was due to the ground levels being above the property. You simply need to lower the ground levels when you are adding in the French gully. We discussed that you believed a damp proof course has been added or inserted previously. It is likely that your property already has a slate damp proof course. We think from memory that you did actually see this. There is no need to add a further damp proof course (regardless of what a specialist damp proof company may tell you). You do however need to lower the ground level and add a french gully.

Checking for Dampness

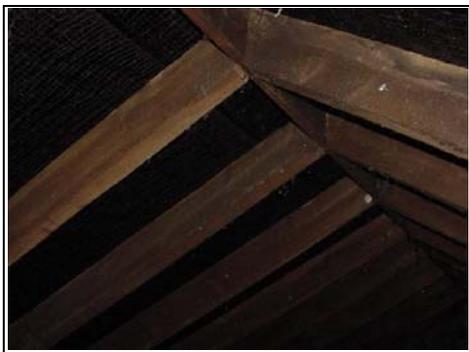
Ridge Board and common rafters (the ones which form the pitch of the roof) showing minimal signs of movement.

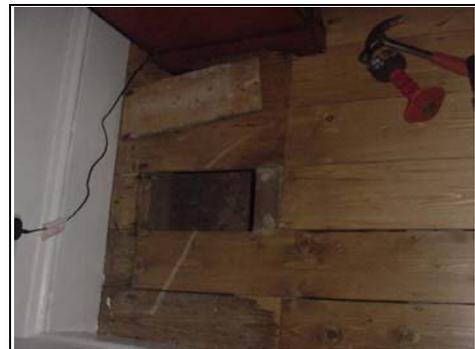
Opening up of the floor to the dining room area

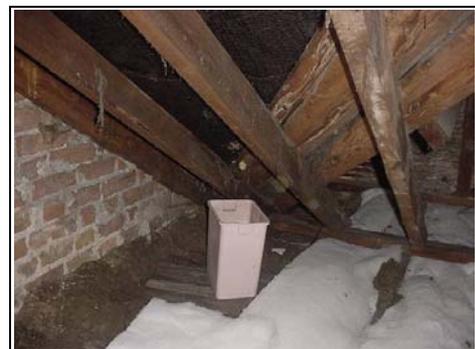
Bucket catching rain water!

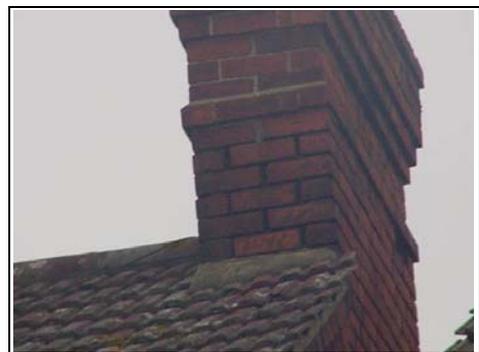
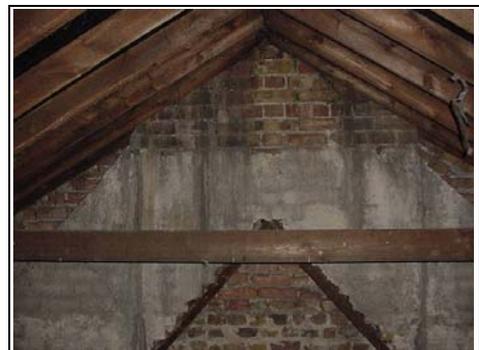
If you recall there was pattern staining internally within the roof space which indicates that the cement flashing to the parapet wall is allowing some dampness in. Again we would recommend that this is replaced with lead.

Pattern staining indicating that dampness is coming through the cement flashings

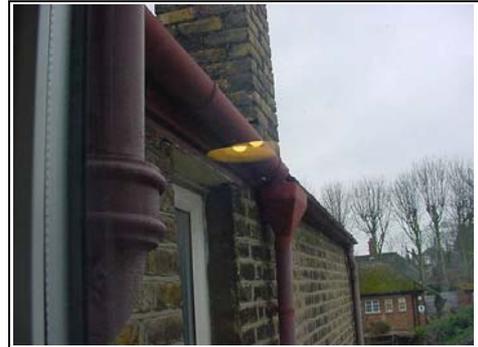
There is staining to the rear bedroom which unfortunately hasn't showed at all in our photos. We believe that this is coming from either the adjacent leaking guttering and/or the adjacent flashing to the chimney leaking. It is not possible to see from our limited view from the property.

Photo taken from your middle bedroom (sorry about the reflection off the bedroom light!)

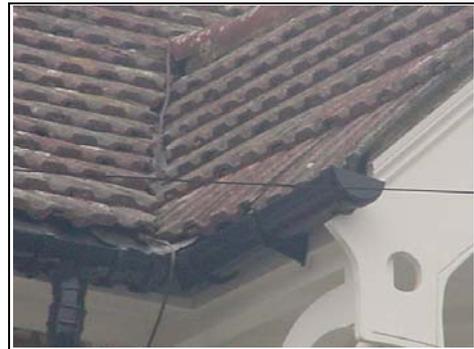
You have valley gutters to your roof where for example the front bay meets the main roof. The valley gutter was difficult to view however from the inside the valley gutter can be seen to be leaking albeit relatively minor.

Valley Gutter from the outside

ACTION REQUIRED: The flashing needs to be checked.

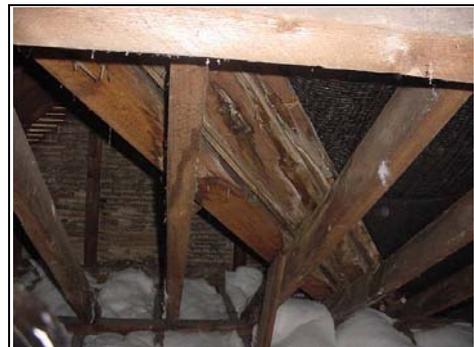
You can see from the darker colour of the far timber, that dampness is coming in via the roof (we believe via the flashings)

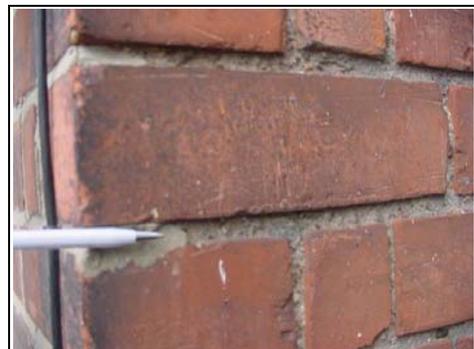
Unfortunately the front of the property has been repointed in a cement mortar. Originally this would have been in a lime mortar which is far softer. The new cement mortar has not only smothered the front of the property (meaning that any rain water which gets into the wall doesn't dissipate that well) but has in turn caused the spalling of the soft red brick.

Here is a close up with a pen indicating where the cement mortar meets the lime mortar

ACTION REQUIRED: Ideally we would remove all of the cement mortar however this is a difficult job. We would recommend that the cement mortar is removed by hand with a hammer and bolster rather than with a skillsaw as this could cause damage to the relatively soft brick work, particularly on the perp ends (the perpendicular or vertical ends of the brick). The skillsaw simply isn't delicate enough to carry out this work. Unfortunately if left, the spalling of the brickwork will get worse. Some of the bricks are already quite badly spalled and therefore it is usually best considered to take any badly spalled bricks out and replace or use brick dust with a lime mortar mix to match the brick colour, but this is difficult to do and in our opinion doesn't look very good.

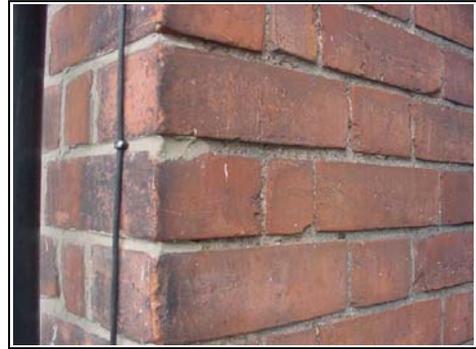
Here you can see on the corner of the property at the front on the left hand side where it has been repointed in cement mortar to the front and you can see where the cement mortar meets the lime mortar

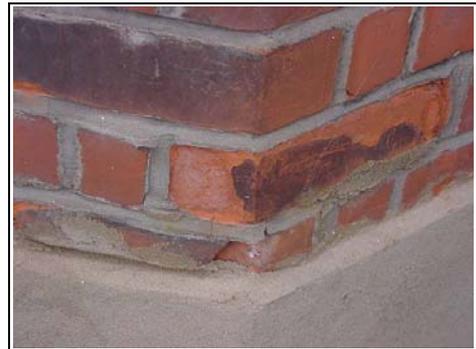
Spalling red brick
