SPECIFIC DEFECTS REPORT

Relating to Cracking to the Plasterwork

12 Claremont Grove, Woodford Green, Essex IG8 7HS

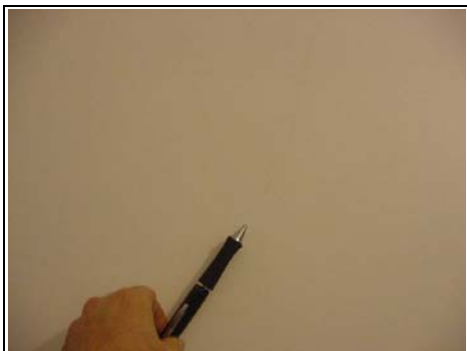
An example of the hairline cracking

From our discussions with yourself and general visual investigations, we believe that the original lime based plaster has had a skim coat of modern gypsum plaster, and then we would term it as being “painted to sell”, albeit that the redecoration leaves a lot to be desired in some areas! These two materials (lime plaster and gypsum plaster) have very different characteristics and they contribute towards the differential movement in the property.

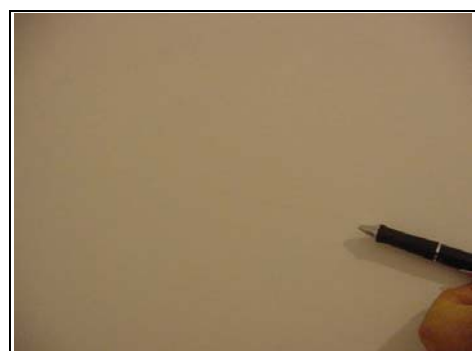
An example of the hairline cracking

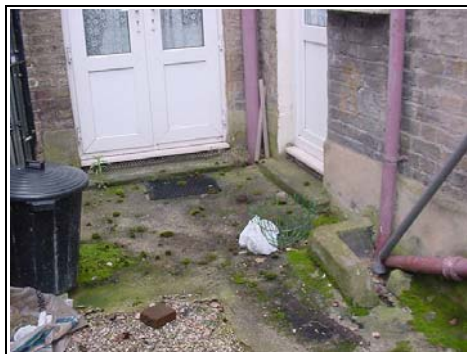
Your home sits on a sloping site. Therefore any rain water will run from the top of your garden to the bottom of your garden. You can however aid how the rainwater travels from the top to the bottom of your garden by adding a French gully (also sometimes knows as a land drain). Presently we can see moss to the rear area of the garden which does indicate that a fair amount of water is sitting in the area.

Moss to the rear area of the garden

We would recommend that the next time it rains, you stand out in the rear garden and check exactly how much rain water comes down and passes your property.

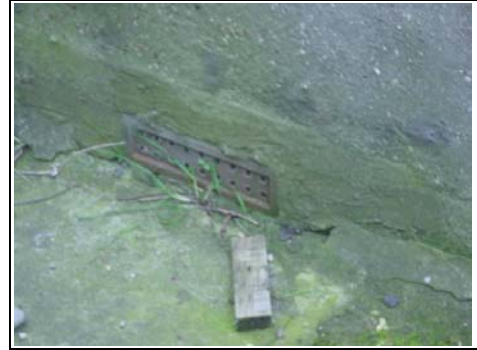
We have already touched upon this point with the adding of a French gully around the property. We would also add that some of your air bricks are effectively adding as gullies due to their location at outside ground level. You could add a temporary protection using brickwork around the gully (as the one in the bottom photograph).

Air vent acting as a gully

We would recommend you check the timber flooring found particularly around the gully points. We also found rising damp in this area, which we think has been caused partly by the rainwater travelling from the top of your garden to the bottom. We have also discussed how your property sits on a sloping site and we need to help the water travel around the property rather than down the side of it. Also in this case water appears to be travelling through your property! We have already touched upon this point by adding a French gully around the property.

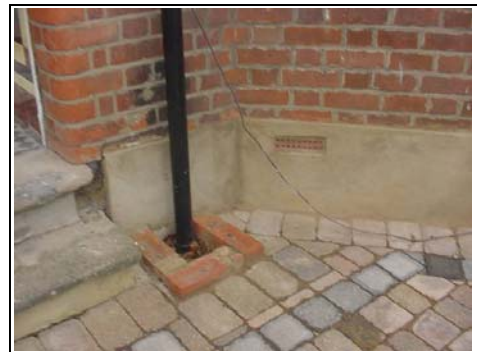
Brick around the gully

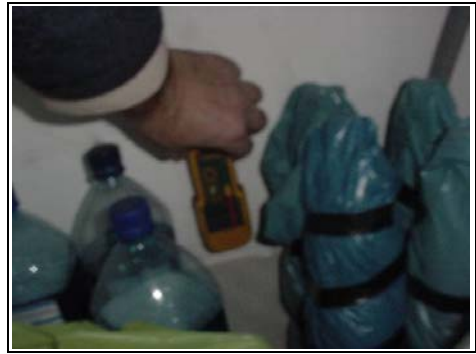
We also checked the property for rising damp using a damp meter and believe the dampness that we discovered which was predominantly to the right hand side of the property (and no doubt could also get to the rear of it) was due to the ground levels being above the property. You simply need to lower the ground levels when you are adding in the French gully. We discussed that you believed a damp proof course has been added or inserted previously. It is likely that your property already has a slate damp proof course. We think from memory that you did actually see this. There is no need to add a further damp proof course (regardless of what a specialist damp proof company may tell you). You do however need to lower the ground level and add a french gully.

Checking for Dampness

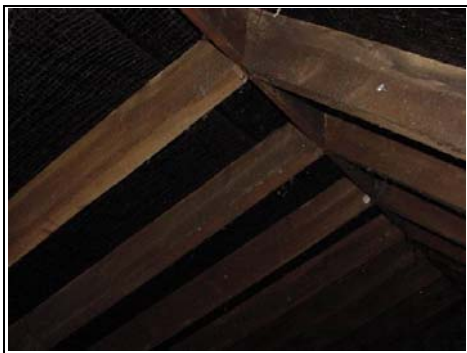
Ridge Board and common rafters (the ones which form the pitch of the roof) showing minimal signs of movement.

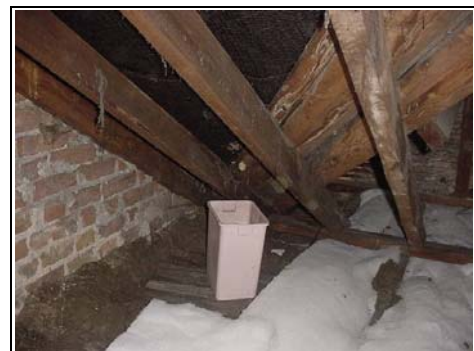
Bucket catching rain water!

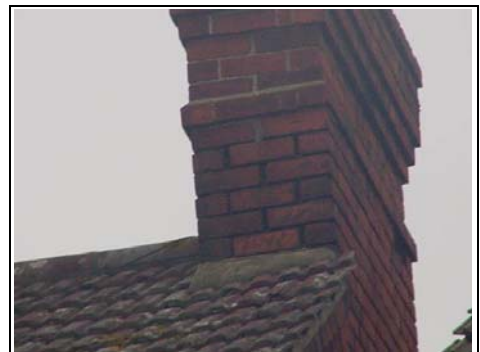
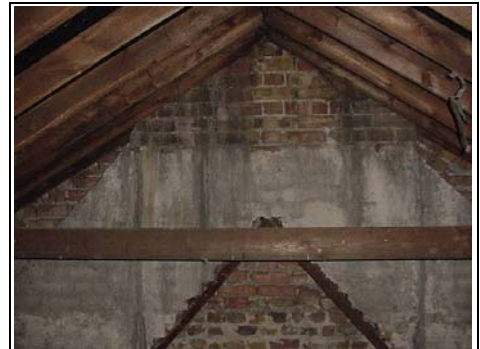
If you recall there was pattern staining internally within the roof space which indicates that the cement flashing to the parapet wall is allowing some dampness in. Again we would recommend that this is replaced with lead.

Pattern staining indicating that dampness is coming through the cement flashings

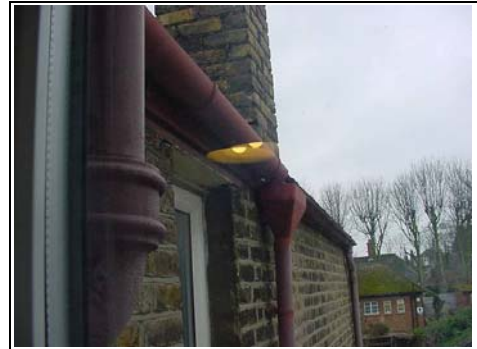
There is staining to the rear bedroom which unfortunately hasn't showed at all in our photos. We believe that this is coming from either the adjacent leaking guttering and/or the adjacent flashing to the chimney leaking. It is not possible to see from our limited view from the property.

Photo taken from your middle bedroom (sorry about the reflection off the bedroom light!)

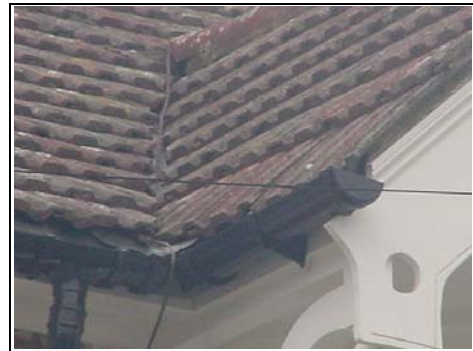
You have valley gutters to your roof where for example the front bay meets the main roof. The valley gutter was difficult to view however from the inside the valley gutter can be seen to be leaking albeit relatively minor.

Valley Gutter from the outside

ACTION REQUIRED: The flashing needs to be checked.

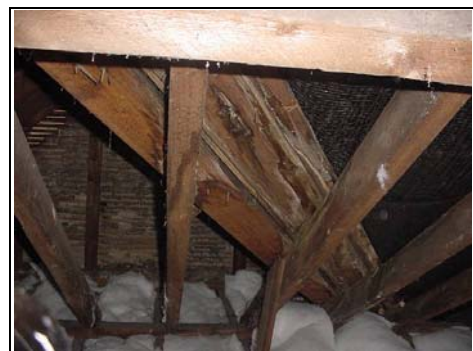
You can see from the darker colour of the far timber, that dampness is coming in via the roof (we believe via the flashings)

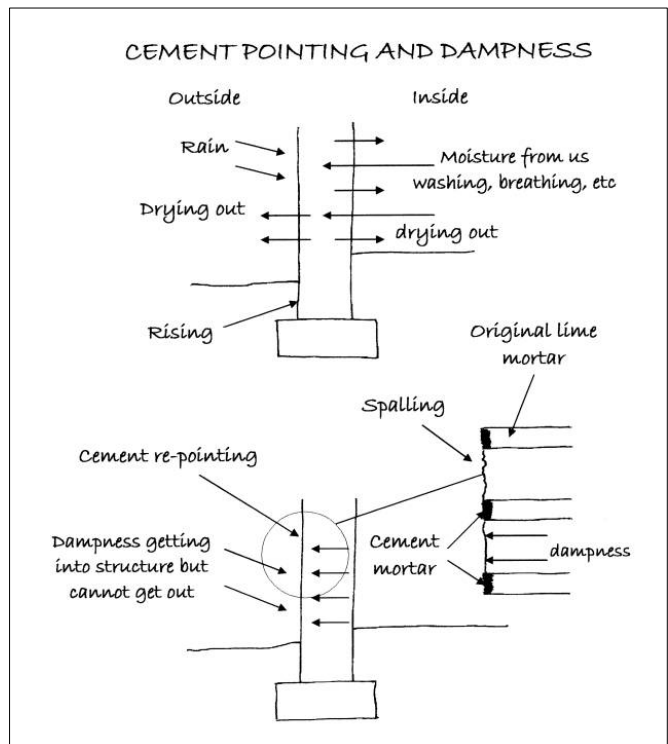
Unfortunately the front of the property has been repointed in a cement mortar. Originally this would have been in a lime mortar which is far softer. The new cement mortar has not only smothered the front of the property (meaning that any rain water which gets into the wall doesn't dissipate that well) but has in turn caused the spalling of the soft red brick.

ACTION REQUIRED: Ideally we would remove all of the cement mortar however this is a difficult job. We would recommend that the cement mortar is removed by hand with a hammer and bolster rather than with a skillsaw as this could cause damage to the relatively soft brick work, particularly on the perp ends (the perpendicular or vertical ends of the brick). The skillsaw simply isn't a delicate enough tool to carry out this work. Unfortunately if left, the spalling of the brickwork will get worse. Some of the bricks are already quite badly spalled and therefore it is usually best considered to take any badly spalled bricks out and replace or use brick dust with a lime mortar mix to match the brick colour, but this is difficult to do and in our opinion doesn't look very good.

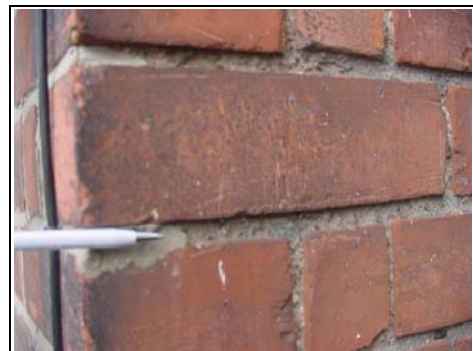
Here is a close up with a pen indicating where the cement mortar meets the lime mortar

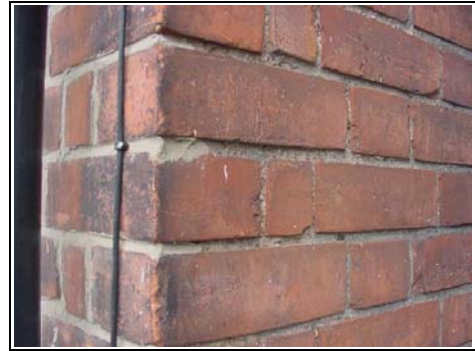
Here you can see on the corner of the property at the front on the left hand side where it has been repointed in cement mortar to the front and you can see where the cement mortar meets the lime mortar

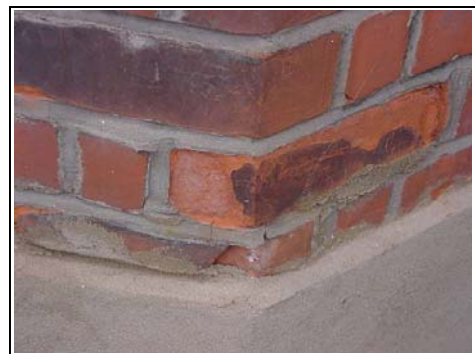
Spalling red brick
