# **SPECIFIC DEFECTS REPORT**

**Relating to Cracking to the Plasterwork Due to Dampness**

**Victorian Terraced Property in London**

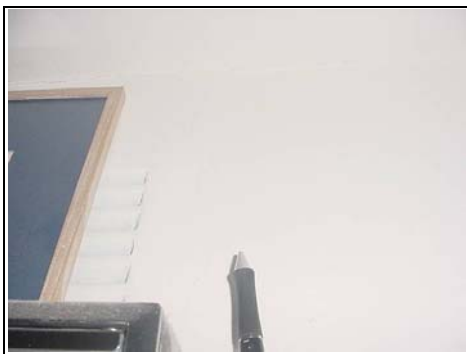
An example of the hairline cracking to the rear wall of the bathroom

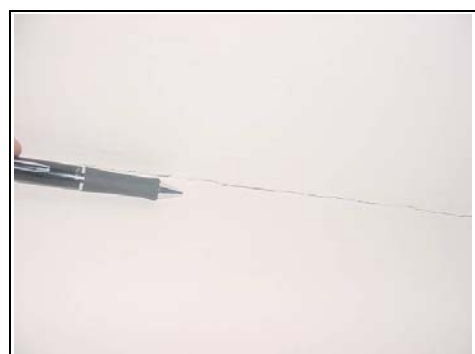
An example of the hairline cracking to the right hand wall of the Kitchen

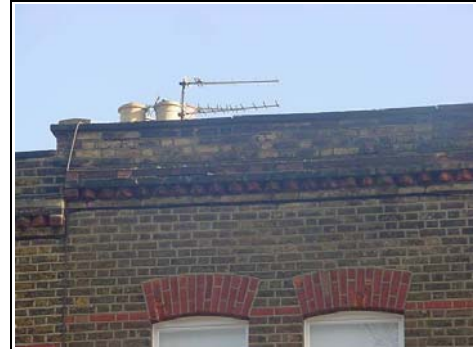
Dampness is getting into the property from a variety of sources for example, the butterfly roof area. The parapet wall needs repointing, possibly having a coping stone added to stop water getting in from the top and we also noted some slates displaced to the butterfly roof, particularly to the perimeter which need bedding into mortar. There is also some repointing required to the rear flat roof flashing.

Defective Parapet Wall to the front of the property which is allowing dampness in to the front wall.

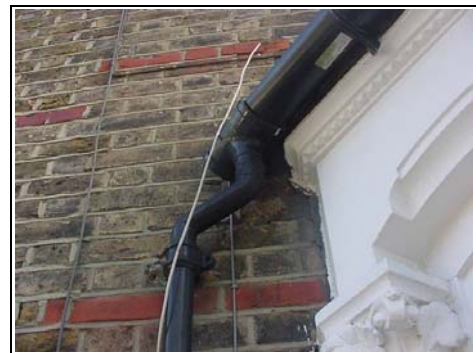
Smaller downpipe to the bay window (which could get blocked and lead to water discharging down the wall in this area which causes additional dampness

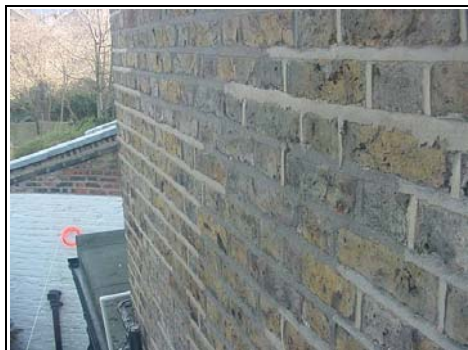
There are signs that this area has been repointed which is probably due to the gutter overflowing above (this was viewed from the rear bedroom)

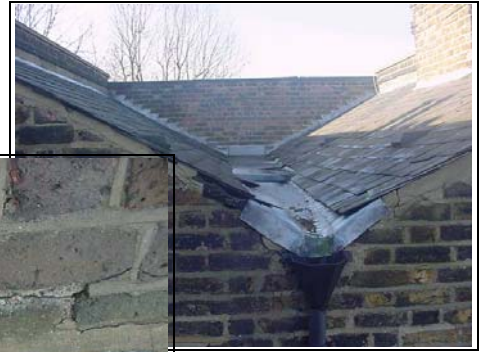
View of your butterfly roof with the missing mortar to either side of the valley gutter

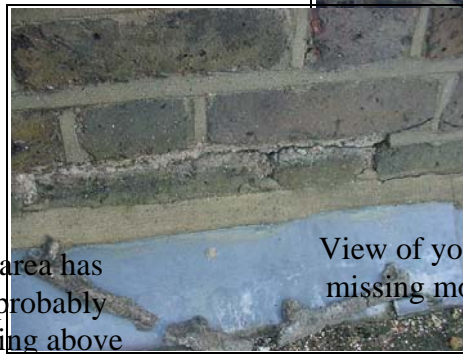
The cement mortar coming away to the flashing of the flat roof

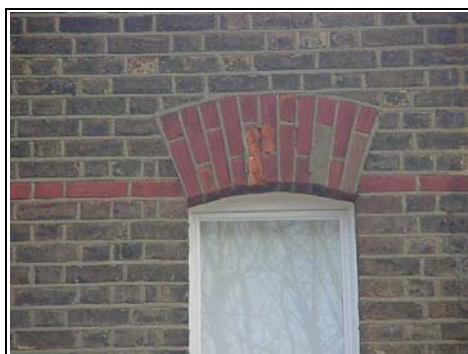
The Walls are no longer breathable as they were originally constructed due to them being repointed in a cement mortar externally and internally having a modern plaster, together with having the original slate damp proof course (assumed) and an inserted damp proof course (assumed). Any moisture which gets into the wall will have difficulty in getting out again. This is resulting in spalling to the face of the brickwork, particularly the softer red bricks.

Spalling soft red brick work caused by the cement mortar and the lack of the ability to breathe

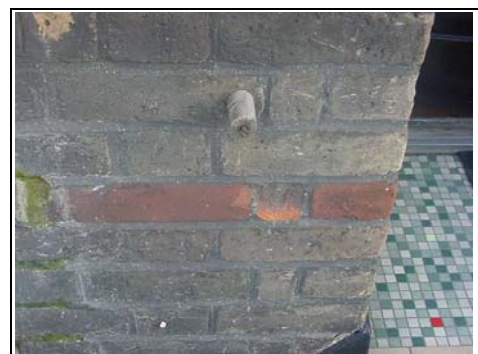
Spalling red brick work

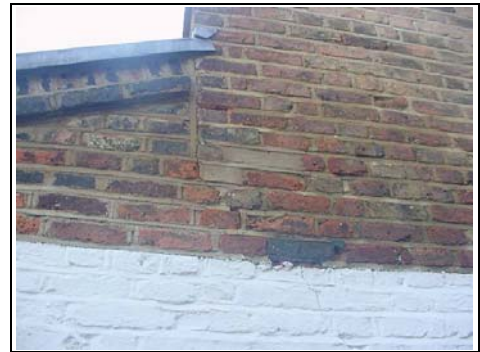
The cracking to your neighbour's property could indicate that there is a leak on the drainage route which is relatively common in this age of property. The movement which is visible to their property indicates that there may be shrinkable clay in the area. Above this percentage it expands causing what is known as heave although this in itself turns to dust causing what is known as settlement.

Your neighbour's wall with a crack where it has been extended

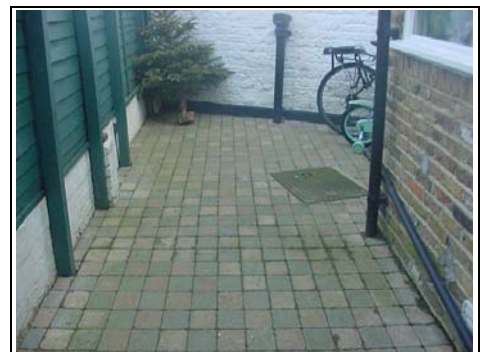
The man hole to the right hand side being along the route which we feel the drains will take

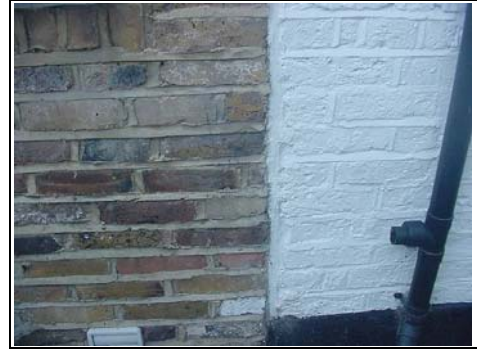
We also noticed that there is a straight joint between the original property and the new property (shown in the photograph) which indicates a modern brick laying system has been used rather than the traditional tooth and bonding system which in our experience tends to allow more movement.

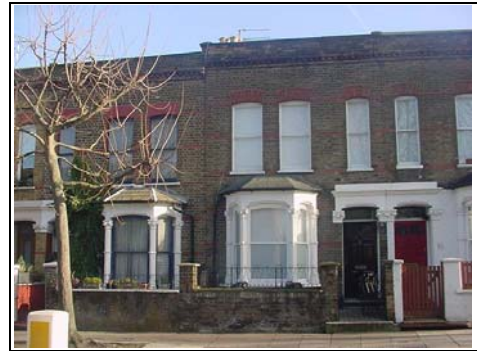
We also noted to the front of the property that originally it was built with a straight joint on the left hand side. This means there can be some additional movement to what we would traditionally see in terraced property.

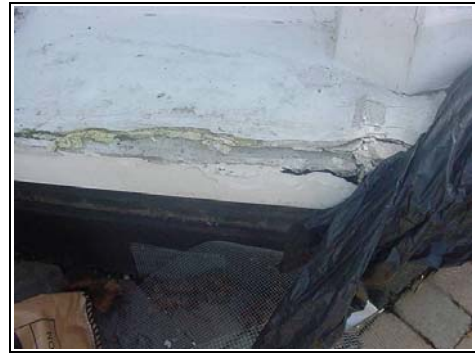
It appears that a repair has been carried out in years gone by to the window sill which involved applying an additional coat over the top on the original sill. This has now failed due to lack of bonding agent (or reinforcements). It is very difficult to advise on a repair method until we see the extent of the condition of the original sill.

De-lamination of Bay Window Sill
