SPECIFIC DEFECTS REPORT

Relating to Wall Dampness

Modern Apartment in Southend

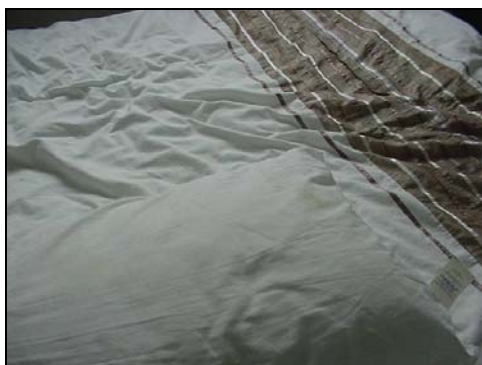
Mould to Pillow

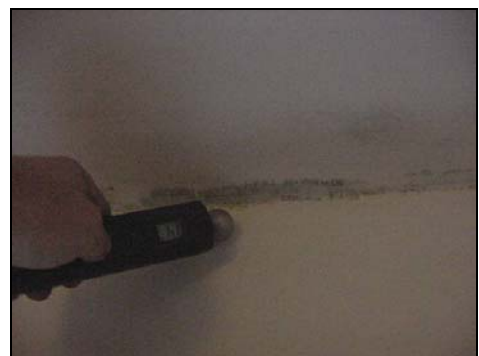
Mould

The property has extensive mould to the external walls (only visible to the top of the main bedroom wall at the time of our inspection) and the shower curtain.

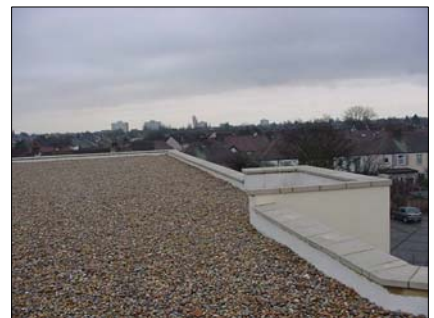
Water would appear to be coming in from the parapet wall at roof level. This we believe relates to the incorrect width of coping stone which has also not been laid to a suitable fall. The incorrect width means that the drip is too close to the brickwork and therefore discharges any rain down the face of the brickwork. This we believe to be a particular problem to the rear of the parapet wall. Unfortunately we do not know what construction is beneath and we believe that dampness is being transferred down via the inner course of brick.

Roof and parapet wall

ACTION REQUIRED: Builder to replace all coping stones or over clad them. We would also recommend a lead flashing is placed on the inner wall to stop dampness ingress.

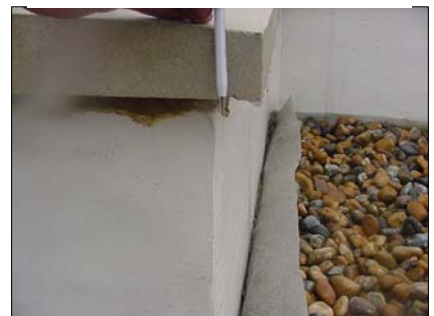
Location of drip next to wall

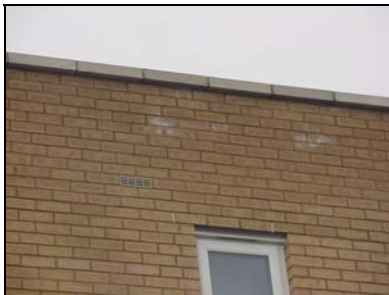
Efflorescence is where a white dust is deposited on the surface; this is where moisture will dissolve soluble salts from building materials such as calcium sulphate, which then evaporates through the permeable brick surface and the salts will be left behind forming deposits leaving a white dust on the walls. This is a certain sign that there is dampness in the brickwork. Expanding salt crystals in these locations result in a fracture to the material, which results in spalling, as mentioned above.

Efflorescence visible on parapet walls

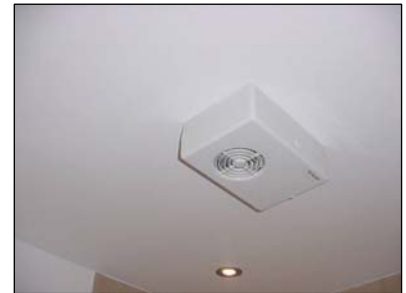
Extract fan
Need to identify where the
extract fan discharges to

Throughout the property we would recommend increased ventilation, for example the extract in the bathroom could be increased to 150mm. We would also check that the extracts are extracting to the exterior of the property; there were no obvious signs of where they ventilate to.
