# **SPECIFIC DEFECTS REPORT**

**Relating to Dampness (as specified on page 3)**

**A 1940s Detached Property**

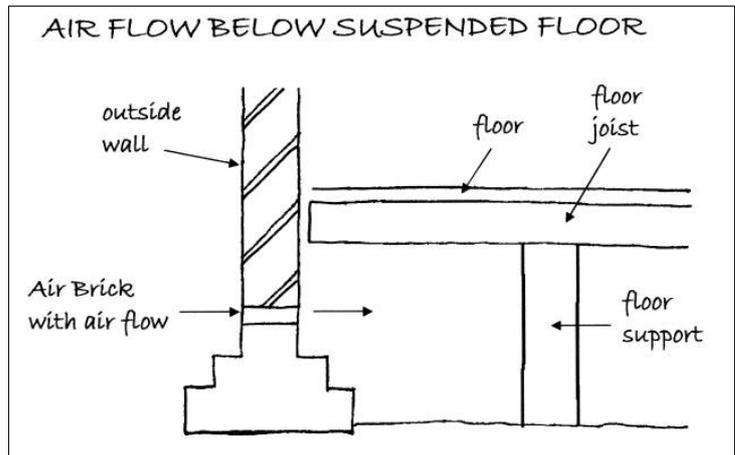
To reduce deterioration of the timber to the suspended timber floor from dampness generally a free flow of air needs to pass under the property. At present we do not feel that you have this through put of air.

**ACTION REQUIRED:** Ensure that all airbricks are clear to allow a through put of air and possibly add additional airbricks.

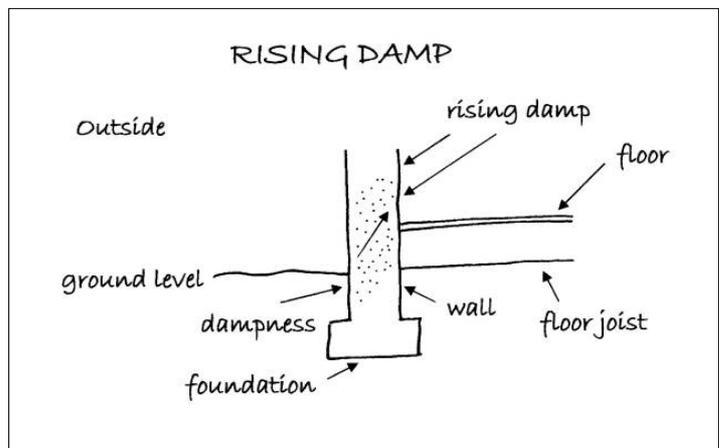
We have identified one area on the right hand side of the wall that we believe is caused by rising damp. There may be some more behind the study desk area.

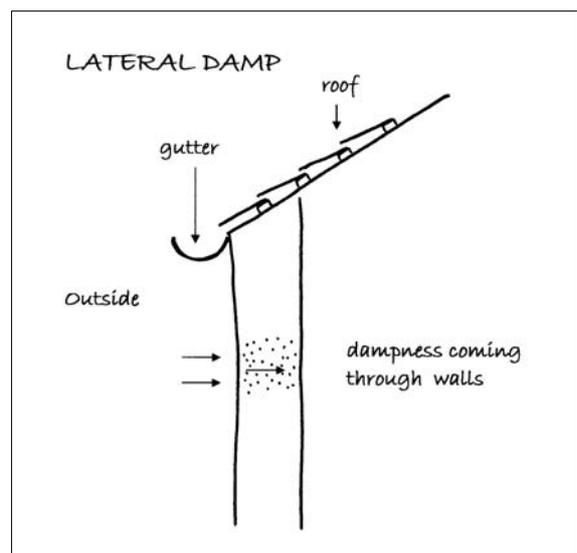
Lateral damp is occurring due to the cracking within the render. This is caused by differential movement between the different types of render that have been used and this is why if you re-render we recommend that a sample is taken of the original render and this is matched as closely in mix as possible.

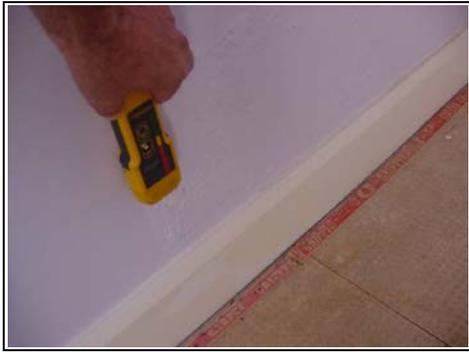
Low level dampness indicating rising damp and high level dampness indicating lateral damp

Low level dampness to the living room wall

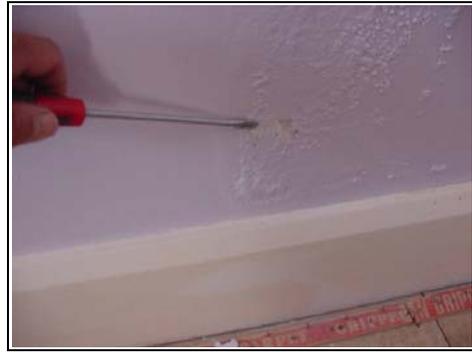
Blistering to the vinyl wall paint in the living room with an efflorescence or lime based paint or mist coat. We are unable to confirm from a visual inspection.

We would recommend that the existing vinyl paintwork is removed and an emulsion-based paint is added to allow the inside of the walls to the right hand side of the property and dividing wall to breathe and dissipate any dampness.

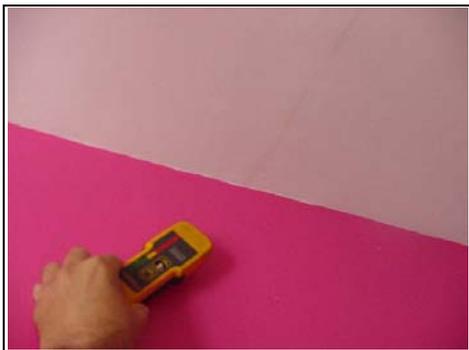
Checking for dampness from the gutters within the bedrooms

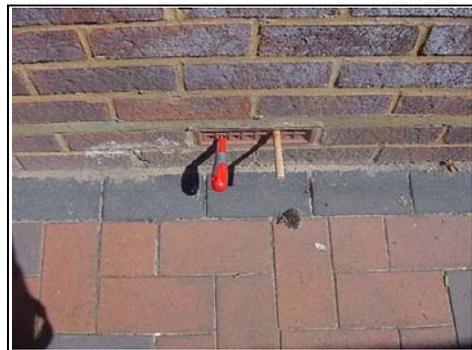
Checking the airbricks

We would recommend that the existing airbricks are checked and cleaned to ensure there is a free flow of air under the suspended timber floor, but you will need to make amendments and adjustments, for example to the rear where they are blocked. If necessary we would recommend the adding of additional airbricks.

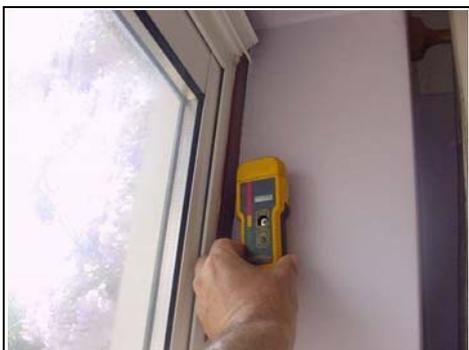
We believe the dampness may be coming through the cracking in the render and dispersing to this point. We would like to monitor this to see how the other suggested works affect this area.

Checking dampness to rear sliding French doors

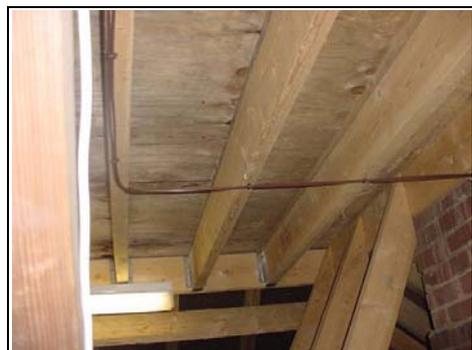
We were unable to access the flat roof for an inspection other than to the underside within the roof area where we noted a darkening of the timbers.

Underside of flat roof

We were unable to access the flat roof for an inspection other than to the underside within the roof area where we noted a darkening of the timbers. In our past experience this is related to dampness coming in and / or condensation. We would recommend that a roof light is added to the flat roof; this will allow access to it for an inspection and also allow ventilation, as well as having the added benefit of natural light in the area.
