Stone Built Example Residential Building Survey

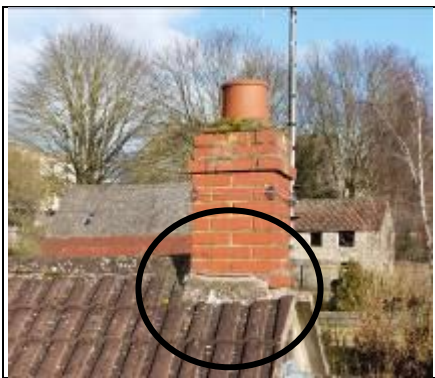
There looks to be moss to the top and general weathering. It has a cement flashing which we would recommend is replaced with a lead flashing. We think the chimney has been removed in part to the left side as we could not see it in the main bedroom which could be causing the cracking that we discuss later on. Equally, it could be concealed.

Left chimney cement flashing
~ Aerial View - 360 Photo ~

ACTION REQUIRED: Replace flashing with lead and check the chimney. Your legal advisor to specifically ask the owner if they have carried out work to the chimney.

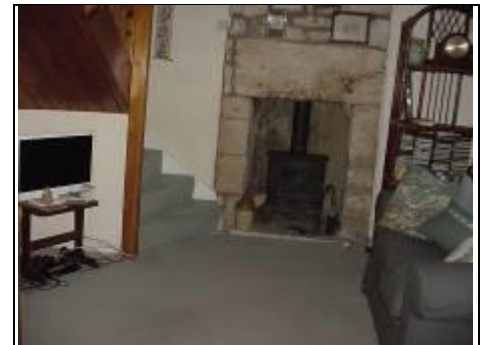
Right chimney closed up

Right chimney in lounge

ACTION REQUIRED: Whilst work is being carried out to the left chimney we would recommend you also check the right chimney at the same time. This is the chimney to the right bedroom which has been closed up.

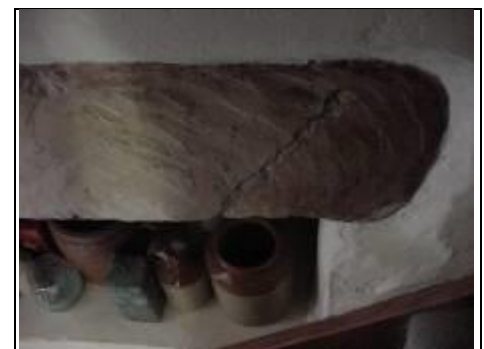
Close up of chimney on stairs with cracking

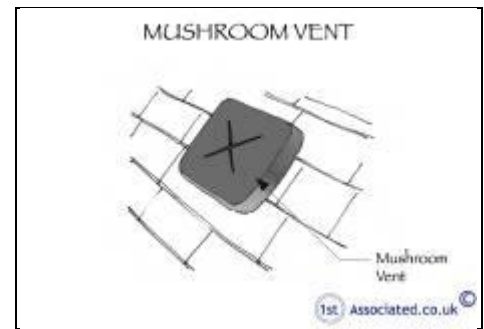
The property has a concrete tile roof however in the listing it describes the roof as a pantile roof. We noted that nearby roofs were both slate and stone. This property has a modern concrete tile roof which were commonly used as replacement roofs in the 1970's to the present day. We could also see the roof has some mushroom vents which we would say dates the roof from about the 1970's-1990's.

Mushroom vent

ACTION REQUIRED: Your legal advisor needs to obtain confirmation in writing from the present owners that permission has been obtained for this roof. Also, we would recommend a meeting with the Conservation Officer with regard to this and other modern interventions that we have noted. In a worst case scenario there are fines and prison sentences with regards to unauthorised alterations to listed buildings; please see our article in the Appendices where the owners got a substantial fine plus had to carry out the works.

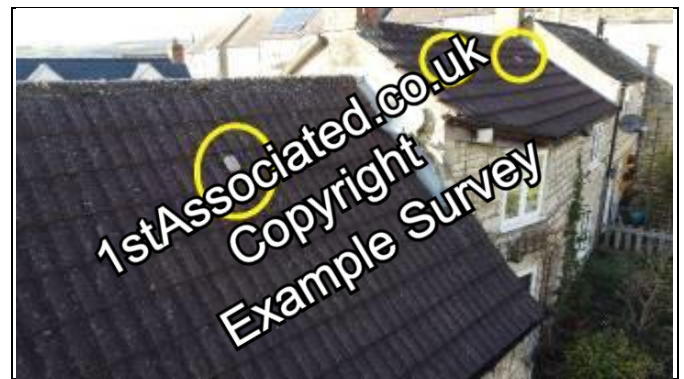
Mushroom vents
~ Aerial View - 360 Photo ~

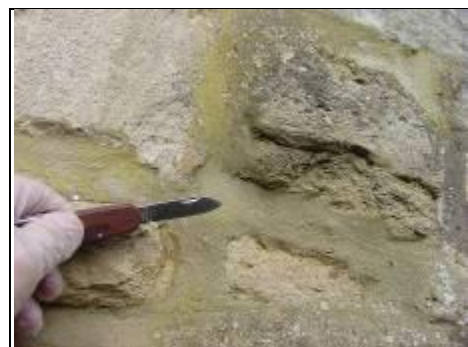
The use of cement mortar causes deterioration to stonework and does lead to the face of the stones deteriorating and also leads to dampness and cracking.

Cement repointing

ACTION REQUIRED: Find the oldest/most experienced bricklayer/mason you can who is skilled in using lime mortar and ask them to work on your property ideally during warmer days. A programme of work then needs to be carried out on replacing cement repointing with lime. This building needs to be able to ‘breathe’ again. We noted in the roof space that the pointing has gilleting (see sketch); it may be that the Conservation Officer may require this type of repointing.

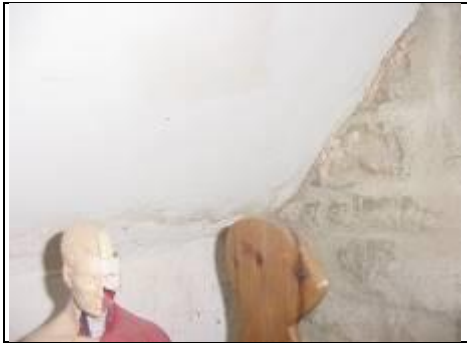
There are problems generally with the gutters and downpipes on the property, for example, the rear gutter is discharging onto the wall as the downpipe has come away. We spoke briefly to the owners and they said they would re-secure.

Damp staining to the rear left room

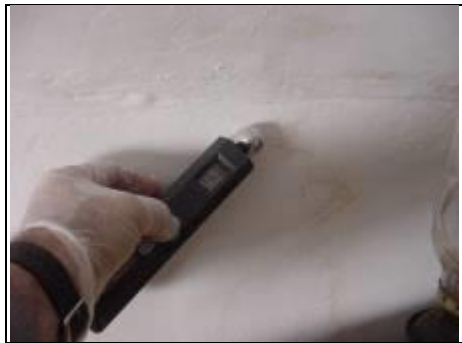
Dampness due to gutter problems

We also recommend that the gutters and downpipes are cleaned out, the joints are checked and the alignment checked to ensure that the gutters fall towards the downpipes.

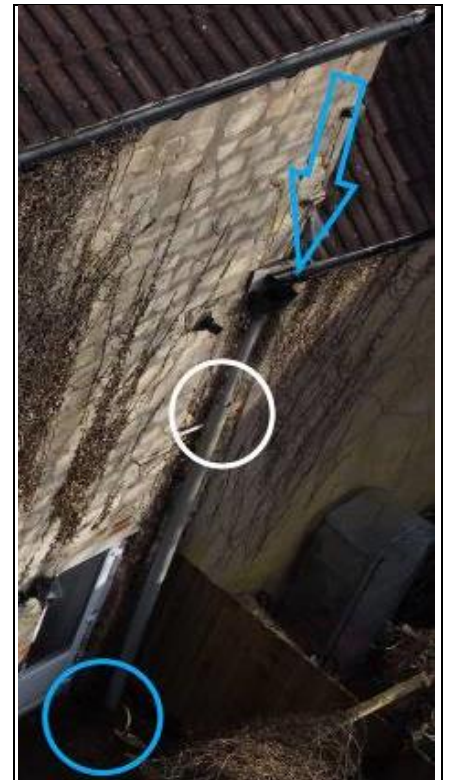
Rear downpipe missing shown by blue arrow. Smaller pipe into larger pipe shown by white circle and downpipe directly into ground shown by blue circle

ACTION REQUIRED: We would always recommend you stand outside the property next time it rains heavily and see how well the drains cope with the rainwater particularly looking at the guttering and the joints.

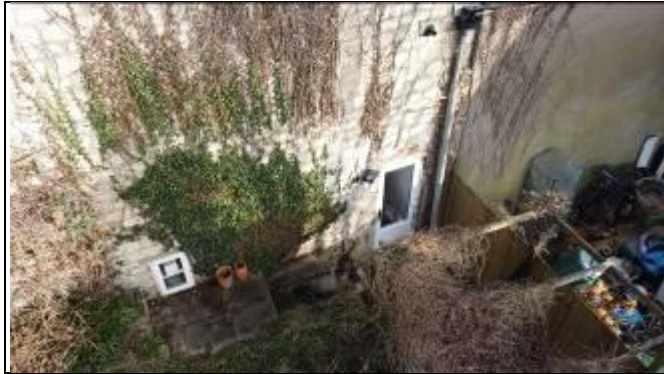
To the rear there looks to have been a covering of ivy which has now been cut back but nevertheless it needs cutting back further and we would recommend removing completely as the ivy limits sunlight and drying out of the building and air movement in the area. It can also hold water and snow.

Ivy to the rear of the property
~ Aerial View - 360 Photo ~

If you want to keep the ivy we would recommend ivy to be on a trellis and not directly onto the building as it can damage it.

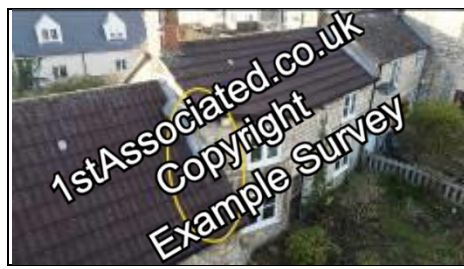
We can see some movement occurring in the property. It is very difficult to assess as we have had a limited view in the roof area due to the amount of insulation and a narrow loft hatch. However, we can see some cracks and repairs to cracks. In our vendor's questionnaire we are advised that the property was decorated throughout in XXX so cracks should not really be visible this soon.

Crack front middle viewed from left

ACTION REQUIRED: We believe the safest way forward is for the existing owners to take out an insurance claim, advising that the cracking has been noted by a structural surveyor (this should cost them nothing other than time to write the letter/email). This usually means that the insurance company will carry out a monitoring exercise (the Building Research Establishment recommend monitoring any cracks for a minimum of one year) to establish if there is any progressive movement. Your future liability should be limited to the cost of the excess on the insurance providing the insurance company is happy for you to take over the insurance claim.

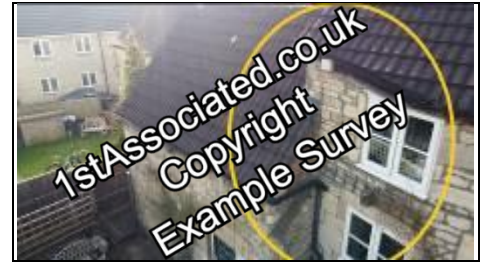
Front middle viewed from right

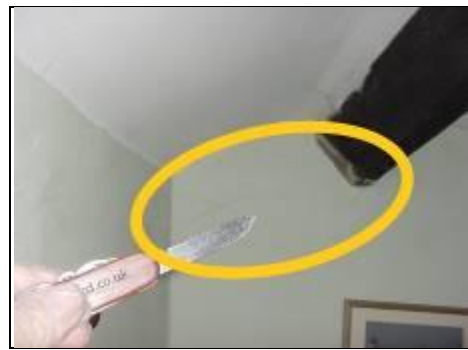
Close up of crack in main bedroom

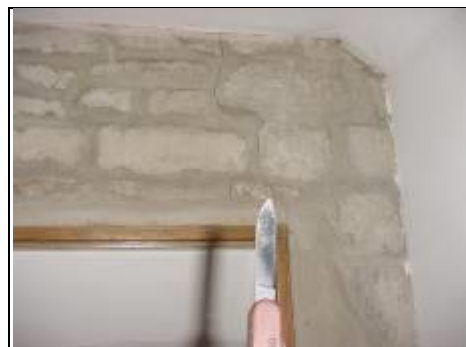
Close up of crack above door in first floor left bedroom

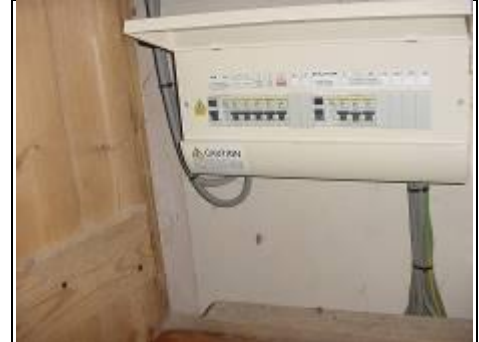
The fuse board is dated and better is now available. We noted an above average level of extension leads being used which generally means there is a lack of socket points.

Fuse board

ACTION REQUIRED: We recommend a new fuse board with a fire resisting metal case and would advise as the property is changing occupancy the Institution of Engineering and Technology (IET) recommend a test and report. Any recommendations from the report should be carried out by a NICEIC registered, or equivalent, approved electrical contractor or similarly approved.

ANTICIPATED COST: £250 - £500 for test and report, £250 - £500 for a new fuse board, in the region of £100 - £200 per additional socket point plus any further work recommended; please obtain quotations.

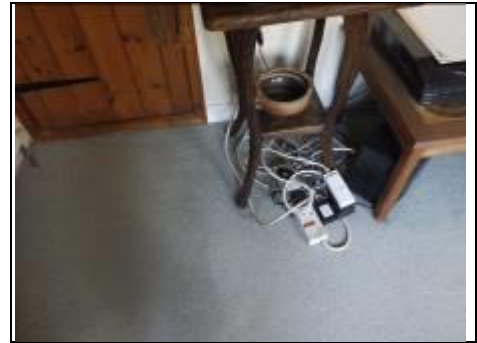
Extension leads

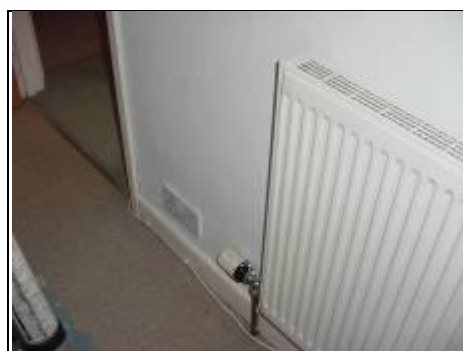
We noted the radiators in some areas are internal/not under the windows which is the usual position. This is often carried out on cheaper central heating systems to save the labour and piping costs of positioning the radiators underneath the windows. However, it then reduces the air movement in the room which can lead to black mould.

Internal radiator

ACTION REQUIRED: We suggest you live in the property and then if there are problems we recommend you move the radiators underneath the windows as this gives a better circulation of air and reduces the chance of condensation.

ANTICIPATED COST: In the region of £150 - £300 (one hundred and fifty to three hundred pounds) per radiator; please obtain quotations.

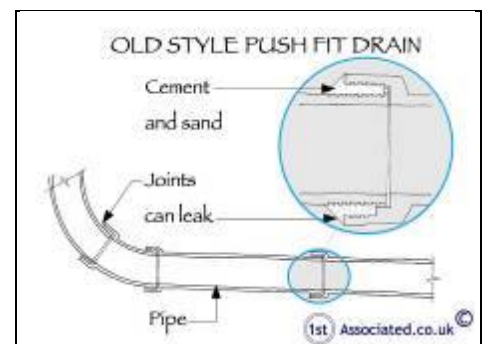
In older properties, such as this, drainage was often push fitted together rather than bonded together which means that they may leak over the years. Whilst we ran the tap for 15 minutes without any build up or blockages the only way to be one hundred percent certain of the condition of the drains is to have a closed circuit TV camera report.

Push fit drain

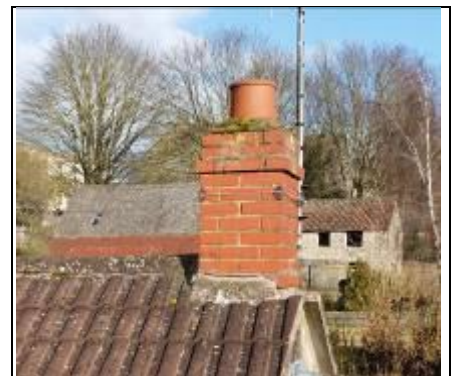
We noted an aerial attached to the chimney which we are not keen on as it can de-stabilise the chimney.

Left chimney

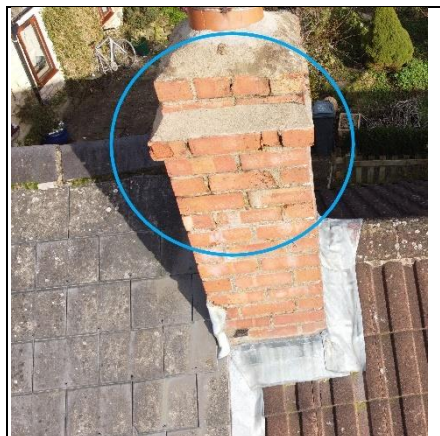
This chimney is brick finished with a lead flashing and one chimney pot. From what we could see from ground level it looked in below average condition considering its age, type and style.

Right chimney joints opening up and efflorescence

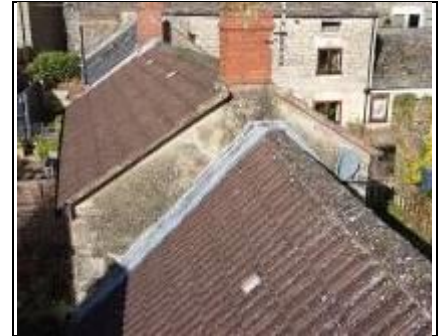
We noted the far left roof overlaps the property on the left side which could be a water trap area and needs to be monitored.

Concrete tiled roofs and step in the roofs
~ Aerial View - 360 Photo ~

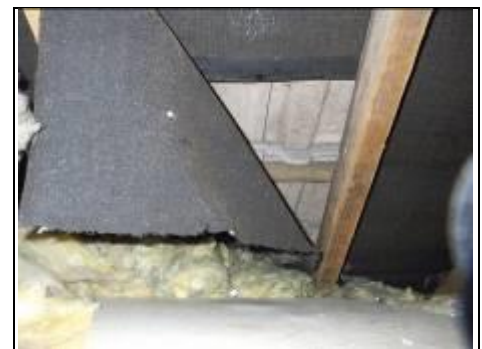
Right roof

ACTION REQUIRED: Repair sarking felt. It also shows that there is likely to be a need to replace a lot of the sarking felt in the not too distant future.

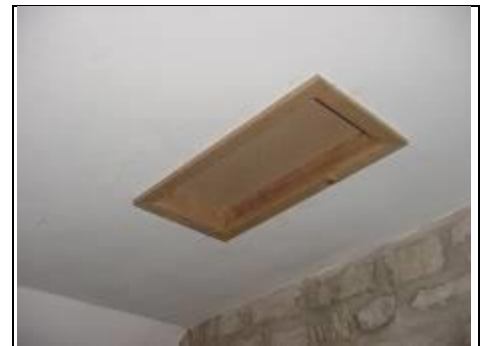
Left roof narrow access

ACTION REQUIRED: We would recommend the access hatch to the left is made wider and an access ladder is added as this would make it easier to use for storage if you decide you need the storage although there is still a relatively low ceiling height in this area.

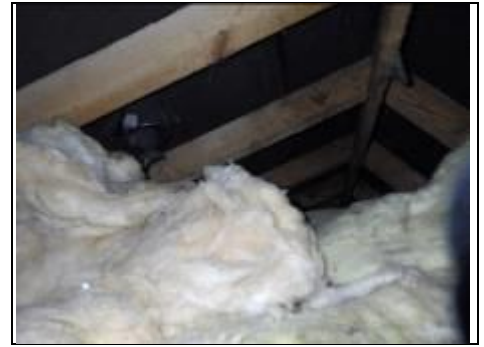
Right roof limited view due to insulation

In the right roof we would also recommend the fibreglass is removed and replaced with insulated loft board.

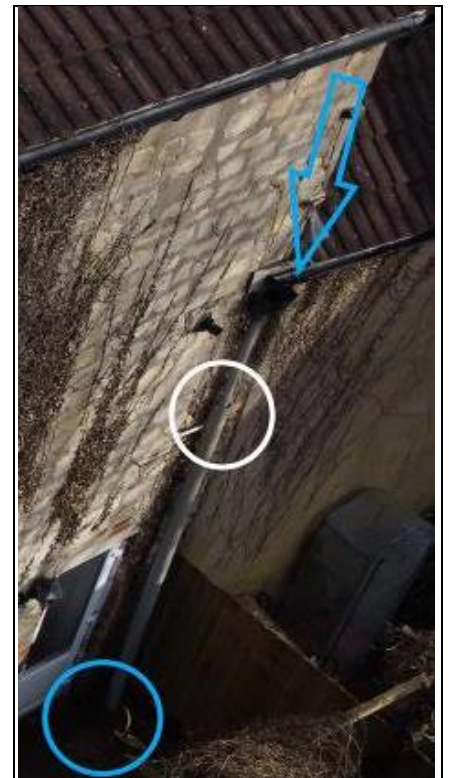
The downpipes feed directly into the ground and we cannot be certain where they go, so if there is a blockage then the drain would have to be opened up. This is a practice we are not particularly keen on; we would much prefer a gully. We would add the front middle gutter goes down to a low point and then runs down the wall.

Rear downpipe missing shown by blue arrow. Smaller pipe into larger pipe shown by white circle and downpipe directly into ground shown by blue circle

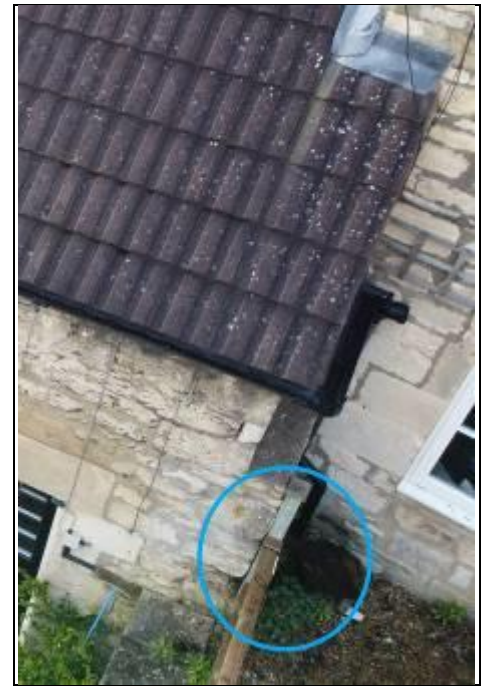
Front middle downpipes feed directly into ground

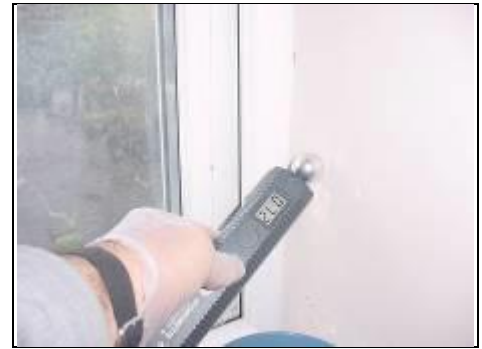
High damp meter reading in bathroom

ACTION REQUIRED: Please see our comments in the Executive Summary.

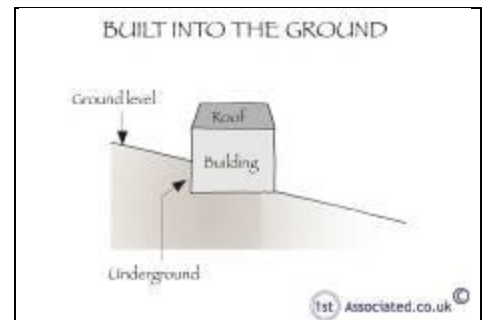
At the time of the inspection there were no signs of condensation however we believe there is a higher possibility than average of condensation particularly in the bathroom which is partly built into the ground.

Built into the ground

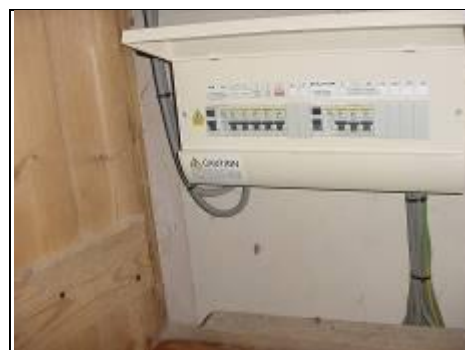
The electric fuses and consumer units were located in a cupboard in the lounge. The fuse board looked 1970's-1990's and better are now available. In an older property a defective fuse board can be particularly dangerous.

Fuse Board

ACTION REQUIRED: We recommend a new fuse board with a fire resisting metal case.

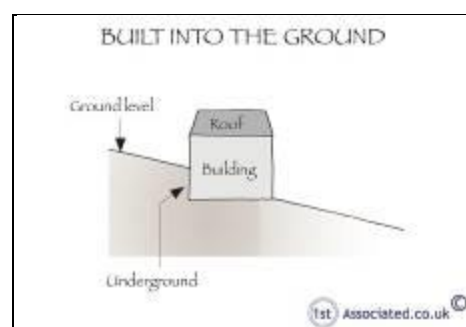
The bathroom is below ground level and therefore more susceptible to condensation and lateral dampness. We would also comment the window is well positioned for water coming in.

Built into the ground

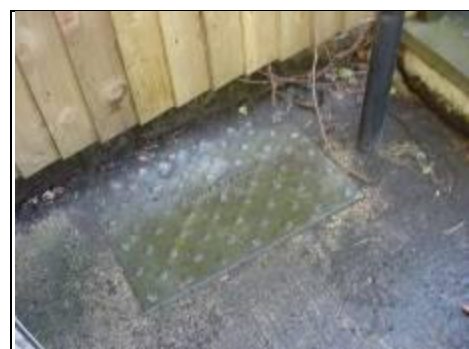
Manhole unable to lift
