JOB REF: xxxxxxxxxxxxxx

# SPECIFIC DEFECTS REPORT

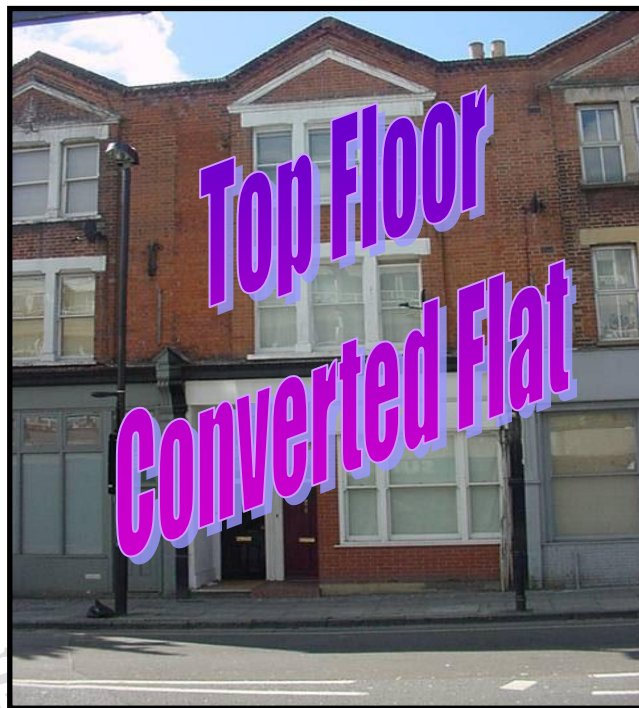
Relating to main roof problems,  
xxxxxxxxxxxx,  
Islington, N7 xxx

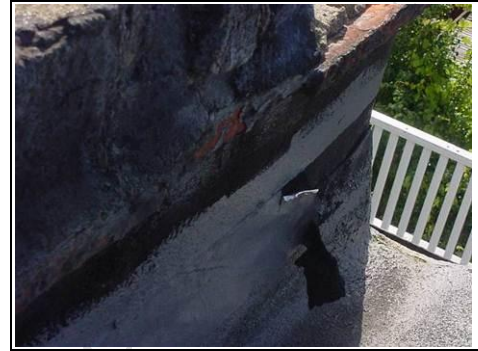
Flashband repairs to the rear of the left hand valley gutter have come away

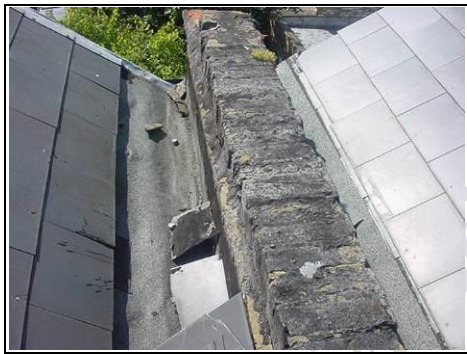
This could affect you as it is in poor condition with the felt becoming un-bonded

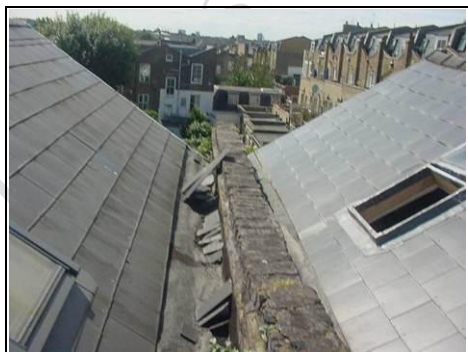
Many slates have been damaged

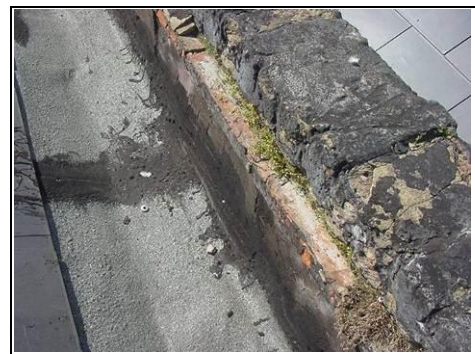
Bitumen repair.  
Also note the parapet wall is letting in water which is why the plants are growing from it

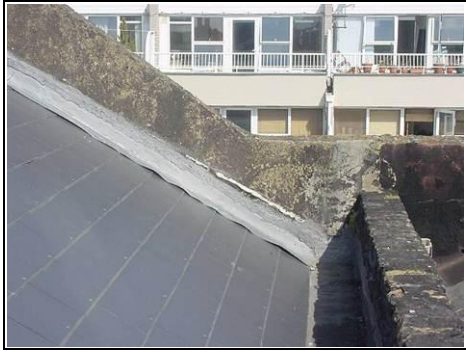
Flashing to the front that's not bedded properly

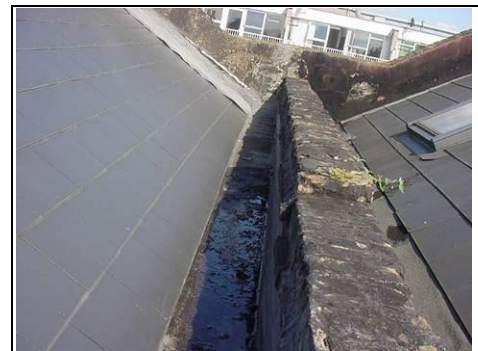
The parapet wall that is allowing water in. This explains the plant growing out of it. This needs to be made watertight

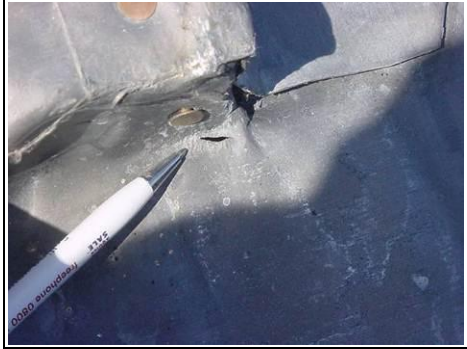
Split lead to the access area

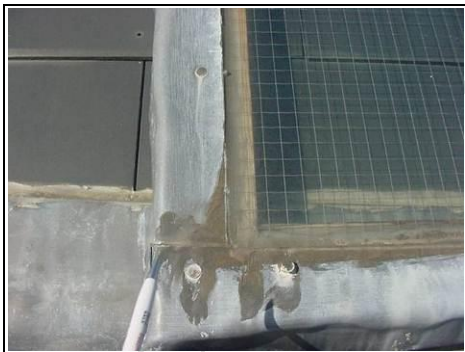
Mastic sealing to access area

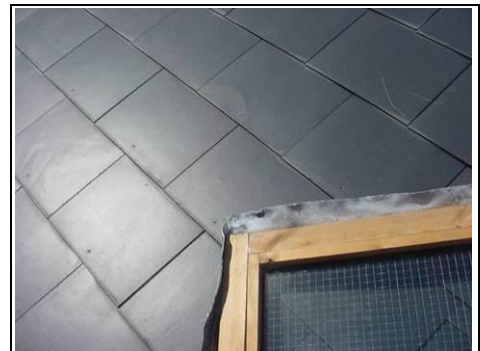
There is a lack of a stop on it.  
This means the weight rests on the lead

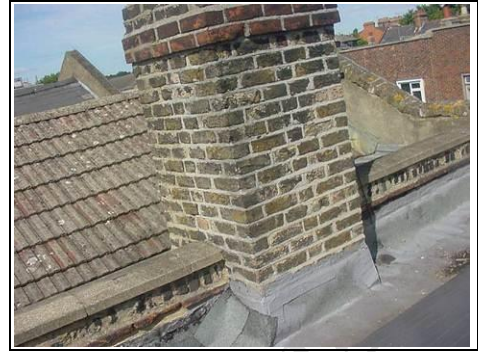
The chimney has felt flashing around it

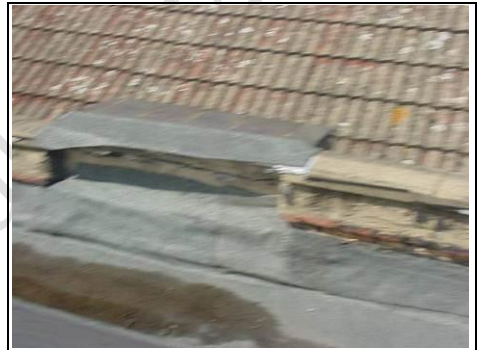
Chimney has been removed with a felt capping in place rather than a paving slab or concrete.

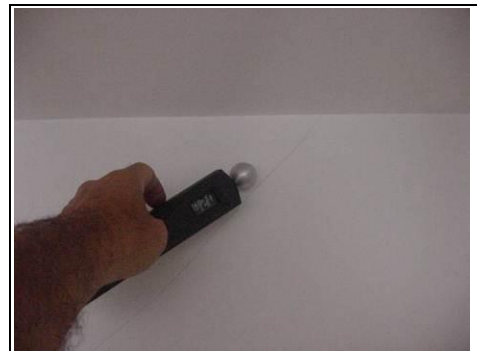
Hairline crack with reading of 28

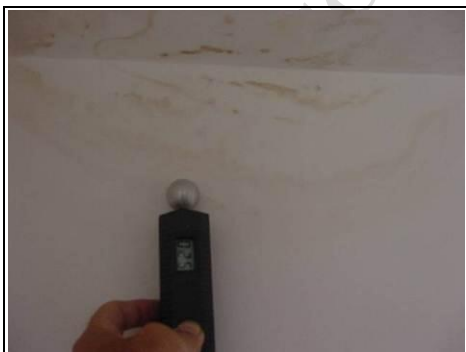
The staining looks to be dependent upon the weather as the reading is currently 25 in some areas meaning that it is drying out

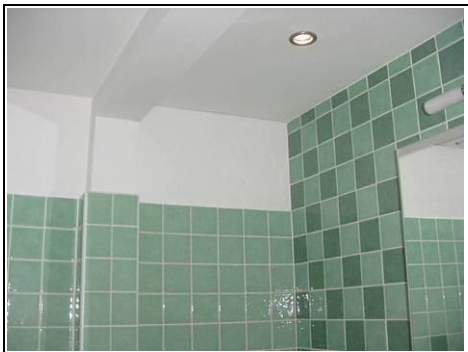
No problems at high level

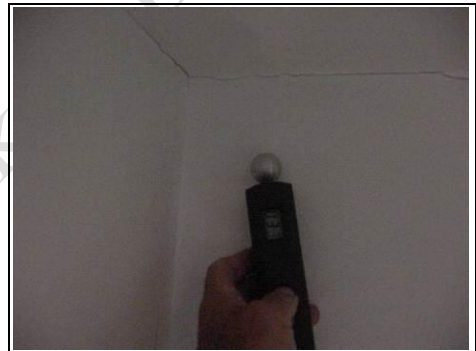
Reading of 33 on the Gann meter.  
This is acceptable but the hairline  
cracking does suggest something  
has occurred

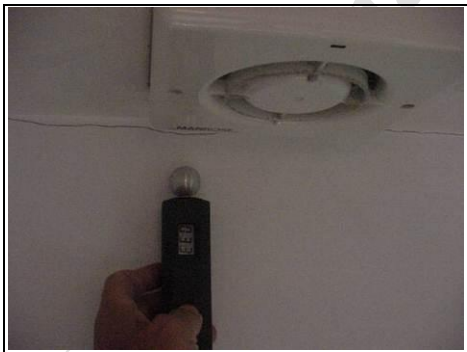
Reading of 33 on the Gann meter

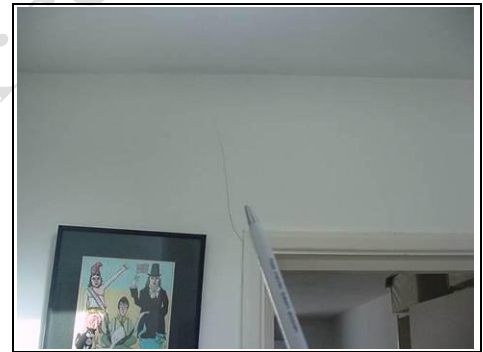
Dampness in the landing

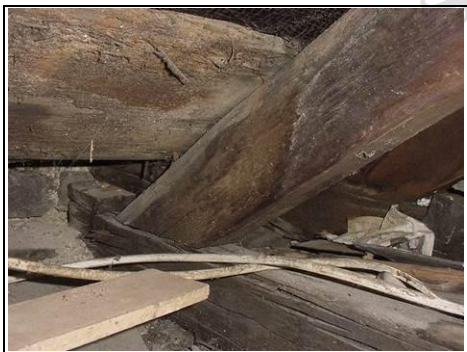
Staining on the timber that is typical from what you see from a leaking valley gutter

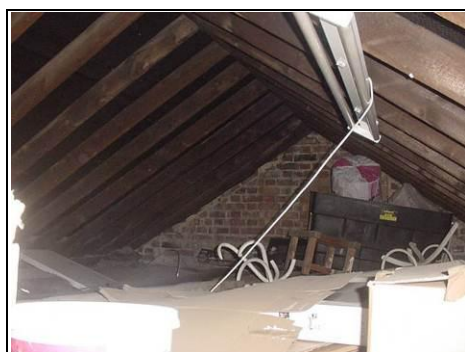
General view of the roof
