# **Example Pages taken from a Property Report and Schedule of Condition**

## **A Converted Victorian Commercial Property in London**

# Property Report

**PROPERTY REPORT**  
**OF**  
**A Converted Victorian Commercial Property, London**

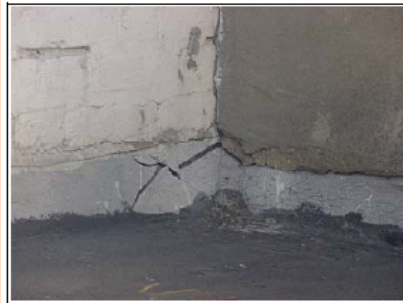
Both the condition of the front and rear flat roof is below average and in need of repair.

Crack to asphalt flashing

**ACTION REQUIRED:** Carry out patch repairs, paying particularly close attention to the flashings and areas that are cracked and blistered.

**ANTICIPATED COST:** To replace we would expect costs in the region of £5,000 to £10,000, depending upon the condition of the decking beneath. An alternative option is to patch repair the roof; expect costs in the region of £1,000 to £2,000. The type of repair you carry out depends upon the type of lease you have. We would be more than happy to discuss this further with you. Quotations should be obtained.

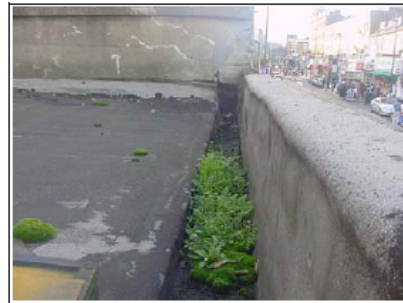
Blocked front gutter and evidence of brushed on tar, indicating repairs to the asphalt

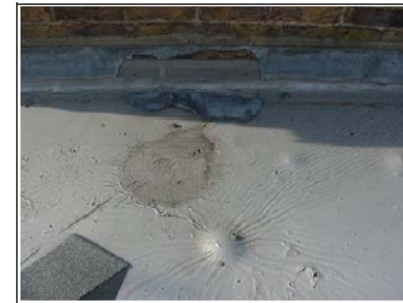
Blistering and old repairs to the rear roof

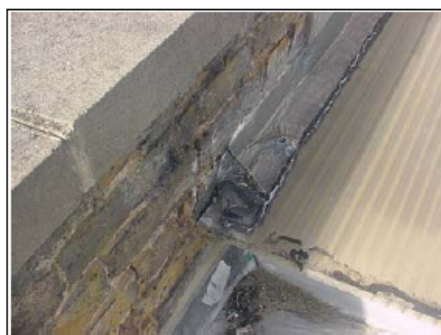
There is a polycarbonate roof over the open stove area. Apart from it deteriorating, particularly to the flashing areas where Flashband has been used (in our opinion a temporary repair material), we do not feel it is appropriate to have a plastic based roof over a heat source, such as the ovens below.

Polycarbonate roof, with deteriorating flashing

**ACTION REQUIRED:** We would recommend that the roof be replaced with a more appropriate material and vented properly. As a minimum, the flashings will need to be repaired and replaced to make them watertight, which is easier said than done, due to the difficulty of access.

**ANTICIPATED COST:** In the region of £5,000 to £10,000. The type of repair you carry out depends upon the type of lease. Again, we would be more than happy to discuss this further with you. Please obtain quotes.

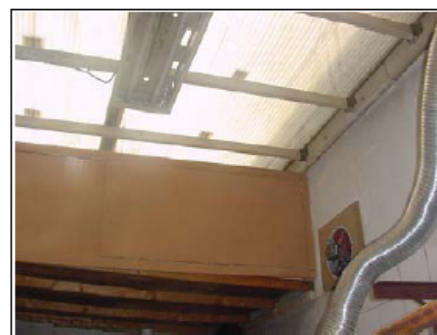
Polycarbonate roof visible from within the property

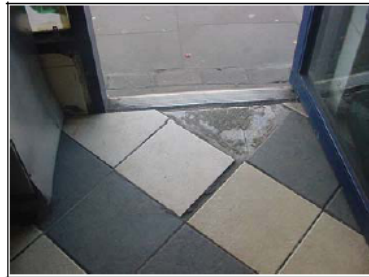
We do not believe that this property meets current Environmental Health Standards (although this does, to a certain extent, depend upon how you get on with the Environmental Health Officer). The kitchen area, apart from needing a general deep clean, has areas of broken tiles and flaking paintwork and areas of no paint at all, when it should have what is termed as a “smooth impervious surface”.

Broken floor tiles

**ACTION REQUIRED:** Repair and redecorate.

**ANTICIPATED COST:** In the region of £500 to £1,000. Quotes should be obtained.

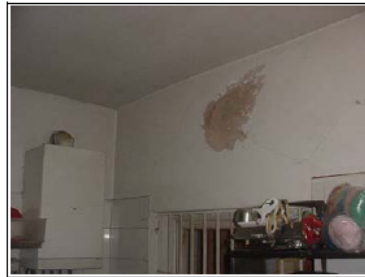
Flaking paint

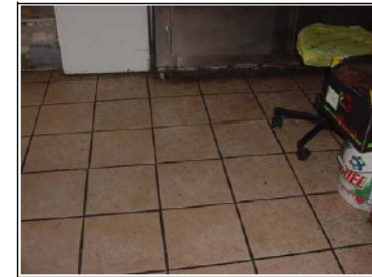
Ingrained dirt

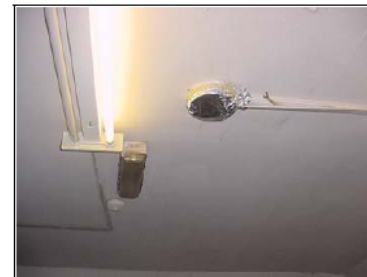
We noted that these were covered with foil and therefore we assume not working.

**ACTION REQUIRED:** We recommend the fire alarm system be reinstated. Ideally, it should connect to the flats and apartments above, so they have prior warning if there is a fire problem in your property, but this would normally be a landlord's initiative (albeit that you may pay for it via a service charge).

**ANTICIPATED COST:** We would expect costs of around £2,000 to typically be your contribution. It is very difficult to comment further without having access to the remainder of the property.

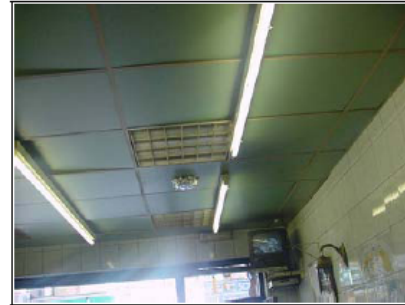
Generally, the decorative condition of the front of the house is poor. We assume, as part of you taking over, that you will modernise the property, for example the dated suspended ceiling system, with the non-working lights within it. This should ideally be replaced, together with a general redecoration throughout.

**ACTION REQUIRED:** Replacement of ceiling and general redecoration and replacement of light fittings.

**ANTICIPATED COST:** In the region of £2,500 to £5,000. Obtain quotes.

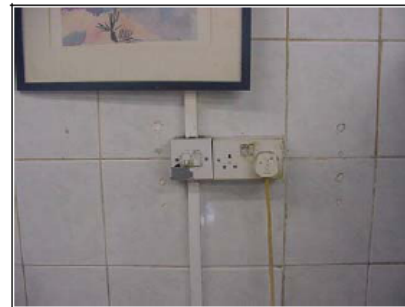
Many electrical points are taped up and various DIY alterations have taken place.

**ACTION REQUIRED:** Have an NICEIC test and report carried out.

**ANTICIPATED COST:** In the region of £500 to have the test carried out and expect £1,000 or so for repair work.

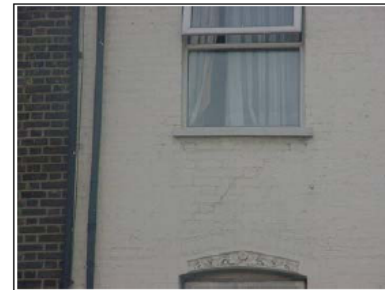
We would advise that, whilst we have not carried out a survey on the remainder of the property, we have identified various areas that are of concern that further investigation would be needed on. For example, we can see cracking over the front left hand window. It may be due to the replacement of a structural window with a plastic window (non-structural).
