RESIDENTIAL BUILDING SURVEY

Lincolnshire XXXXXXXX

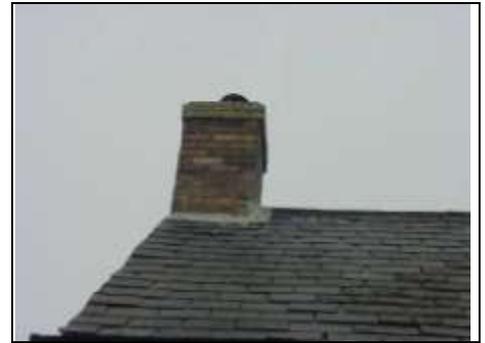
All four chimneys are weathered and require repair and repointing.

Rear left chimney

ACTION REQUIRED: Repair and repoint as necessary, check flashings and also check flaunchings (the top of the chimney).

ANTICIPATED COST: £3,000 - £5,000 (three thousand pounds to five thousand pounds); please obtain quotations.

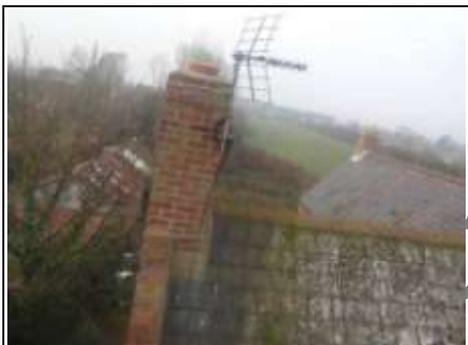
Front left chimney
Aerial view – 360 photo

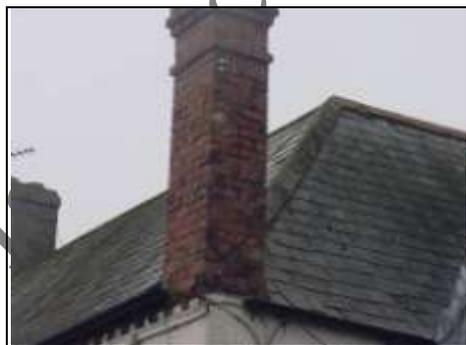
Front middle chimney

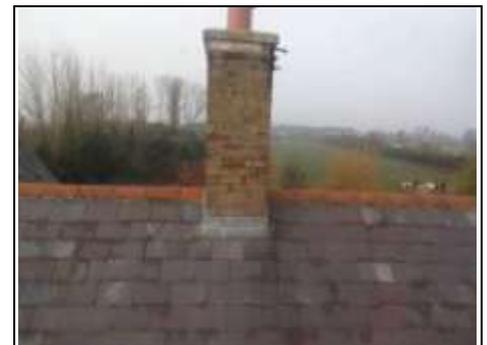
Front right chimney needs re-pointing at the base
Aerial view – 360 photo

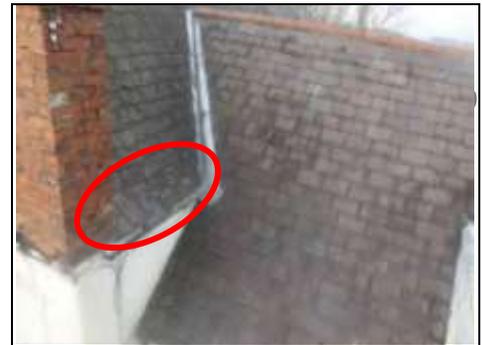
Slipped slates and lead tingles to the front right roof
Aerial view – 360 photo

ACTION REQUIRED: We believe several of the roofs will require repair and or re-slating within the next five to ten years.

ANTICIPATED COST: Depending on which roofs are carried out £5,000 - £15,000 (five thousand pounds to fifteen thousand pounds) (per large roof). When the roof work has been carried out we would also carry out any associated wall and window work etc. utilising the scaffolding that will be needed for the roof repairs; please obtain quotations.

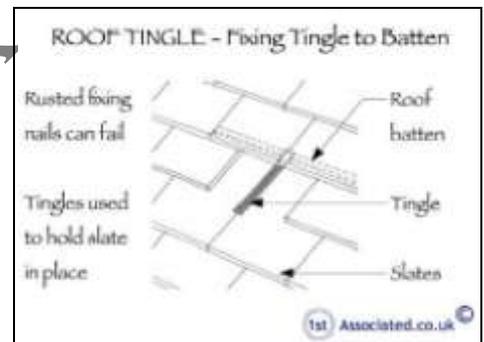
Tingles are a way of repairing a slate roof where the nails have deteriorated.

Roof tingles

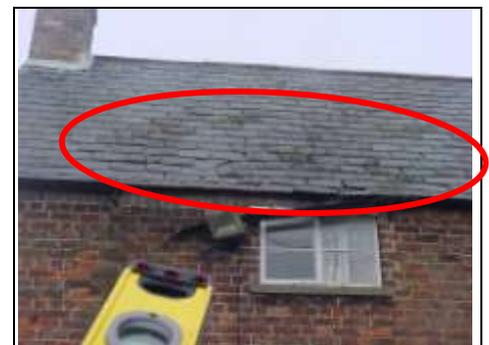
Slipped slates to the rear left

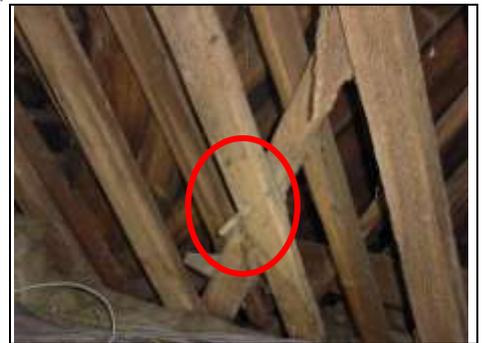
Peg fixings in the roof

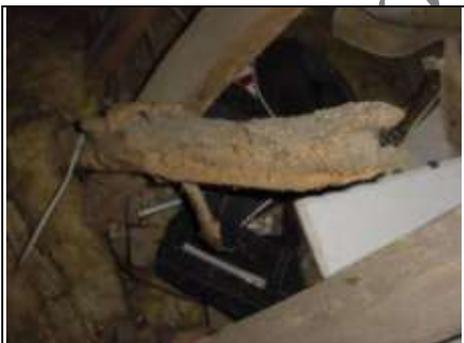
Old timbers

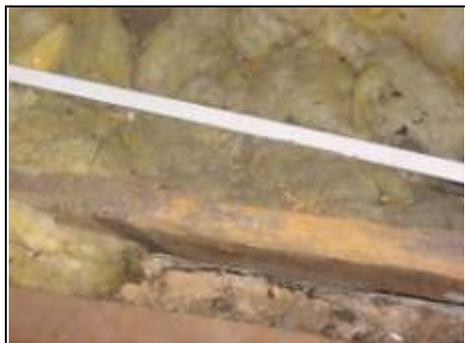
Woodworm in the roof

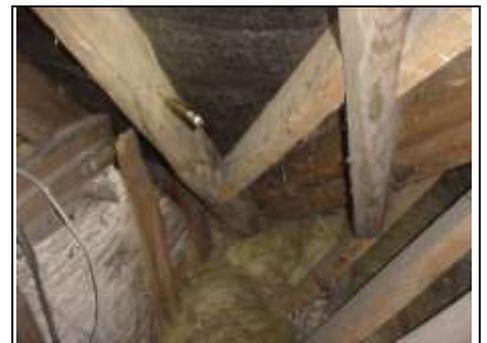
When you carry out the roof cover / slate roof repairs you must carry out repairs to the roof structure. There are various timbers that are split or are bending and need replacing particularly to the valley gutter to the rear and to the roof to the front right side.

Split timbers to the rear valley

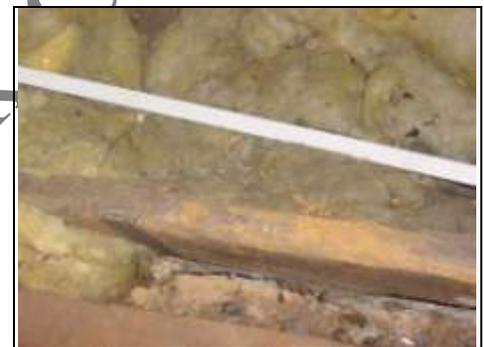
You will also notice there is some woodworm in the roof structure which we believe is active although there is a fair proportion of old woodworm.

We think the woodworm activity will be reduced if not stopped all together once the roof is made water tight moving the dampness (woodworm like dampness) and also getting air ventilation in to the roof and heating to the building.

Woodworm in the roof

We would strongly advise against using chemicals or any other sprays to treat woodworm as we feel there are far better ways of dealing with woodworm in the long term.

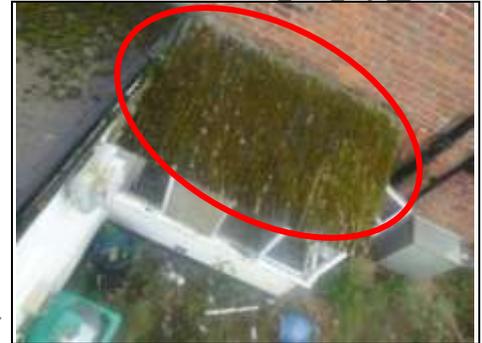
The rear entrance roof is asbestos and is deteriorating. We believe you have already agreed to remove this area. There also looks to be a manmade slate to the left side roof (in a blue oval) which may contain a small amount of asbestos as it was fairly common in older manmade slates (all directions given as you face the property).

Asbestos roof to the rear entrance

ACTION REQUIRED: If you wish to confirm you are 100 percent free of asbestos, you need to have an asbestos survey carried out.

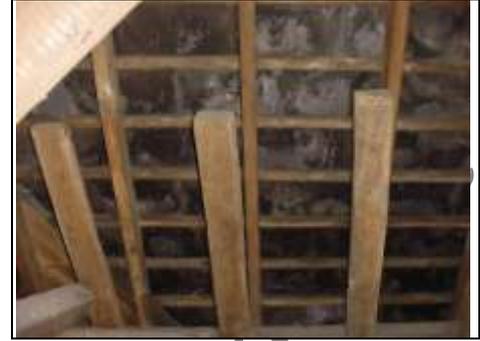
It should be noted that in some areas of the roof it has an older style of construction with no protective underlayer. This means that when the rain gets through and remember you have a lot of tingles holding the slates so there is no secondary protection.

No protective underlayer to older style construction

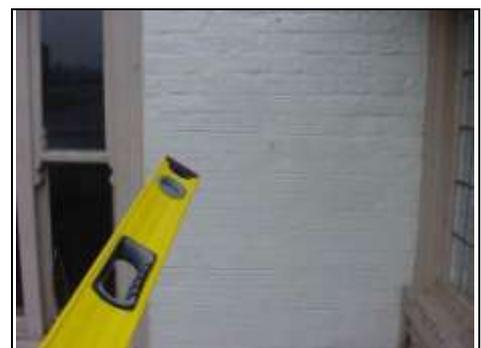
The brickwork is deteriorating considerably in some areas, to the point where it has had repairs. Unfortunately, these have been carried out wrongly in cement mortar which can cause more damage than good. Also there looks to be cement mortar to the front that has been painted over and made to look like bricks.

Cement mortar to look like bricks

ACTION REQUIRED: Remove all the cement mortar and replace with lime mortar and repair the bricks as necessary.

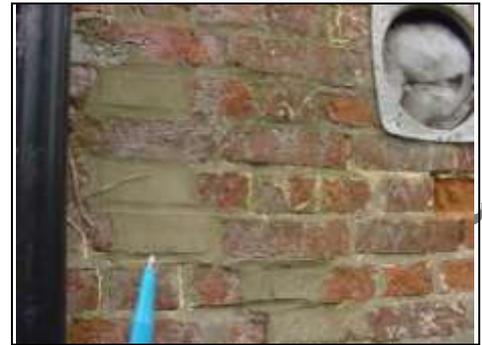
Ad-hoc pointing in cement mortar

ANTICIPATED COST: £2,500 - £5,000 (two thousand five hundred pounds to five thousand pounds) this work will be carried out over a long period of time. Work is best carried out over the summer months. You need to find a good bricklayer that is experienced in using lime mortar; please obtain quotations.

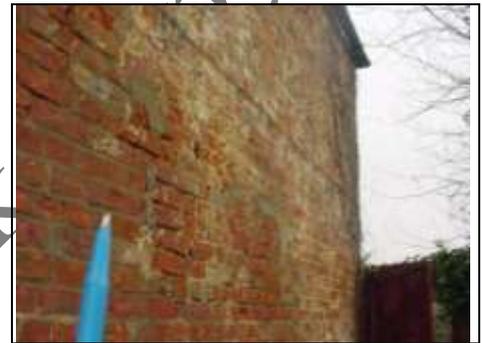
Whole bricks replaced with cement mortar

Unfortunately, the re-pointing, whilst well meaning, is not appropriate for this type of construction. A cement mortar has been used rather than a lime based mortar. We recommend you use lime mortar in any future repairs regardless of what the builders say! Using lime mortar will limit further damage to the brickwork, which is almost impossible to repair successfully. However, we would add that many, if not most, of the properties that are re-pointed are re-pointed wrongly; it is only in recent years that we have discovered the problems that can occur from it.

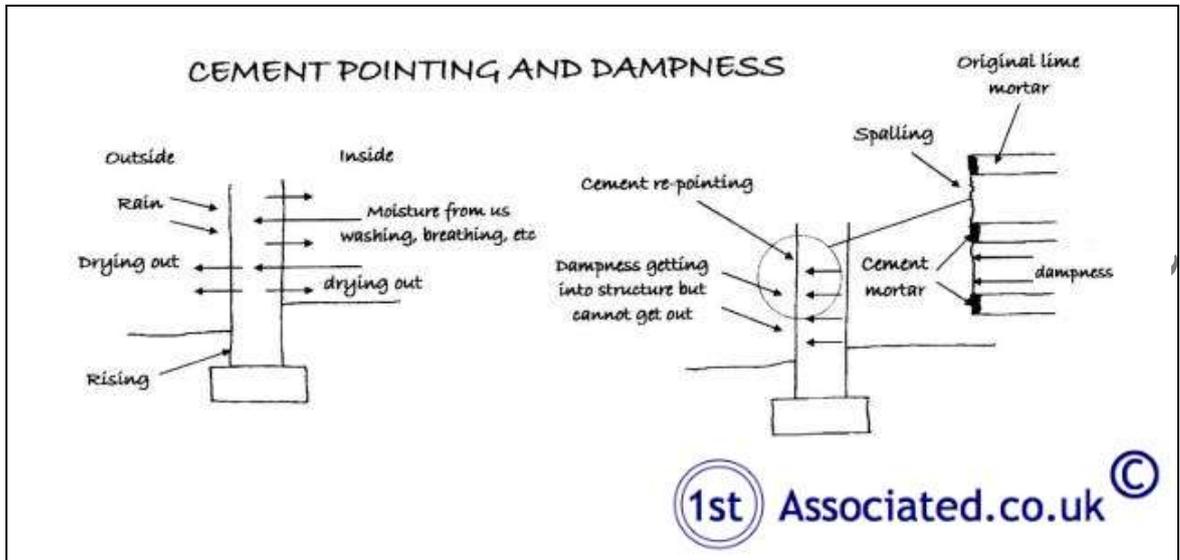
Cement pointing and dampness

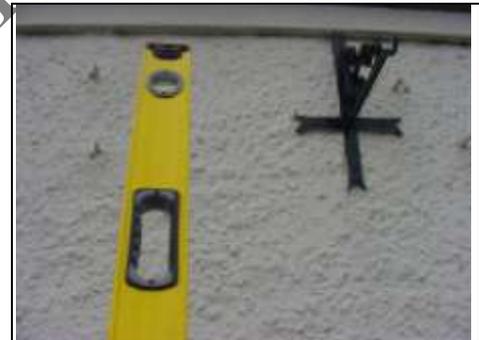
Crack and possible tie bar

The bracket that looks like it is for a hanging basket may also be a tie bar.

ACTION REQUIRED: We would recommend that you open up sections of the wall to see what the wall is constructed from and also to check if the tie bars are giving support to the structure.

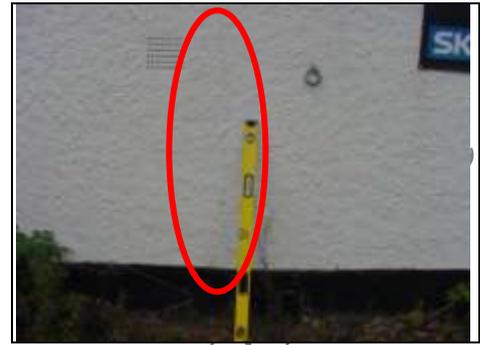
Vertical cracking to the right side render

The cracking needs monitoring. Before you legally commit to purchasing the property we would recommend the existing owners take out an insurance claim, advising that the cracking has been noted by a structural surveyor (this should cost them nothing other than time to write the letter).

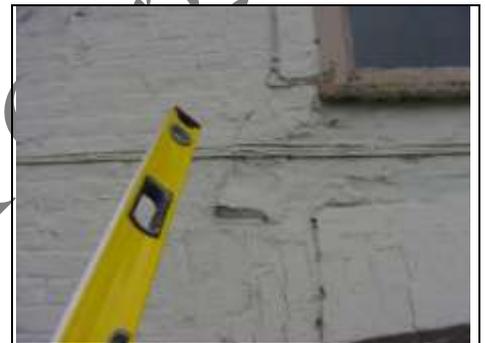
We suspect that there has been water discharging down the left side of the building which has caused deterioration.

Cracking to the window

ACTION REQUIRED: Stop dampness from roof and guttering. Stop rainwater draining from the roof and guttering down the walls. Check and repair lintels (they maybe timber). Check and repair walls which may involve removing of the cement render externally and the modern plasters internally and allowing the walls to dry.

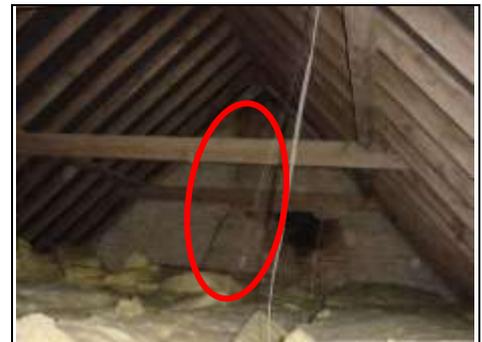
Crack on the front right, hidden
within the function room roof

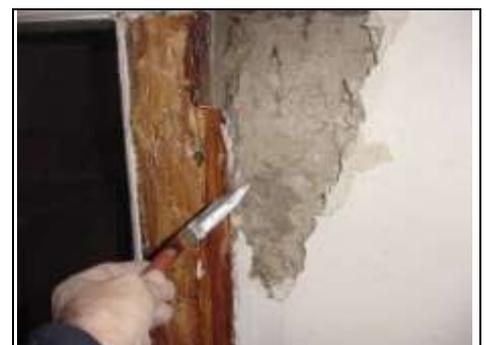
We can see on the internal walls that there is still wattle and daub. We simply do not know what the brickwork hides.

Wattle and daub in the walls

ACTION REQUIRED: We recommend opening up sections of the wall both internally and externally. You may well find some nice timber frame that enhances the look of the building.

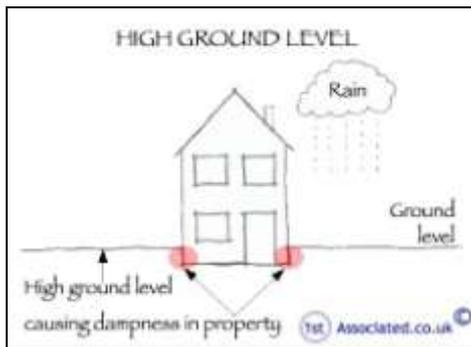
The ground level around the property is relatively high leading to dampness getting in particularly where the building is built from the soft red brick.

High level ground

ACTION REQUIRED: Lower the ground level around the property and we would also recommend you add a French drain.

ANTICIPATED COST: £2,000 - £4,000 (two thousand to four thousand pounds); please obtain quotations.

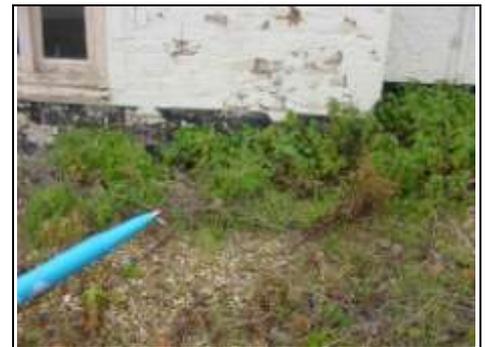
Ground level is high to front left

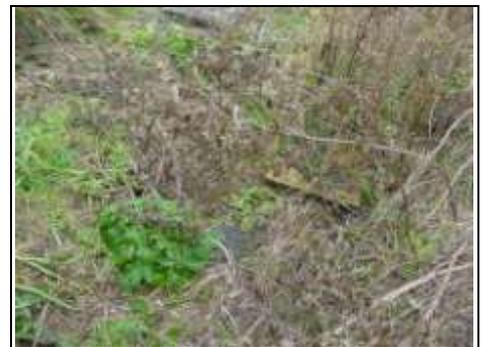
To the rear left side of the property there is what we would describe as an over grown swampy area. We had our best view from the flat roof at the back of the property.

When we were looking down to this area from the flat roof it looked like the ground had been washed away. You advised that you were going to level the ground, you do need to make sure there is not a natural collection of water in this area or even a spring. If there is you need to get the water away from the building

Swampy area

ACTION REQUIRED: We recommend soak aways are added to the entirety of the rainwater drainage, which will need to discharge as far away from the building as possible.

ANTICIPATED COST: It really depends on how much ground work you have already allowed for, but we expect for three soakaways plus drainage and guttering in them, costs to be in the region of £5,000 to £10,000 (five thousand to ten thousand pounds). Please obtain quotes.

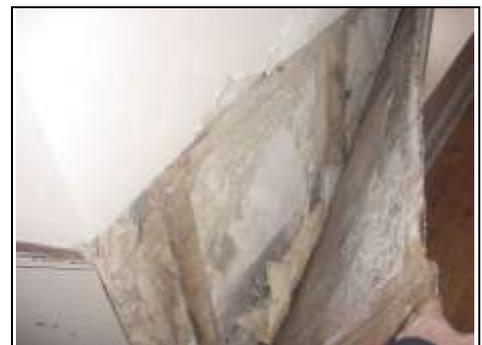
Perks of the dry lining / false wall is to hide the dampness coming through into the property which is considerable. Even with the repair work that we have mentioned you may get an element of dampness coming through. You have to consider part of the character of this building.

Dry lining internal walls

ACTION REQUIRED: You need to decide exactly what sort of finishes you want internally, but we think you will probably end up dry lining some of the property.

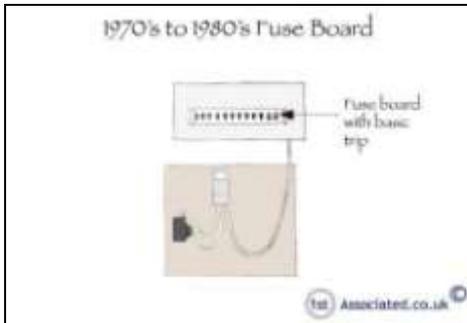
The electrics are dated and were not working at the time of our survey.

1970's Fuse board

ACTION REQUIRED: It may be worth having a new system installed. We recommend an Institution of Engineering and Technology (IET) test and report to be carried out by an NICEIC registered and approved electrical contractor or equivalent.

ANTICIPATED COST: £250 - £500 (two hundred and fifty pounds to five hundred pounds) for a test and report and would expect costs in the region of £2,000 - £5,000 (two thousand pounds to five thousand pounds) for a new system; please obtain quotations.

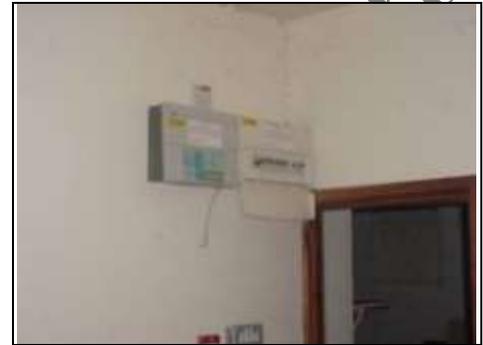
Electrics in the function room

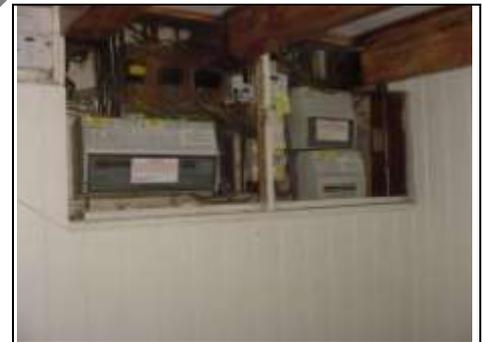
Electrics in the bar area

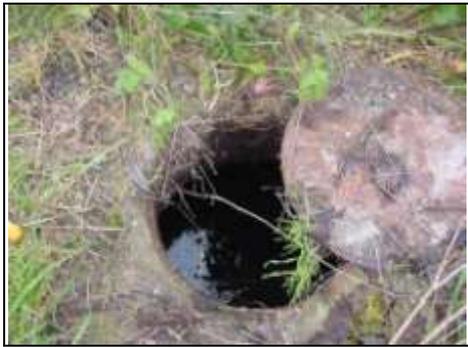
We believe there is a well in the garden, we would put a sump pump into this to see if it is a well, a septic tank or something similar. Place the sump pump into this and pump out what is in there to see if we can see the size and construction of the septic tank.

Well in the garden

ACTION REQUIRED: We recommend you pump out the well with a sump pump or get a company to drain it to see how it is constructed and put a new septic tank in depending upon the capacity etc.
