**COMMERCIAL BUILDING SURVEY**  
**OF**  
**A Listed 18<sup>th</sup> Century Commercial Property**  
**Restaurant / Bed and Breakfast Establishment**  
**Abingdon, Oxfordshire**

**FOR**  
**Mr C**

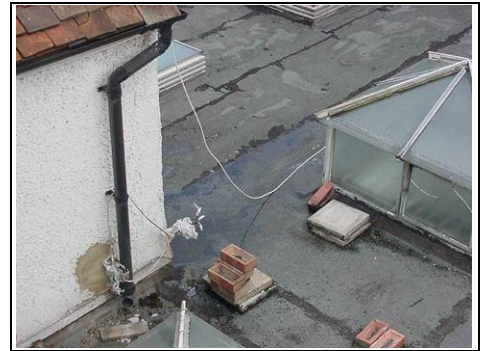
Water sitting on the roof

**ACTION REQUIRED:** We recommend that ultimately complete replacement is necessary, including the decking beneath.

We recommend when you do re-roof that you use a high performance felt and insulation cut to falls (to ensure the roof has a fall on it and that you have better insulation) and lead flashings. We would also give consideration to opening up the roof so that it can be accessed and also improving the roof window / roof light. The owner made some comments about the roof windows being too heavy, but we think this is because the roof structure itself is in a poor condition. We would not be surprised if the structural supporting timbers in the roof had to be replaced as well once the roof is opened up.

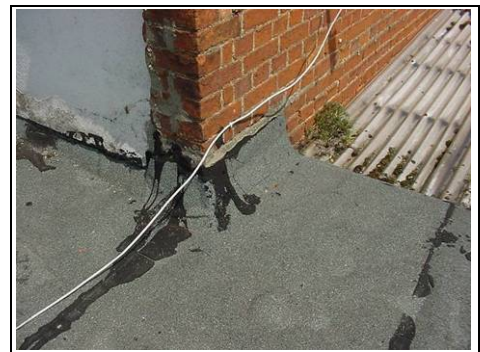
Poor flashing detail and blisters to the felt

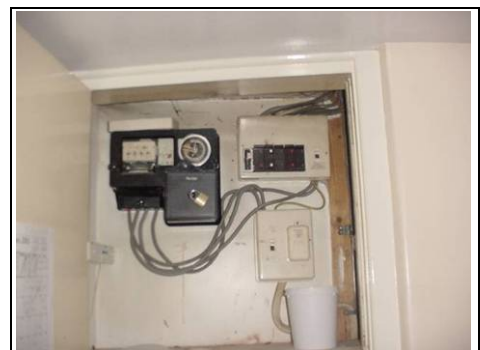
1960s fuse board on the top floor.

**ACTION REQUIRED:** Replace the fuse boards and have an Institute of Electrical Engineers test and inspection.

**ANTICIPATED COST:** In the region of £1,000 - £2,000 depending of course on what is found. We would also ask that you take the opportunity to make general improvements to incorporate how the business will develop over the future years.

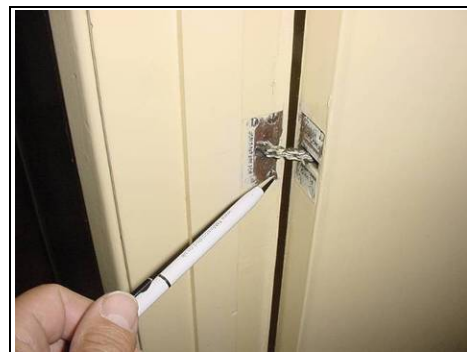
Central door closer (known as a perco door closer). The doors generally need upgrading to fire doors and door closers added.

**ACTION REQUIRED:** We would recommend that a specialist is brought in to look at your obligations under the Fire Regulations Self Assessment, which came into force on 1<sup>st</sup> October 2006.

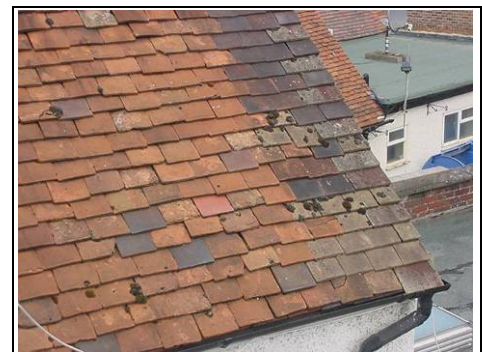
You have a mixture of tiles on the main roof which is never ideal as they will have different characteristics and are different sizes; for example the tile that we pointed out to you that was sitting in the guttering.

Mixture of tiles

**ACTION REQUIRED:** Thoroughly clean and clear gutters, check alignment and repair as necessary. With regard to the roof we suggest a roofer spends one to two days checking the roof and also that you have a supply of tiles handy and also that you clear the debris that has amassed on the flat roofs.

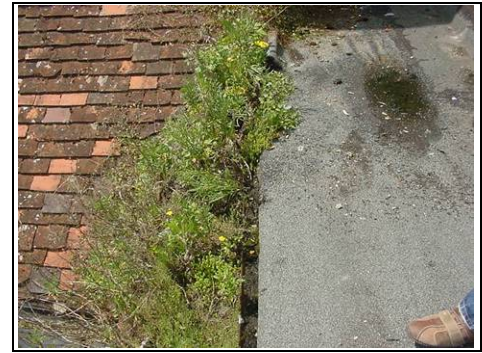
We would point out, again as we showed you, that the guttering is full of debris and literally has plants growing out from it, particularly to the rear right hand side (all directions given as you face the property from the front), and also to the rear left hand side.

We would also add that the mixture of cast iron and plastic gutters and downpipes is not ideal and often leaks can occur to these.

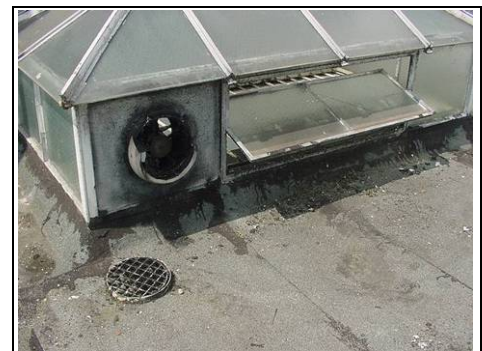
From what we could see the roof windows / roof lights are leaking and need general repairs to the flashings and general repair to the unit.

**ACTION REQUIRED:** Repair roof windows / roof lights and repair the flashings.

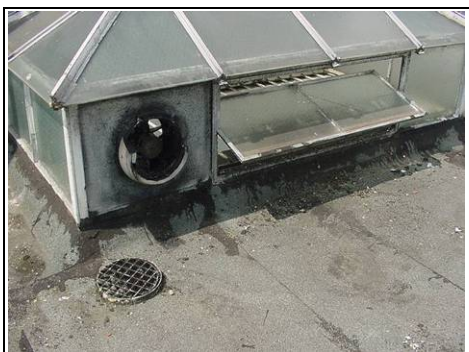
Generally, overall, repair work is required to the flashings and also a number of panes of glass should be repaired as they are probably leaking.

Box shaped roof light

**ACTION REQUIRED:** We would repair the existing roof lights and would caution against replacing the larger units as they allow ventilation in the kitchen area.

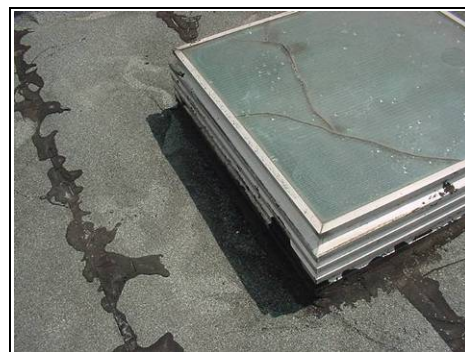
Flatter style roof light

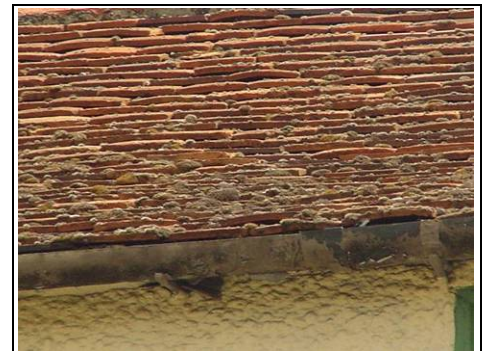
We would comment we could see spalling, displaced tiles, wrongly sized tiles and moss; all need repair or replacement.

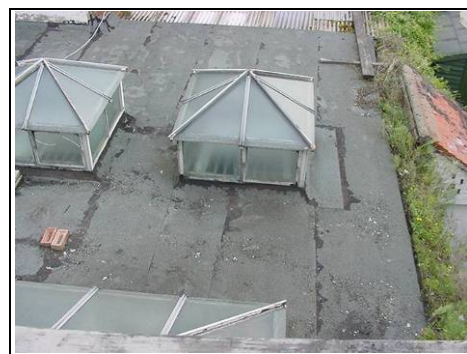
The felt flat roof is in a poor condition, the decking is giving way in several areas. Please see our comments in the Executive Summary.

Flat roofs typically have a life between 20 and 30 years, depending upon the quality of workmanship, materials and decking, although some roof manufacturers do claim they last longer. However, in this case, the decking beneath the felt appears to be damp and giving way.

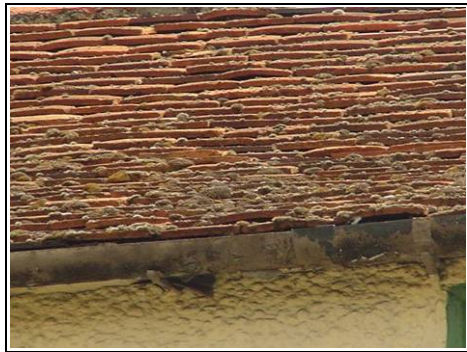
The gutters obscured our view of the fascias and soffits.

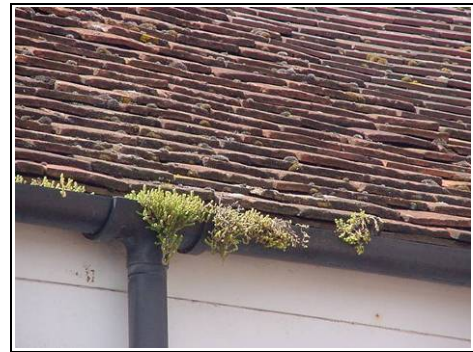
We would expect the fascias to be deteriorating where the gutters are blocked.

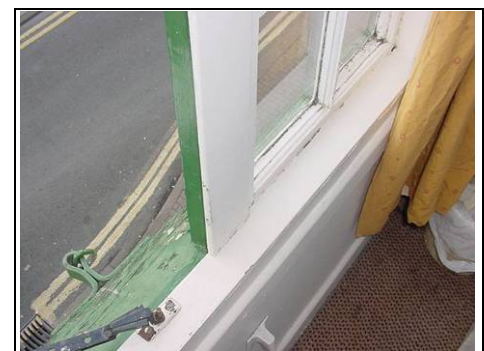
This is one of the better windows.

**ACTION REQUIRED:** Repair and redecorate as soon as possible. We would term the windows as ‘saveable’.

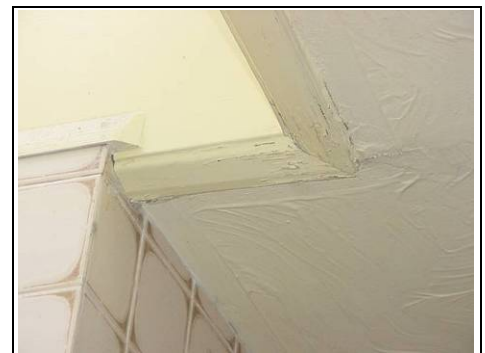
Water leaking through the flat roof.

**ACTION REQUIRED:** Repair roof before you redecorate. Please see our comments in the Executive Summary.

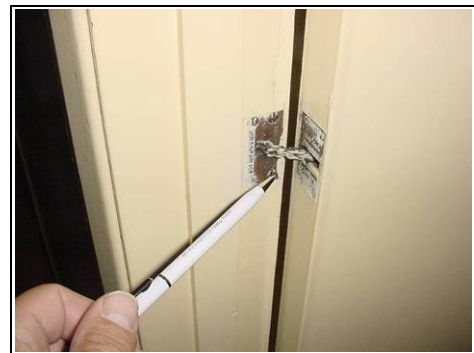
Perco door closer

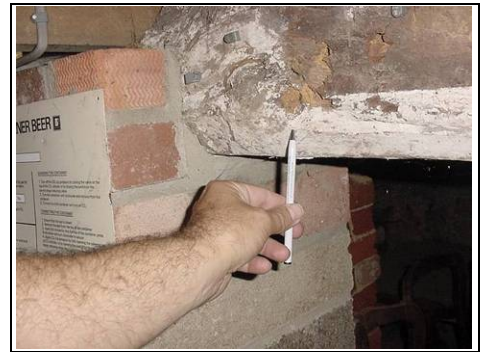
Woodworm not active.

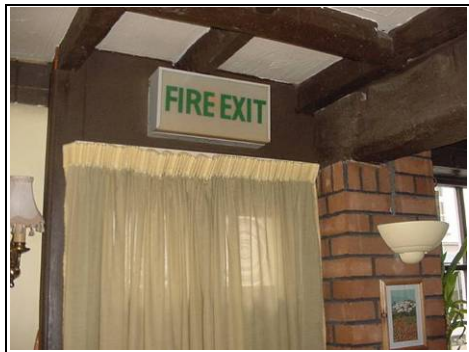
Old style fire exit sign needs changing.

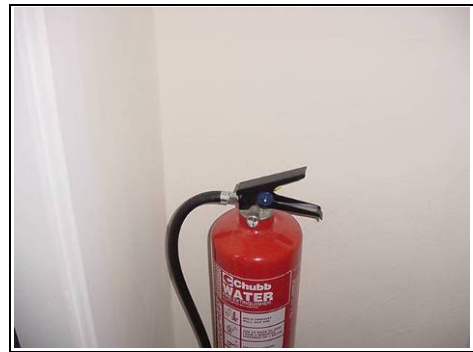
Fire extinguisher not identified.

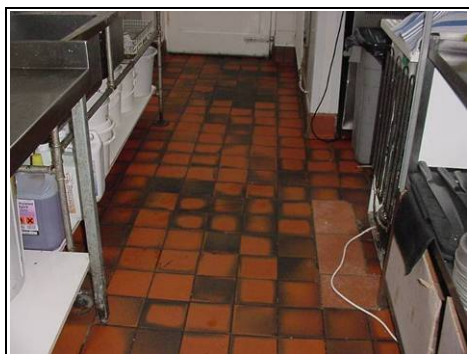
Tiles need a good clean

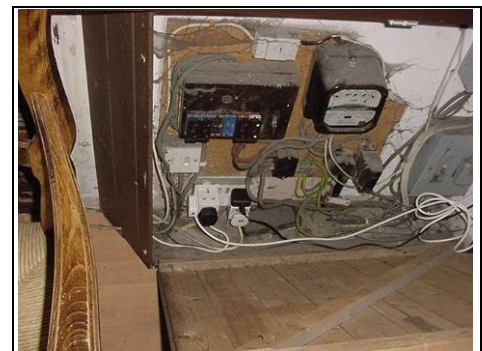
1960s ground floor fuse board
