COMMERCIAL BUILDING SURVEY

**Barking,
Essex, IG11**

We have been instructed to inspect and prepare a Commercial Building Survey for XXX Barking, Essex, IG11.

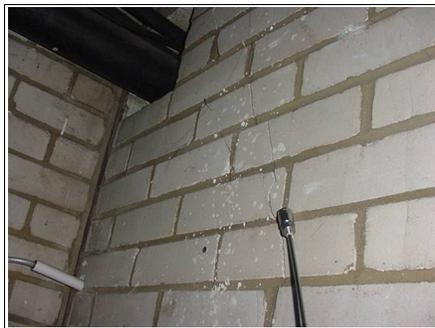
Cracking inside offices with the concrete roof on left hand side

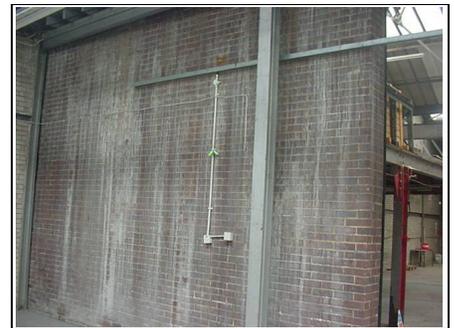
Dividing wall between left hand and middle section where valley gutter is leaking

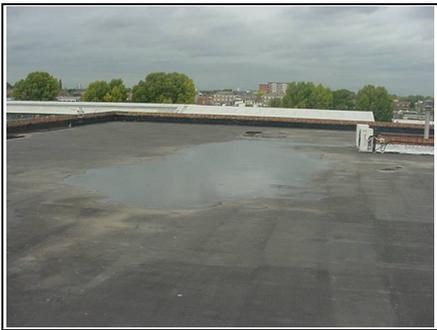
The flat asphalt roofs to the concrete frame building are flat (as opposed to having a fall) and are allowing water to pond and damage the roof structure and building.

Ponding to flat roof, which is not falling towards outlets and coming through roof.

ACTION REQUIRED: To make the roof 100% watertight we recommend an insulation cut to falls laid over the roof, finished in a high performance felt if you intend to use the building in the medium to long term. In the short term patch repair may be an option, depending upon how you wish to use the building.

ANTICIPATED COST: Re-roofing would cost in the region of £50,000 to 100,000, depending upon the exact specification. Patch repair in the region of £5,000 - £10,000 over a period of time with major works being carried out in the summer of 2012. Please see comments on overall structure.

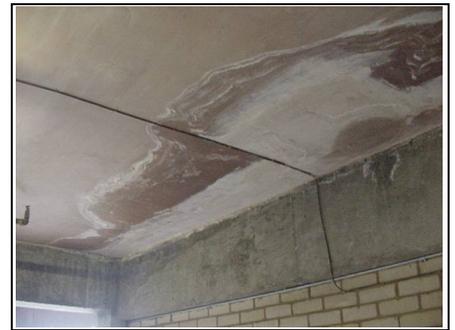
Water coming through roof.

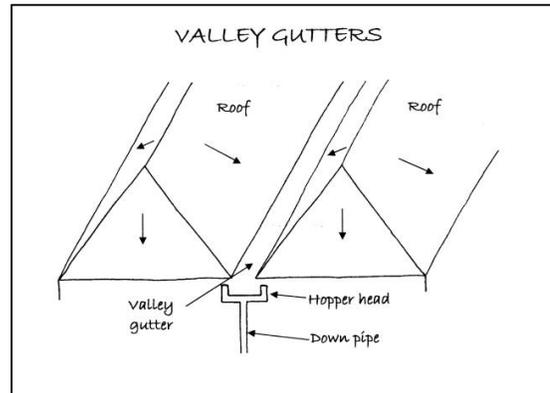
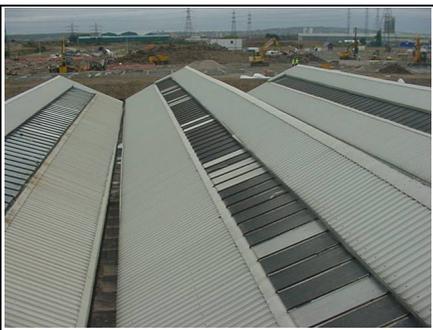
Rainwater/dampness is coming through the valley gutters. This can be seen internally on the dividing walls and also causing deterioration to the metal structural frame and fixtures and fittings.

Left hand valley gutter

Right hand valley gutter

It is likely that the entirety of the valley gutter needs water proofing. There are various ways of carrying out this, from temporary fixes to permanent long term. It needs to be carried out to limit the damage that can be caused to the structural metal frame.

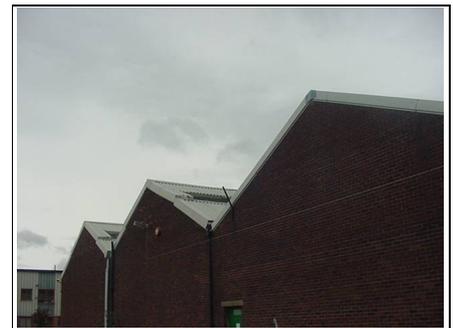
Valley gutters from the rear of the property

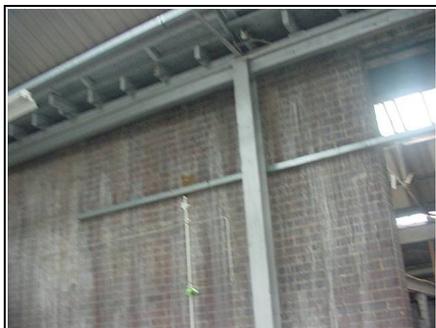
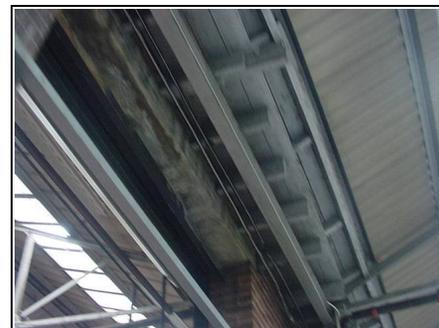
Leaking valley gutter

It is most important to understand how long term deterioration can affect a metal frame structure with rusting and corrosion. This can be unseen to the human eye so needs specialist testing to ensure that there are no major defects in the frame. It will be an unacceptable risk to use this area without carrying out such testing. Failure/collapse can be sudden and without warning in this type of structure.

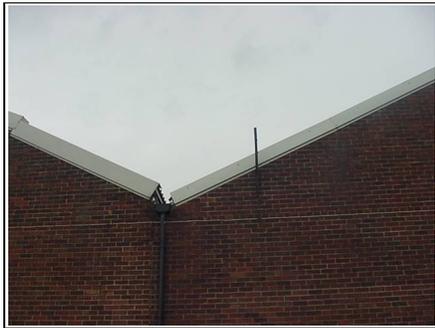
2.2 The drainage is not adequate and is leaking. The hopper heads and downpipes are leaking and are not fit for purpose.

Rear hopper head

Re-sizing of the hopper heads and checking that all gutters and downpipes are watertight and capable of taking the amount of water. We generally recommend over-sizing of the gutters and downpipes as this will reduce the need to maintain the gutters at high level.

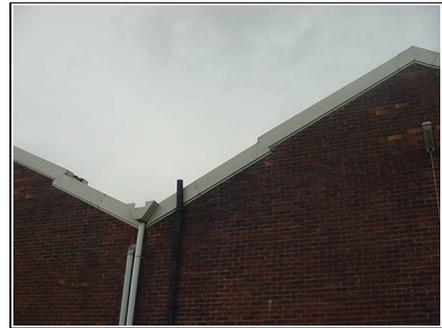
Rear hopper head not large enough to take main water from roof

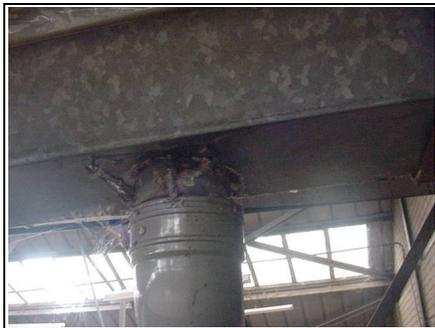
Internal leaking downpipe from the valley gutter

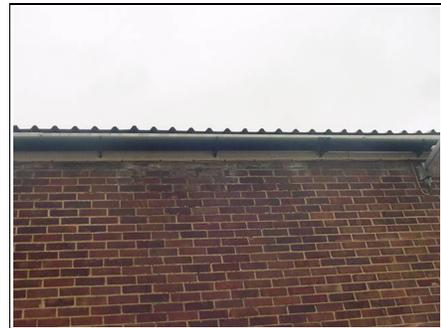
Leaking external gutters

We would always recommend that the gutters and downpipes are cleaned out, the joints are checked and the alignment checked to ensure that the gutters fall towards the downpipes.

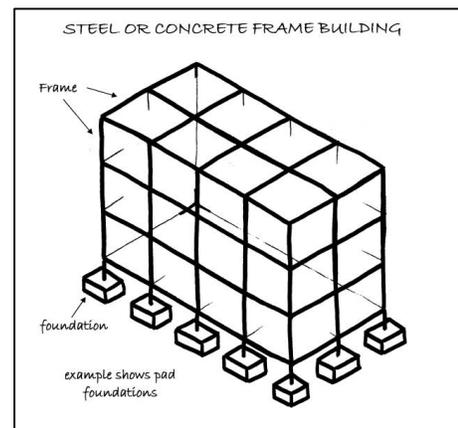
3.1.1. Deflection at first and top floor level.

3.3 The above on its own would put many people/organisations/businesses off purchasing this property. This structure needs to be opened up before you commit to purchase.

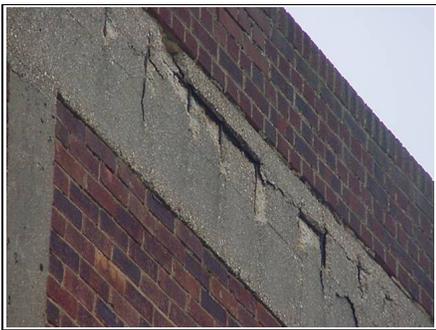
Problem with concrete frame structure – reinforcement visible and deteriorating

ACTION REQUIRED: Testing, as previously recommended in Section 3.

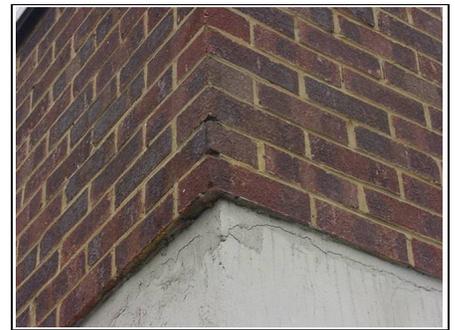
3.2 Repairs have been carried out on this concrete frame previously, whether these are cosmetic or structural is unknown.

Close up of concrete repairs

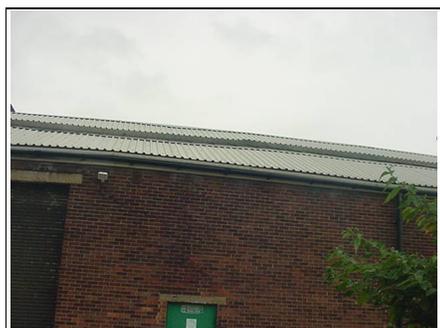
There is twisting and bending and rusting visible to the metal structural frame. We feel this in part is being caused by the dampness coming in via the roof, however we cannot discount problems with the foundations bearing in mind the cracking that we can see throughout parts of the structure.

Twist in metal frame and distortion in brickwork

ACTION REQUIRED: We recommend that investigations are carried out to establish the original foundation design and also the metalwork capacity, as it appears to have been affected by ground conditions and the dampness. Testing needs to be carried out to ensure the rusting has not affected the integrity of the metal frame, particularly to the bolt fixings, where rusting and corrosion can be seen.

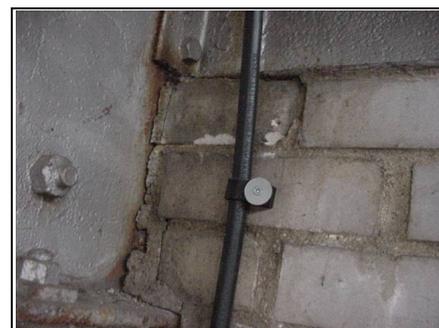
Close up of visible rusting

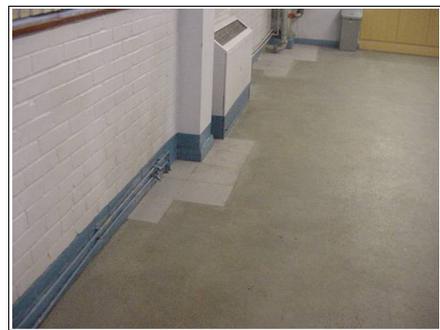
Floor tiles in canteen area that could have asbestos

ACTION REQUIRED: The selling agent Glennys advised an asbestos report is available. We have not seen this but we are aware that there are different levels and qualities of asbestos reports. You need to obtain a copy of this and understand the report and the cost implications of the recommendations with regard to asbestos.

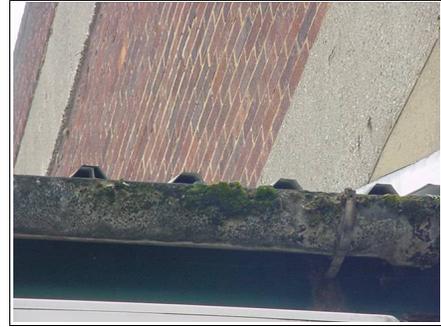
Asbestos gutters

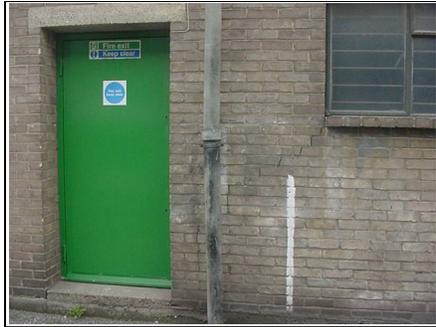
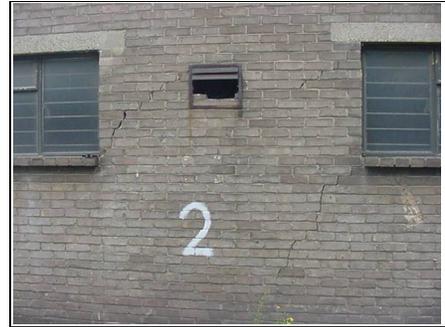
7.1.1 The left hand side, both external and internal walls of the warehouse, particularly to the brickwork warehouse section.

Cracking to left hand side

ACTION REQUIRED: Cracking movement generally makes it difficult to sell, with major reductions in price negotiable. If the structural frame is established to be stable then you will be able to rebuild the walls, although it has to be said that the way the walls are buckling, particularly on the right hand side, does indicate that the structural frame is taking excessive support off them.

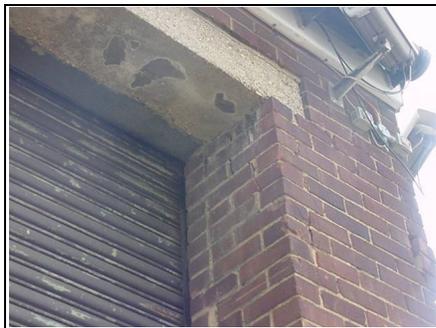
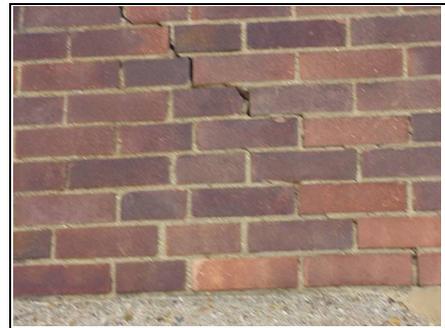
7.1.2 Right hand side of the property, particularly around the warehouse door area.

Cracking to right hand side

Unusually thick brickwork construction may conceal problems, deterioration to lintel and brickwork in this area

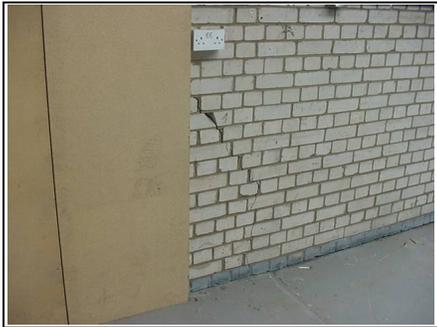
Raking crack on left hand side

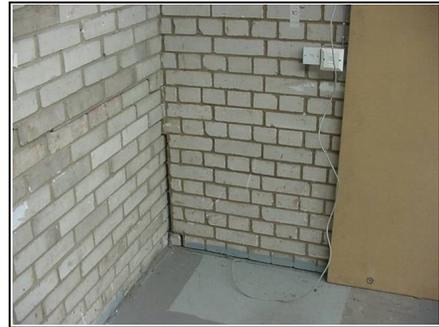
Vertical crack at junction of wall side

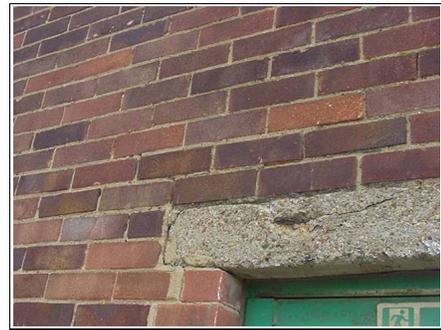
The lintels offer support over the doorways and walls. We can see that some of these are deteriorating, which indicates that it is water damaged and that it is now getting to the point of exposing the reinforcement and they will lose their integral strength.

Example of a lintel with an exposed reinforcement bar

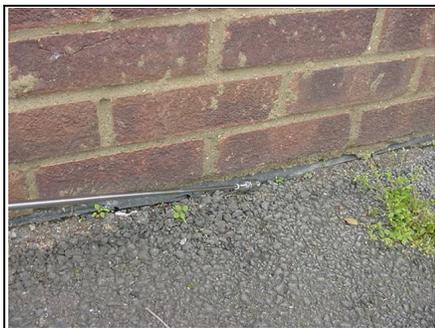
We noted in certain areas of the office building the tarmac forming the surrounding car park has been raised so that it makes the damp proof course ineffective (too low) and dampness will ultimately get into the property.

Damp proof course too low

ACTION REQUIRED: Lower external ground level; 150mm is normally recommended and/or add a French drain (please see Appendices).

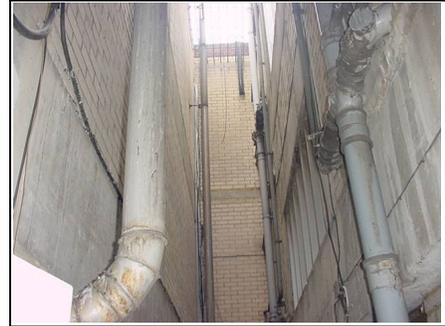
Leaking soil and vent pipes in internal roof void

ACTION REQUIRED: You need a full test on the water supply and the drainage within the property. You will have to also accept that you will have on-going maintenance issues when you occupy the property.

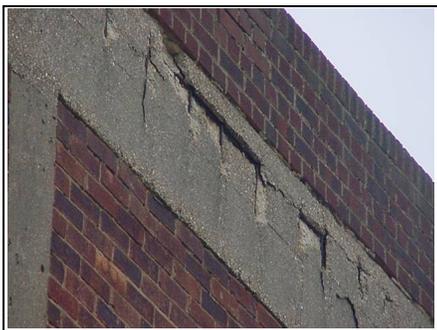
We can see that there have been repairs to the concrete frame. This may be hiding inherent defects.

Deteriorating concrete frame

ACTION REQUIRED: You need to ask the existing owners why and who carried out the repairs to the concrete frame and for any information in relation to this. They will help you with deciding how to carry out future repairs.

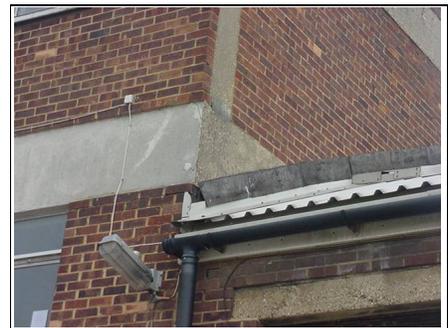
Repairs to left hand side and non repairs to right hand side

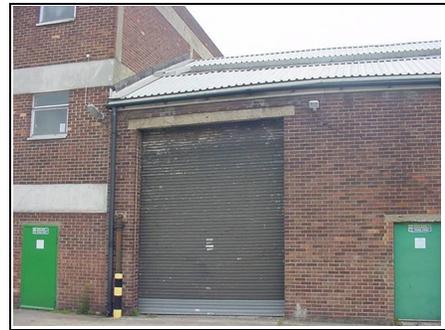
Major repair work is required to the brick walls and checks to the metal frame.

Twist in the building

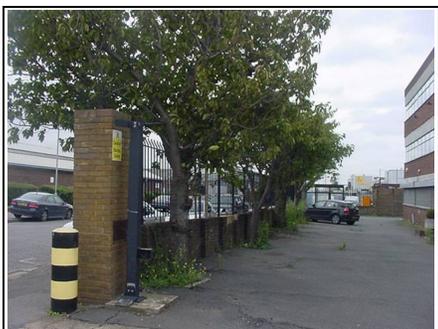
The trees are damaging the front boundary wall and also the car park. You need to make a decision as to whether you wish to retain them or cut them back and carry out repairs, which in turn will mean there will be future repairs.

Trees are affecting the car park

ACTION REQUIRED: Reduce and maintain the trees and repair the wall and car park area.

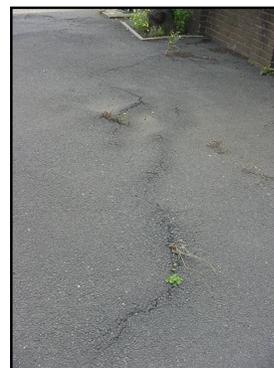
Trees causing problems to front wall and car park

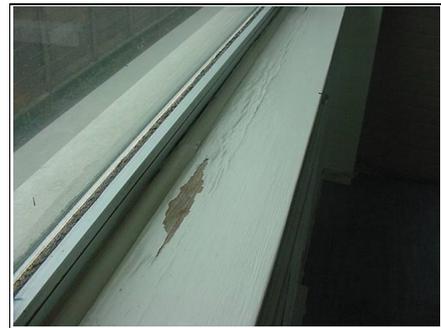
Condensation being caused by aluminium windows visible on left hand side

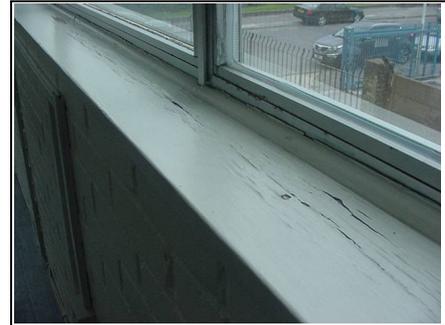
Left hand side condensation occurring on aluminium windows

ACTION REQUIRED: Please see our comments in the Executive Summary for further comment and the Appendices with regard to cold bridging.
