PROPERTY REPORT

Public House, Bedfordshire LU1

We have been asked to inspect and prepare a Property Report and Schedule of Condition in Slip End, Bedfordshire LU1

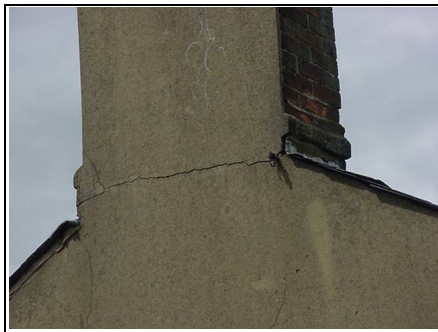
The chimneys are allowing dampness in. You will need to carry out work to the chimneys to stop the dampness.

Crack to main chimney

ACTION REQUIRED: General repointing and repair to the render and checking the flashings.

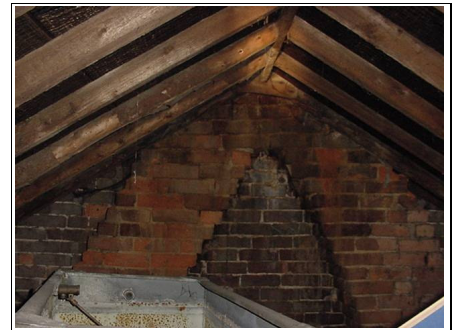
Dampness visible within the roof space of the chimneys

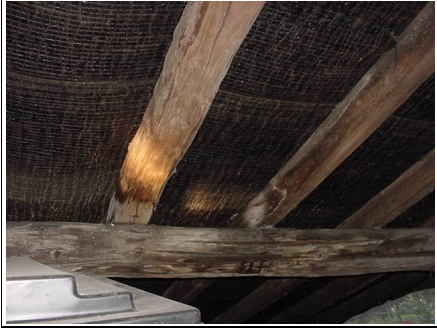
We noted dampness coming in to the pitched roof. This could also be condensation; we noted tingle repairs to the slates.

Dampness found within the roof structure.

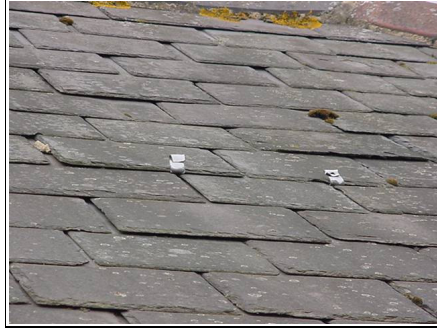
Repairs with lead tingles

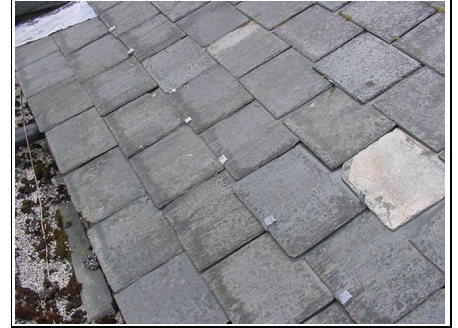
More repairs with lead tingles

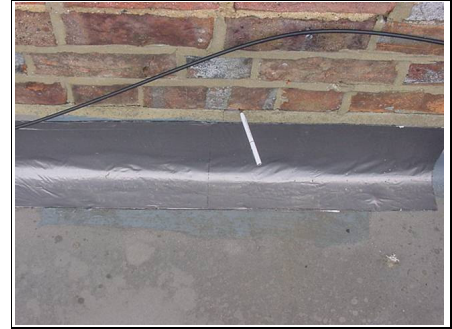
This roof has had various patch repairs, including the repairs shown in the adjoining picture and also Flashband repairs, which is like a sticky backed layer.

Flashband repair

ACTION REQUIRED: All the roofs now need to be looked at and repaired properly by adding lead flashing to them.

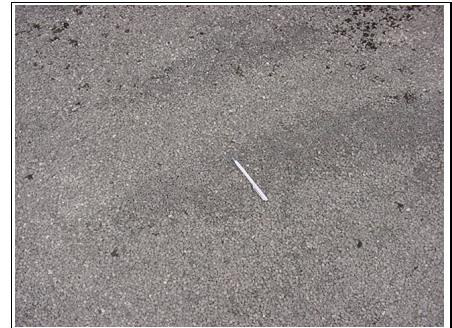
The pen indicates one of the many blisters on the flat roof. There is also cracking around the felt flashing that needs to be replaced with lead. Also, there is moss on the roof, indicating that the roof is flat in areas, and water is sitting on it.

Blisters within the flat roof

ACTION REQUIRED: A fall needs to be added to each of the roofs. We would also recommend insulation, ideally insulation cut to falls. This would also help reduce the condensation in the property.

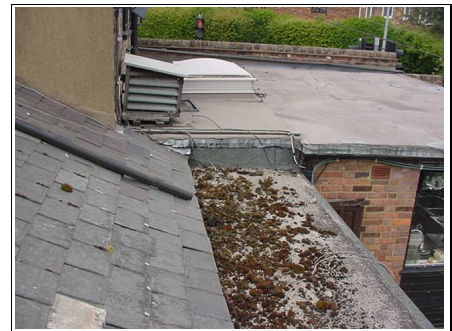
The moss indicates that the roof is flat, with water possibly discharging into the adjoining roof and the upstand is starting to deteriorate.

Moss sitting on the roof

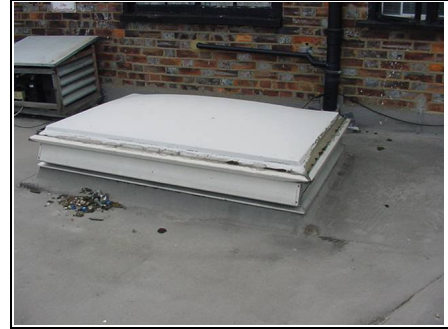
There is a roof light to the rear of the corner bar. We are advised that this leaks, although at the time as it was not raining we could not establish how. Often we find it is the flashings that leak. In this case there is also a crack in the unit too.

ACTION REQUIRED: Repair / replace unit as necessary.

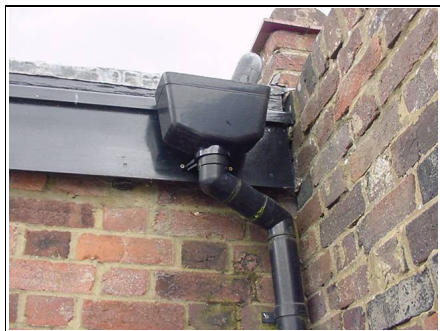
The plastic gutters are leaking in many areas leading to rainwater discharging down or into the building, for example the front right hand corner (to the toilet area) and the rear left hand corner (to the kitchen).

Leaking hopper head

ACTION REQUIRED: Repair, replace guttering and add extra brackets as required. A better alternative to plastic guttering may be aluminium as it has more strength.

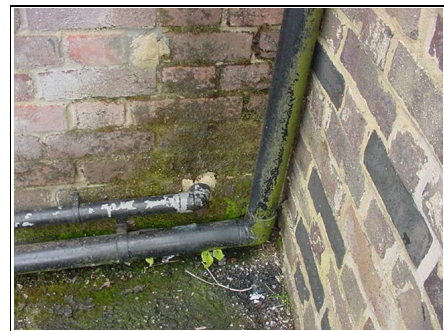
Deterioration to the wall

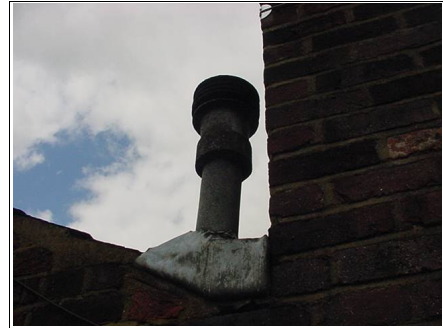
We noticed an asbestos flue adjacent to the chimney. There could be asbestos elsewhere within the property. Typically leases require a Type II Asbestos Report.

ACTION REQUIRED: Your Legal Adviser needs to confirm if the property owners have an existing asbestos report exits and/or if your lease requires one.

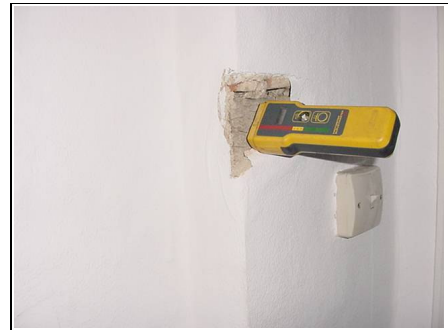
Within the property to the corner bedroom, we could see that bonding are present. In years gone it was considered necessary to add timbers within the structure to hold it together. Ironically, these timbers rot and can cause movement within the structure. This may be the cause of the movement that we have identified earlier.

ACTION REQUIRED: The bonding timbers need to be identified within your Lease as a known issue.

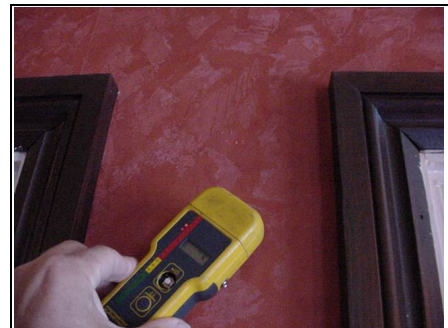
At the time of the survey the carpet was saturated near the toilet area and we also found dampness within the wall. From our investigations we believe this may relate to one, or a combination of, the following:-

Dampness coming in through toilet walls

ACTION REQUIRED: You need to progress through the various items mentioned and eliminate them.

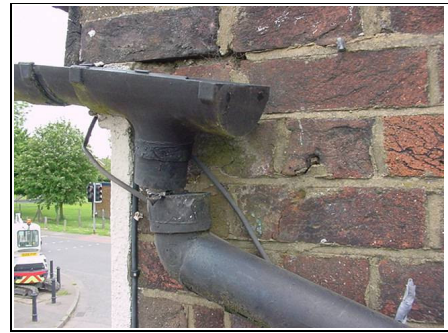
- i) the gutter and downpipe not being connected on the front right hand corner – we would also check the remainder of the gutters and downpipes.

The gutter and downpipe do not marry up

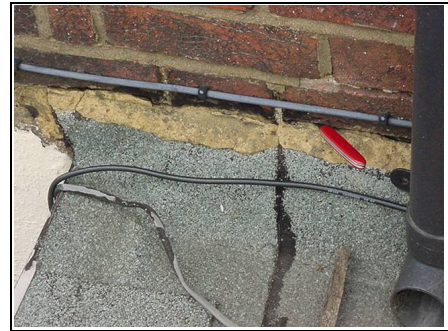
- ii) Felt flashing which was cracking above it.

Cracking above the flashing

ACTION REQUIRED:
Replace it with a lead flashing, probably pointed in.

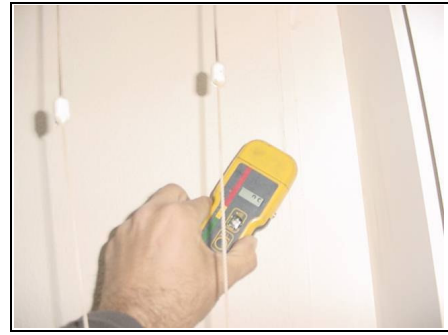
- iii) Chimney that is allowing dampness in at first floor level, which could be transferring down.

Dampness to chimney

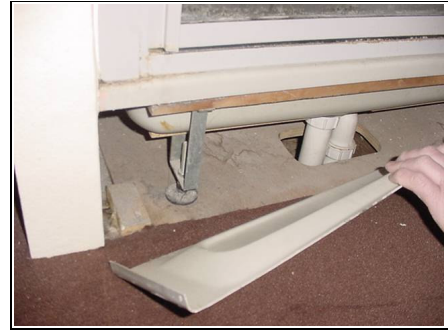
- iv) The pre-formed hollow shower unit could be giving, and in turn, causing the pipework to move and leak water.

Looking under shower unit

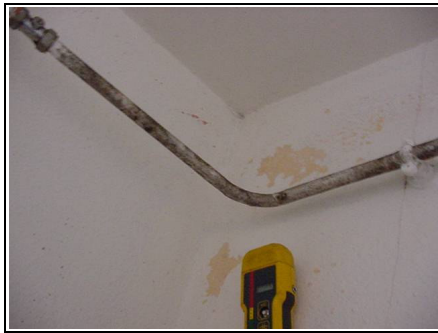
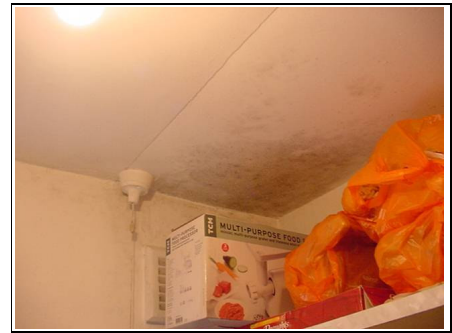
Condensation was visible to several areas, including the male and female toilets and the boiler room. In all cases this was flat roofed areas. We would recommend insulation is added to this area and the heating improved and the ventilation improved.

In all cases there was a flat roof area above. We would recommend that insulation is added to the roof area. Also, the heating needs to be improved, as does the ventilation to remove the condensation.

ACTION REQUIRED: Repairs to roofs and the addition of insulation, together with ground floor heating ventilation.

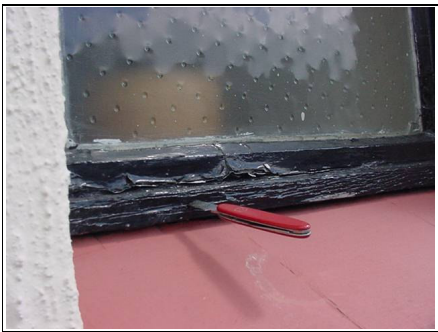
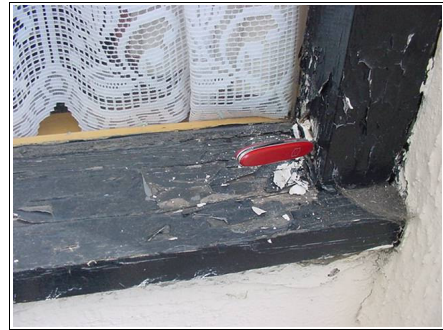
You have a mixture of different types of windows. A common factor is that most of the timber ones have wet rot. This is a long outstanding problem, the windows have been filled many times over the years, and in fact we would go so far as to say that you have filler on top of the filler.

ACTION REQUIRED: The windows need to be completely overhauled, repaired and redecorated.

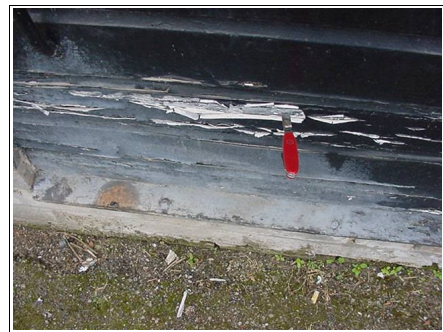
The close boarding paintwork is flaking.

ACTION REQUIRED: Repair and redecorate.

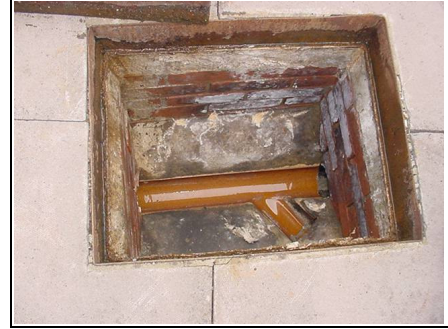
The manhole cover to the rear has been lifted. No drainage tests have been carried out. During our discussions with the existing occupier we were advised that the drains have been blocked three times in the last three months.

ACTION REQUIRED: We would therefore recommend a close circuit TV camera report to check the condition and it may be that a grease trap is also required.

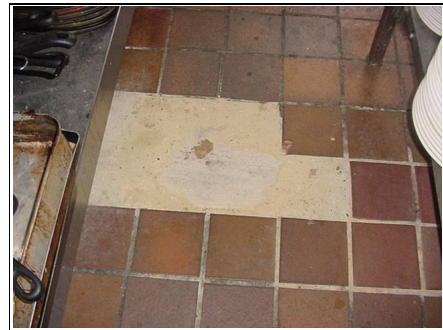
The kitchen would not meet current Environmental Health standards. Its smooth impervious surfaces in these area and missing quarry tiles to the floor mean this is not possible. We would also add there are no fly shields to the window and the light does not have a luminaire, together with the electric point over the fryers.

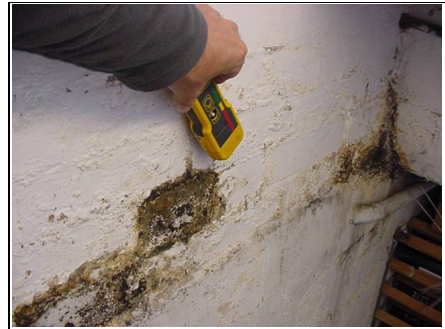
Whilst this area is unoccupied, there is dampness coming in on the stair to the cellar. We would recommend a French gully is added to divert water away from the area.

ACTION REQUIRED: Add French gully. However, the problem will be difficult to resolve satisfactorily.

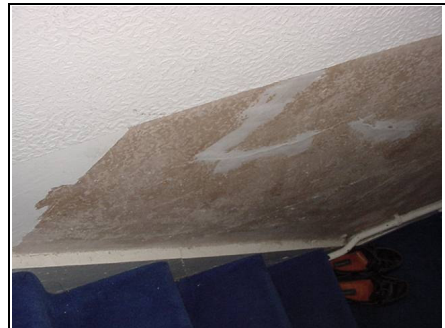
12) Staircase Wall with Dampness Coming In

We believe this may be due to defective rendering; there are hairline cracks visible.
