**SCHEDULE OF CONDITION
OF
A Public House
Bedfordshire**

INDEPENDENT CHARTERED SURVEYORS

Address

SCHEDULE OF CONDITION

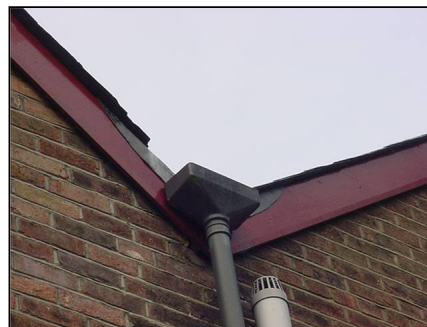
2) Valley Gutter

There is a valley gutter to the rear of the property. These are generally considered to be problem areas. Within the roof space we could see some dampness getting through and the situation can only get worse; although presently, as far as we could see, it does not affect the private living accommodation.

ACTION REQUIRED: We would recommend that a roof light be fitted to the valley slope of the roof to allow inspection of the valley gutter (from the roof space) and access to clear it of leaves and other debris on a periodic basis.

ANTICIPATED COST: In the region of £1,000 - £2,000.

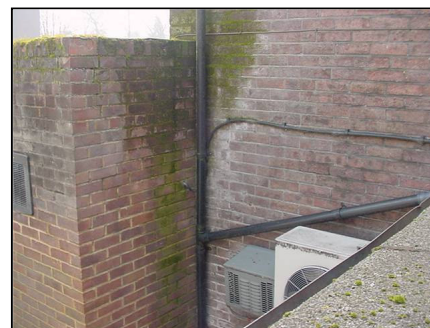
On the left hand side there are signs of dampness in the cellar area. We believe this relates to overflowing downpipes and gutters, although it is difficult to be certain without seeing the property during rainy weather.

ACTION REQUIRED: Further investigation needed.

ANTICIPATED COST: We would recommend the sum of £1,000 be set aside. The dampness needs to be resolved as it goes into the cellar area and we do not believe it would meet current Environmental Health Office standards.

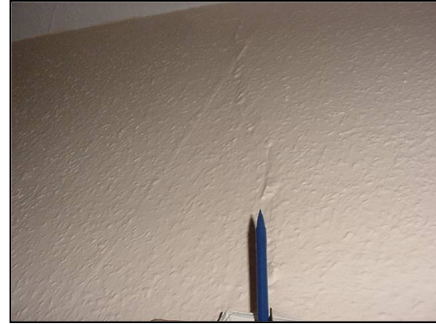
To the right hand side of the property there is evidence of subsidence from diagonal cracking to both the external of the property (rear right hand wall) and internally visible within the corridor area on the first floor.

During the course of our inspection we identified that this area is of newer construction than the original property and this movement indicates differential movement and settlement to this area possibly relating to drainage leaks.

We noted that the surrounding area has been repointed, therefore this has reduced our ability to inspect the area for further cracking.

ACTION REQUIRED: We would recommend that the present owners are asked to instruct their insurance company to investigate the matter further.

We would expect a close circuit television drainage report to be carried out and also monitoring of the cracks to establish if they are progressive.

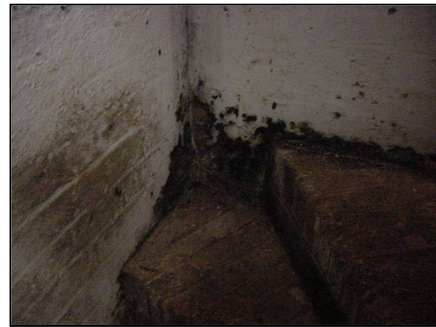
There looks to have been a leak to the centre of the ceiling and this needs to be resolved before redecoration takes place.

ANTICIPATED COST: In the region of £500 - £1,000, allowing for work to be done over a number of days to allow the public house to keep operating.

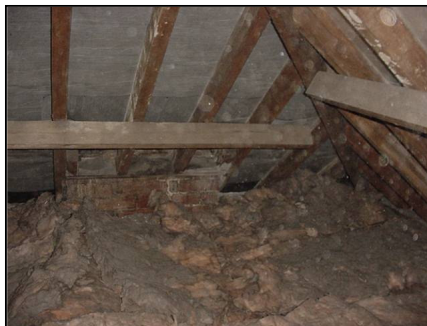
Base of the left hand chimney
showing some signs of dampness

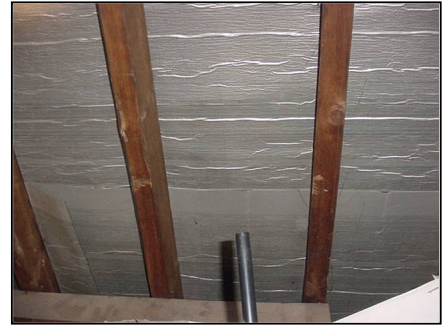
We noted a plastic underlayer. This type of underlayer was popular in the 1970s/1980s and does tend to 'sweat' in the warmer months, which can cause condensation. We were pleased to see that it has been vented, which should help to reduce this.

ACTION REQUIRED: The roof space / loft should be inspected during the summer months to assess the level of condensation.

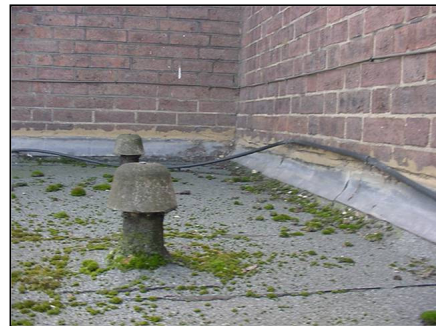
Rear left hand side roof

This roof is flat, as is indicated by the amount of moss sitting on the roof. However, we were pleased to see that it is also vented. This roof will have a life of five to ten years.

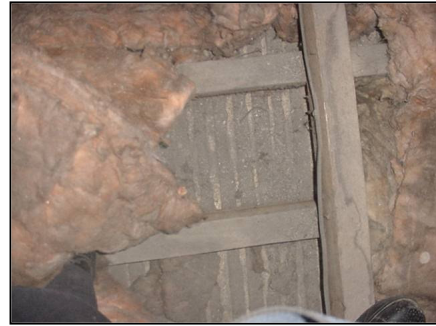
Our main concern with this roof is the condensation that has already been mentioned and the ceiling where the lath and plaster appears to have lost its key in some areas and this can only get worse (for example the front left hand lounge).

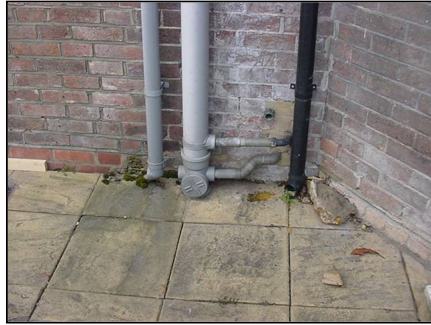
The gutters and downpipes are predominantly plastic. We noted that some of the downpipes (for example to the rear right hand side) discharge directly onto the floor, which is never ideal as it can lead to dampness into the property and also undermine the foundations in a worse case scenario.

Discharging directly onto the floor

ACTION REQUIRED: The downpipes that discharge directly onto the ground would be best being redirected into drains.

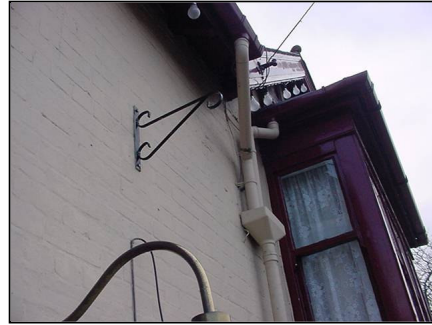
Leaking downpipe

We would always recommend that the gutters and downpipes are cleaned out, the joints are checked and the alignment checked to ensure that the gutters fall towards the downpipes.

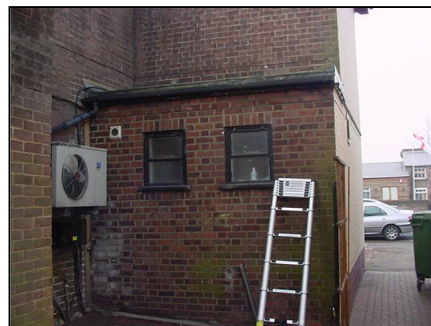
Diagonal Cracking

We were advised by the present operators that they believe there was subsidence to the property in the 1980s.

ACTION REQUIRED: Your Legal Advisor to speak specifically with the present owners about this and obtain any literature and information relating to this.

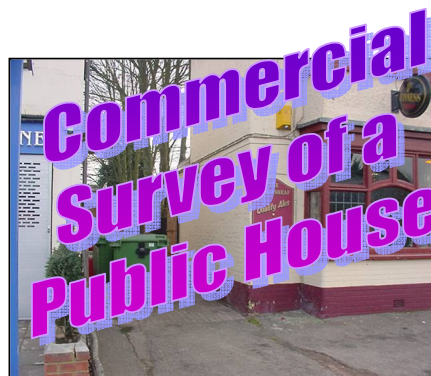
There are areas to the property that have painted brickwork. This is never ideal as it seals the brickwork, which should be left to breathe.

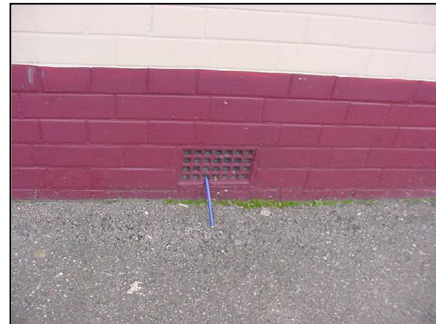
There are airbricks located to the front of the property, but there do not appear to be any located to the rear. There should be an airflow from the front of the property to the rear.

ACTION REQUIRED: Open up the floor to the rear of the property and add airbricks, if it is a suspended timber floor.

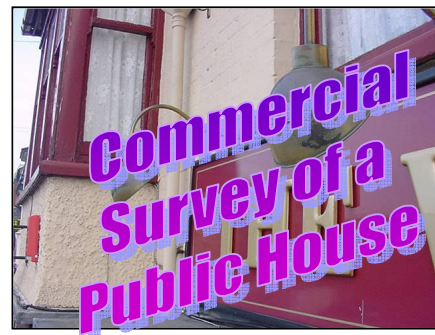
The signage is in need of redecoration. The lights are starting to tarnish and deteriorate.

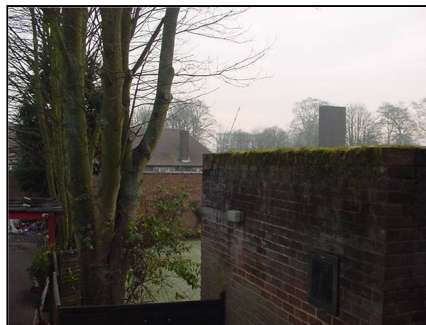
There are various trees to the rear of the property. There is one mature tree to the rear left hand side within five meters of the property (most insurance companies require specifically advising of the tree). It is adjacent to the kitchen, which looks to be a newer extension and it is usual for Building Control to require the foundations to be built to allow for the close proximity of a tree. This usually means them being deeper or a tree root guard being put in place. Without opening up the foundations we cannot comment further.

Tree close to the property. Also note the deterioration to the parapet wall.

ACTION REQUIRED: An arboriculturist (not a tree surgeon) is required to inspect the trees in the next few years and any action recommended should be taken.

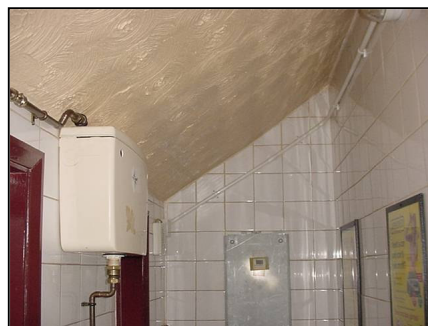
Pitched artex ceiling with some hairline cracking with a leak to the front corner.

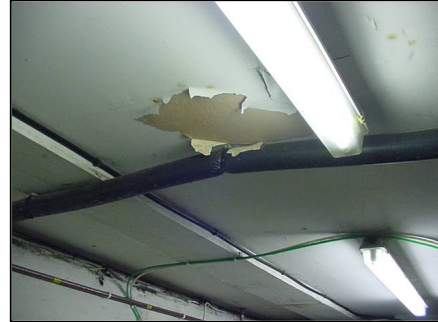
Painted plaster. Slightly dated. Signs of a leak to the centre of the ceiling.

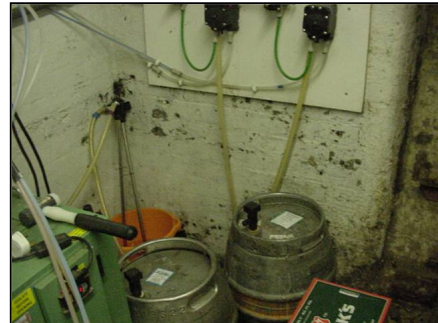
Painted brickwork in below average condition. In need of redecoration. Old fixing points not made good to walls. Rusting iron metal ironwork to base of staircase. (Staircase not lined).

Mould around staircase area and also rot to timbers.

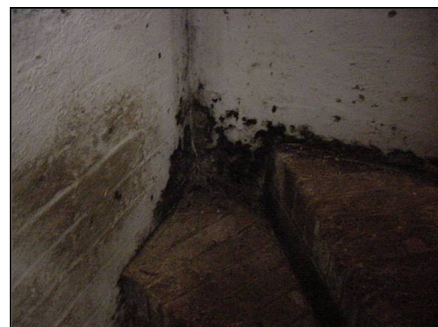
There is mould in this area via a leak.

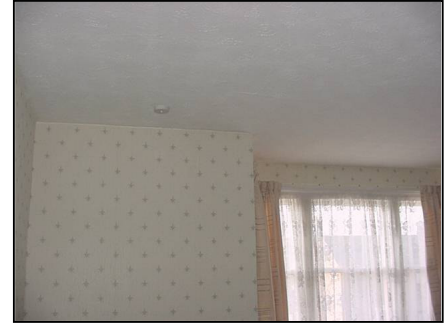
Lath and plaster, which looks to have lost its key; there is cracking indicating this. Light artex painted finish.
