SCHEDULE OF CONDITION

Houghton Conquest,
Bedfordshire.

INDEPENDENT CHARTERED SURVEYORS

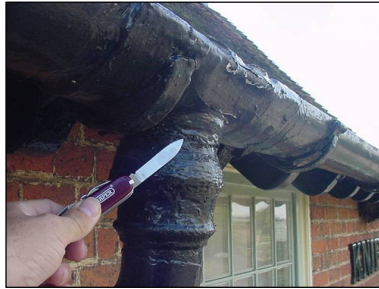
Old repairs to cast iron gutters and downpipes

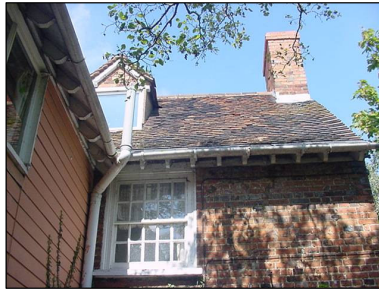
Chimney

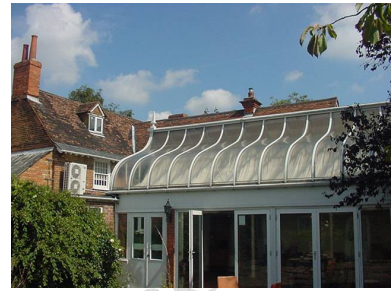
Conservatory area

<p>Large conservatory advised being redeveloped not included in Schedule of Condition</p>		<p>Ad hoc repointing</p> <p>Re-stain and resecure</p>
<p>Fascias and Soffits: Exposed rafter feet</p> <p>Windows: Timber and metal</p> <p>Doors: Plastic</p>		<p>Redecorate in the summer of 2012.</p> <p>Redecorate</p>

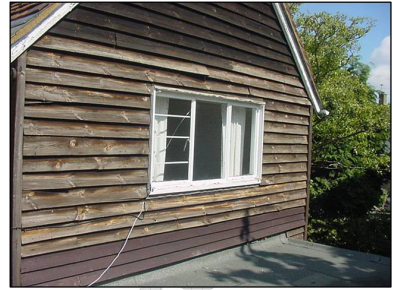
Shiplap boarding

Walls: Flemish bond brickwork Shiplap boarding Concrete frame structure	Fading	Ad hoc re-pointing Re-stain Please see comments on the left hand side elevation
Fascias and Soffits: Exposed rafter feet Windows: Timber casement windows, timber sliding sash windows and metal windows Rear dormers plastic windows Timber single glazed panels to conservatory base and also to the rear		Redecorate in the summer of 2012. Require redecoration Plastic windows unlikely to be looked upon favourably as Listed building
Comments: Trees growing within influencing distance close to the property on the right hand side		Arboriculturist report required. Likely to be needed to be cut back.

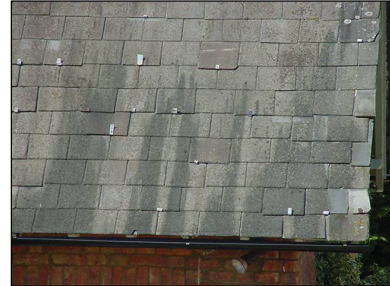
Roof with lead tingles

DESCRIPTION	CONDITION	ACTION REQUIRED
<p>Roofs:</p> <p>Pitched slate tile with tingles</p> <p>Left hand side: Two inward facing hollow pitched flat roofs</p> <p>Centre valley gutter which discharges to the rear of the property</p> <p>Lead flashing and flashband</p> <p>Fire breaks:</p> <p>Room Seven inspected –no fire barrier found</p>	<p>Leak to rear</p>	<p>Repair. Ensure watertight. Repair and re-point.</p>

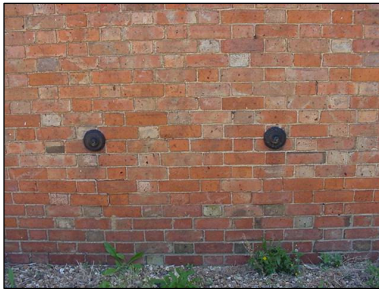
Tie bars

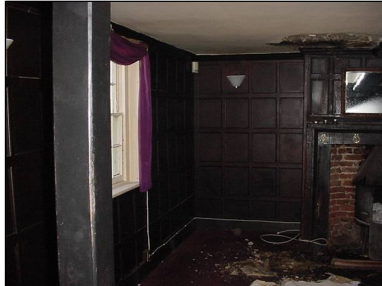
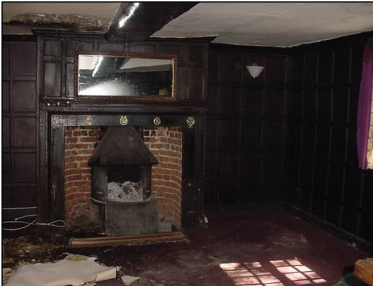
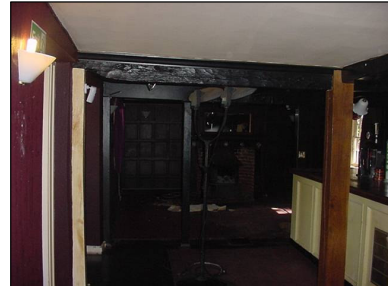
Bar
(left hand side)

DESCRIPTION	CONDITION	ACTION REQUIRED
Ceilings: Lath and plaster Central spine beam	Water coming through, ceiling down in two areas

Pipework goes into the chimney pipes currently leaking into the bar below where the ceiling has come down.

Make watertight. Repair, prepare and redecorate.
Walls: Panelled Fireplace: Cast iron burner	Stained, some marking particularly to rear wall.	Repair, prepare and redecorate.
Floors: Carpet over joist and floor boards	Marked	Clean and/or replace
Detailing: Windows: Two 10x10 Georgian single glazed	Paint flaking	Repair, prepare and redecorate.
Services: One radiator on bar

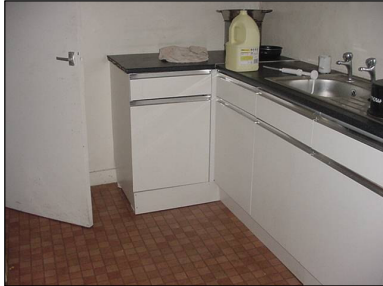
Kitchen

DESCRIPTION	CONDITION	ACTION REQUIRED
Ceilings: Gloss painted	Marked	Benefit from redecoration.
Walls: Gloss painted Part of chimney	Marked	Benefit from redecoration.
Floors: Vinyl covering over timber floor	Deflection falling towards centre of the building	Clean
Detailing: Windows: Georgian style sliding sash Doors: Flush painted	Marked	Ease and adjust. Repair, prepare and redecorate. Repair, prepare and redecorate.
Appliances: The appliances have not been inspected, as we are not expert in this area, you should seek expert advice.

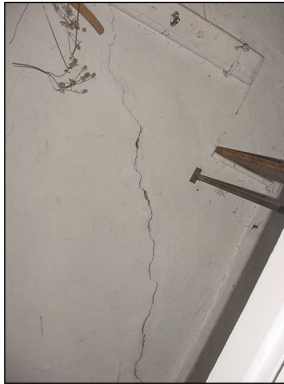
Crack

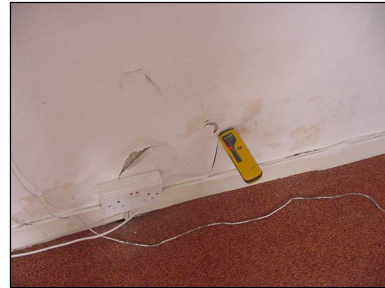
Damp coming through walls

DESCRIPTION	CONDITION	ACTION REQUIRED
Ceilings: Painted	Marked	Benefit from redecoration.
Walls: Painted Two cupboards around chimney both with panelled doors	Marked Dampness Extensive cracking running for approx two and a half metres from floor to ceiling diagonally to right hand side.	Repair, prepare and redecorate. Resolve dampness Monitor cracking as per BRE recommendations for one year. Place an insurance claim.
Floors: Fixed carpet	Uneven falling to the centre	Clean

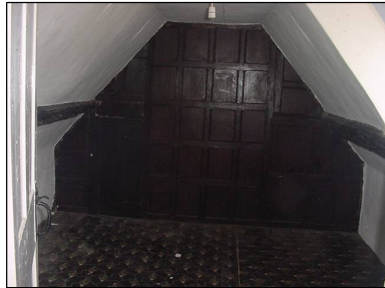
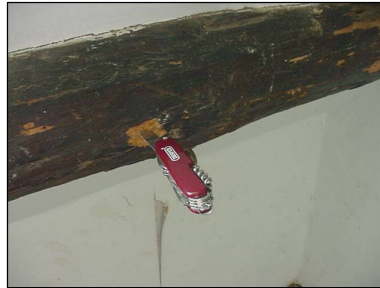
Left hand side Room

DESCRIPTION	CONDITION	ACTION REQUIRED
Ceilings: Lath and plaster Papered and painted	Paper is coming away. Marked	Repair, prepare and redecorate.
Walls: Panelled wall to left hand side Panel access to left hand gable wall Two vaulted to pitch of roof, papered Two purlins visible	Damaged and marked Paper coming away Woodworm	Requires sanding and re-staining. Repair, prepare and redecorate. Open up walls, check extent of woodworm.
Floors: Lino Joists run from front to rear	Active woodworm in floor joists

Clean or replace Open up floors, check extent of woodworm.

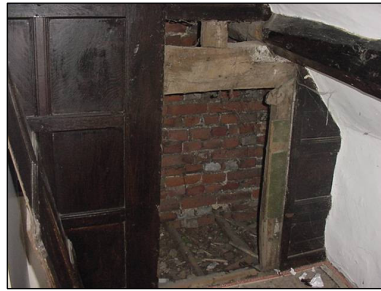
Small floor joists visible

DESCRIPTION	CONDITION	ACTION REQUIRED
Ceilings: Lath and plaster Papered and painted	Partly newly painted assuming that there was a roof leak here recently	Repair, prepare and redecorate.
Walls: Vaulted papered and painted. Timber panel to right hand side Two purlins	Heavily marked Purlin to rear seems to have the worse of the woodworm	Repair, prepare and redecorate.
Floors: Timber	Woodworm found	Open up floors, check extent of woodworm.
