# PROPERTY REPORT

**Mid Terrace  
Town Centre  
Office Premises**

## **INTRODUCTION**

We have been asked to inspect and prepare a Report and Schedule of Condition on the subject premises.

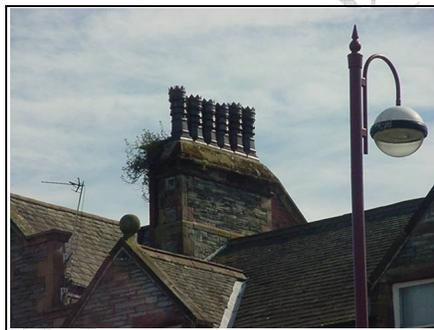
We can see that work is required at high level to the chimneys, roofs and gutters. We can see leaks within the top floor offices which have occurred from the roof particularly to the rear of the property. Unfortunately or fortunately because these rooms are formed partly within the roof, if there is any roof leaks then you know about it very quickly. We can see blistering to the walls in the offices which we would attribute to leaking gutters and downpipes.

Chimney with plants growing from it

**ACTION REQUIRED:** Ideally we would recommend excluding all high level work from the lease. High level work needed is to scaffold the property (which would be expensive in itself), to clear the vegetation from the chimneys, check and repoint and the same with the roof and the gutters. The gutters have a lot of vegetation in them and it is likely that the gutters will need tarring and possibly replacement sections however if left these areas will allow dampness in the property.

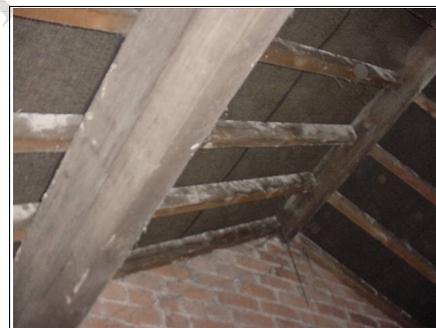
The inside of the roof inspection was very limited (head and shoulders only) but what we could see was in average to below average condition.

Timbers can be seen to be discolouring indicating dampness and/or condensation

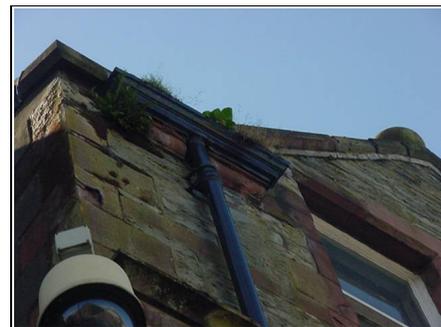
Blocked high level gutter

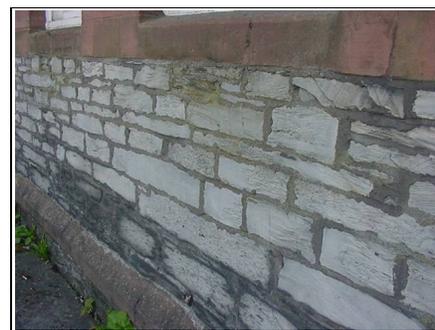
2.1 We can see signs of dampness coming through the walls and also getting damp meter readings. This is known as lateral dampness. We believe this is caused partly by the cracking to the render to the rear and partly by defective gutters and by defective pointing. Unfortunately the re-pointing has been carried out with cement mortar so this stops the building from dissipating the dampness (think Vortex type coat rather than a raincoat with regard to how this building should work when dealing with rainwater).

This type of building therefore should have an open breathable joint in a lime based mortar in our opinion.

Poor quality cement re-pointing to stonework

The work required to reduce the dampness getting into this property is first of all to make the property watertight at high level, i.e. ensuring the gutters and downpipes take water away and then in the case of the stonework we would recommend repointing in a lime based mortar and repairs to the plasterwork internally. Again internally we would recommend a lime based plaster, this puts up with dampness far better in older properties (whatever you do, don't use modern gypsum plaster as this doesn't cope with dampness very well or renovated plasters which locks the dampness into the property). To the rear you will need to seal all the hairline cracking and replace any damaged or deteriorating render.

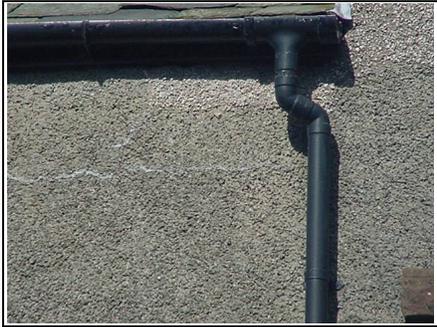
There is hairline cracking in the render so deterioration to some areas. This cracking will need sealing and also we believe there are defective areas of render that will need repair.

Hairline cracking to rear render

**ACTION REQUIRED:** We would recommend that the external work is excluded from the lease with the landlord carrying out the work, so effectively you will have an internal maintaining lease only. With the dampness in the property this would mean that you are likely to have to carry out a system of adding false walls as dampness is not a quick fix.

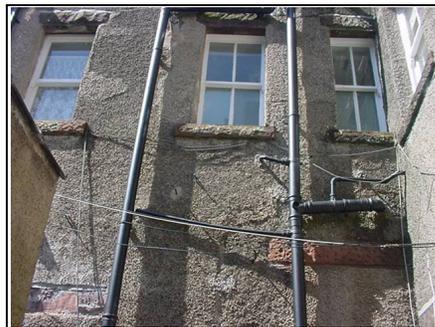
Lower render area starting to deteriorate

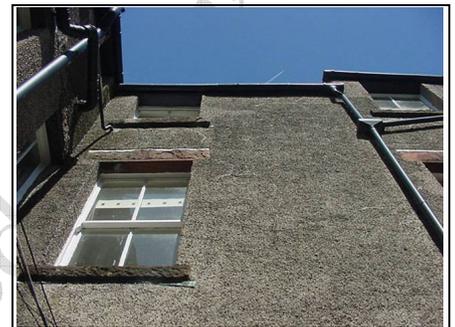
Repairs to hairline cracking that has taken place on render to rear

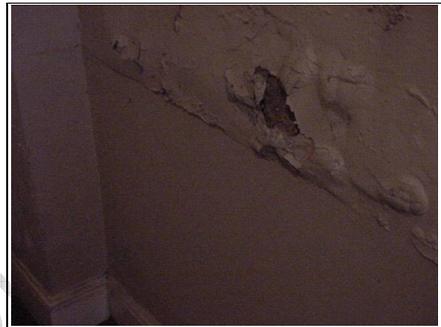
Close up of dampness above damp proof course that has been inserted

**ACTION REQUIRED:** As mentioned earlier this age of property should be using breathable materials rather than materials that give the sealing affect (sealing the moisture in) and it is very difficult to un-do. In this particular case there are problems with regards to the drains outside draining into the property and into the wall and also the ground floor which we cover in the next section.

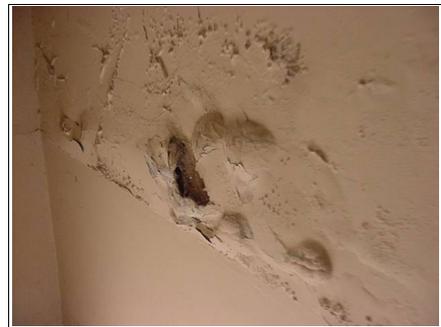
Damage to wall in rear hallway caused by damp proof course inserted

**ANTICIPATED COST:** Unfortunately this wall can't be repaired in isolation; it needs to be carried out externally to the gutters and downpipes and yard area and also the flooring. We would recommend replastering in a lime based plaster which we would expect to be in the region of £1,000 - £2,000; quotations required. You do also need to check to see what is on the other side of this wall.

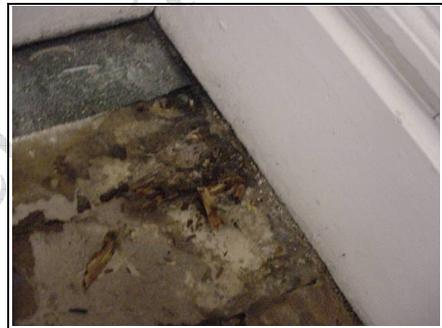
The floor is formed with a suspended timber floor. Unfortunately we have not been able to open this up nevertheless from the damp meter readings we obtained on the ground floor level, the lack of air vents to the rear of the property and the areas of concrete floor to the entrance we believe there is a problem with the floor.

Damp floor

**ACTION REQUIRED:** Before you commit to purchase this property you need to open up a section of the floor, we suggest sections (1) to the front of the property in the front office and (2) to the rear of the property in the rear office and adjacent to the rear exit door. We would be more than happy to return to comment further. You need to have contractors on hand to open up and replace the timbers, ideally the areas that are opened up should be adjacent to airbricks so we can see that these are really working although the airbricks to the rear appear to be at the wrong level unless there are vent trunks through the wall itself.

**ANTICIPATED COST:** To open up and put back the floor we would expect costs in the region of £250 - £500; quotations required. Note that the floor is damp and that new timber may be required. There will be major expense if these timbers need renewing or extensive repair.

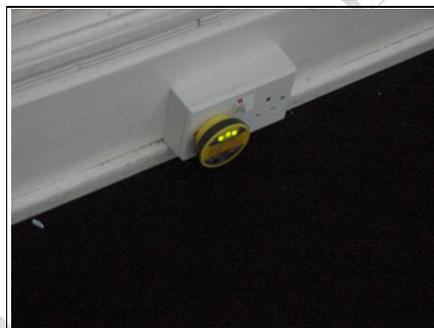
We carried out an earth test which was satisfactory in the sockets which worked but some of them didn't work for example the front office left hand side low level wall socket point.

Working socket

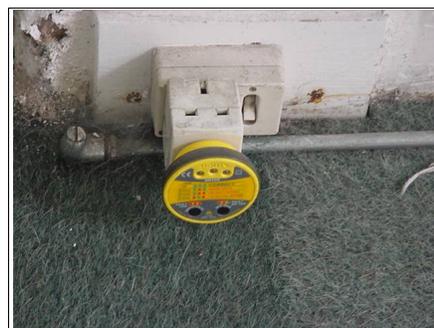
Non working socket

**ACTION REQUIRED:** If you are looking to take on the building for the long term then you do need to look at re-wiring the whole of the property. In addition the existing lights would not meet current recommendations and they generally need to be changed to what is known as Category 2 lighting level although it does depend on what work you are carrying out in the offices.

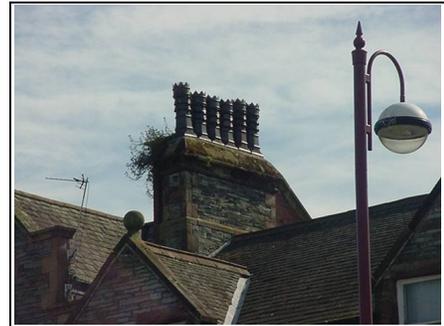
One stone built chimney to the left hand side with six chimney pots and a lead flashing. We noted vegetation and grass growing from the chimney indicating that it needs repointing.

Chimney with plants growing from it

**ACTION REQUIRED:** Please see our comments in the Executive Summary.

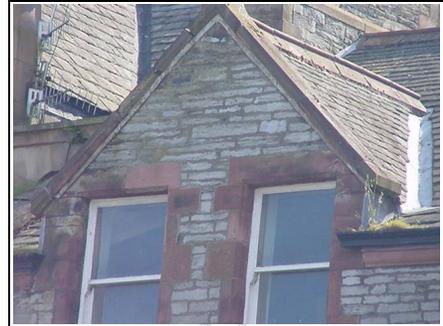
Light can be seen to the coping stones of the parapet walls on the front gable

**ACTION REQUIRED:** You need to check and inspect and repoint when carrying out high level work.

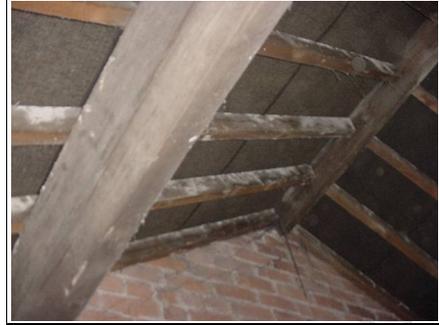
The property has a hessian based protective underlayer indicating that it has been re-roofed post war. Due to an awkward angle to get into the roof (it was over the stairway) and the small access area we have only carried out a head and shoulders inspection, however we would comment that we could see white staining on the timbers (known as batons) indicating that dampness or condensation is occurring in the roof which we were surprised to see. This may indicate problems with the roof therefore a close inspection needs to be carried out when the high level work is taking place.

This photo shows the common rafters (the ones that form the pitch of the roof) and the dark area between is the underlayer.

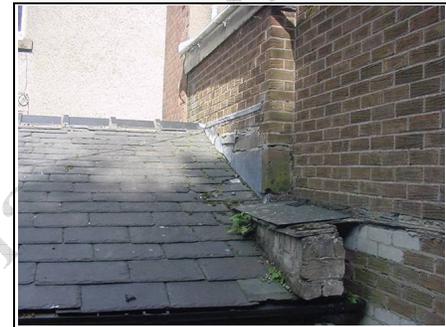
Poor detailing

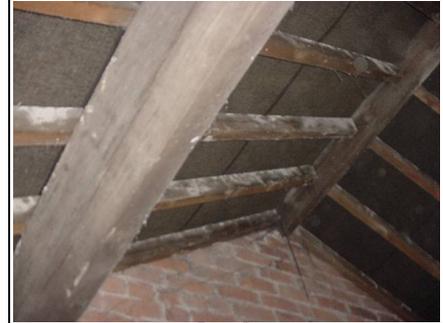
Rear roof – timbers can be seen to be discolouring indicating dampness and or condensation

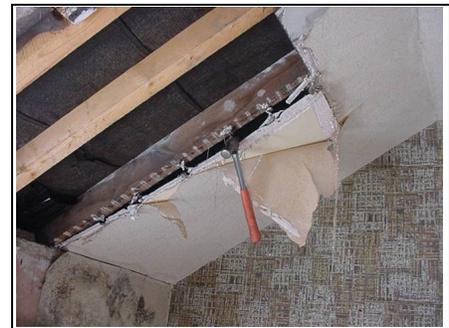
Due to the way the property is constructed part of the top floor rooms are formed in the roof; we can see areas where repairs have been carried out. To the rear there looks to have been replacement of several of the common rafters (the ones that form the pitch of the roof) indicating that there is major problems with this roof.

Underside of roof in top rear room

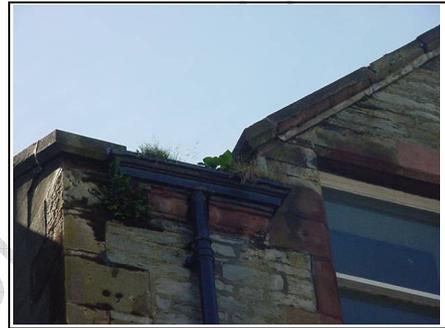
The gutters and downpipes are predominantly Cast Iron with some Plastic with vegetation and grass growing from them.

Grass growing out of gutters

**ACTION REQUIRED:** Clear and repair. We would always recommend that the gutters and downpipes are cleaned out, the joints are checked and the alignment checked to ensure that the gutters fall towards the downpipes.

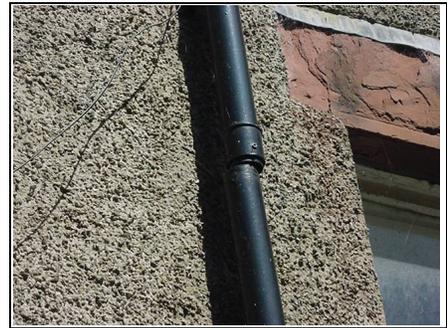
Broken downpipe

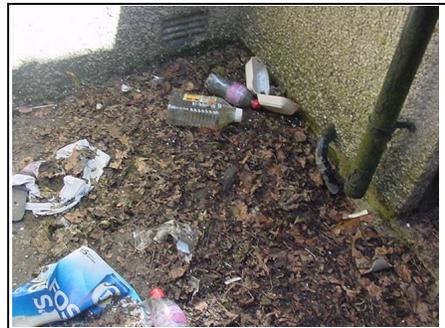
Gulleys that need clearing

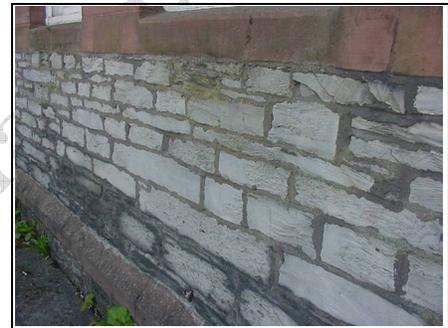
Poor quality cement repointing to stonework

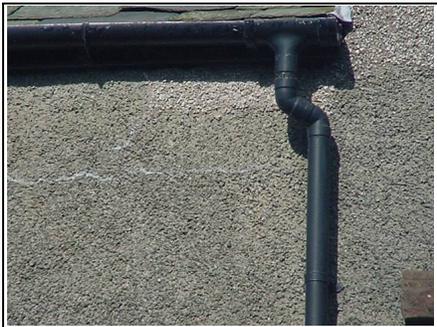
Hairline cracking to rear render

**ACTION REQUIRED:** Please see our comments in the Executive Summary.

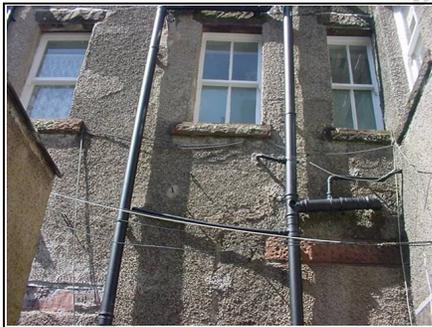
Lower render area starting to deteriorate

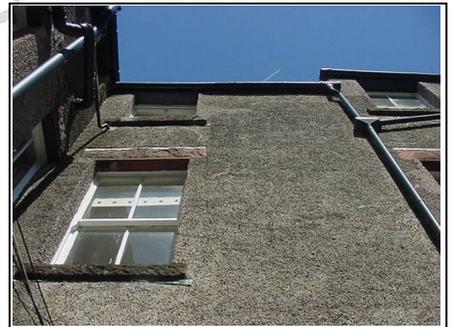
Repairs to hairline cracking that has taken place on render to rear

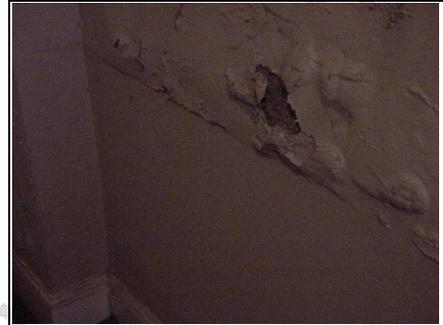
Close up of dampness above damp proof course that has been inserted

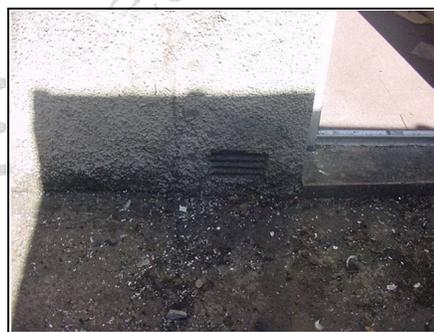
There are airbricks visible to both the front and rear of the property however the airbricks to the rear of the property look too high to be used within the floor. As mentioned elsewhere within the report that unless there is a conduit passing air from the airbrick location through the wall and into the floor you will have to add airbricks to the rear of the property.

Airbrick to rear of property – you can see floor level to right hand side

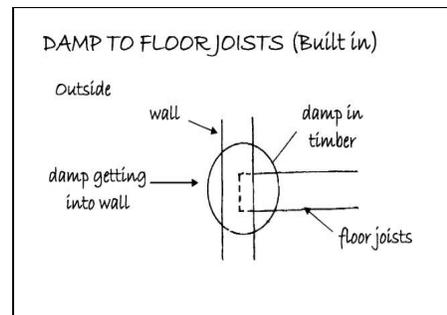
There is a lot of deflection to these walls, far more than we would normally expect which is unusual in this age of property as the timbers are normally substantial and can cope with some rot to the raft ends.

**ACTION REQUIRED:** We would recommend the floor is opened up to check and we would also look to see if these front and rear walls are tied in to the main structure at the same time.

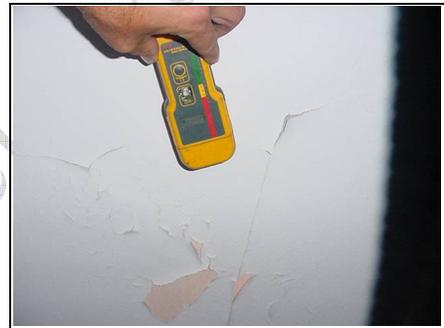
Tests were taken with a moisture meter at random points to external walls. We generally got high dampness readings and/or visually noticed dampness coming through the property in the form of mould.

Dampness

**ACTION REQUIRED:** Please see our comments in the Executive Summary.
