COMMERCIAL BUILDING SURVEY

Basildon

INDEPENDENT CHARTERED SURVEYORS

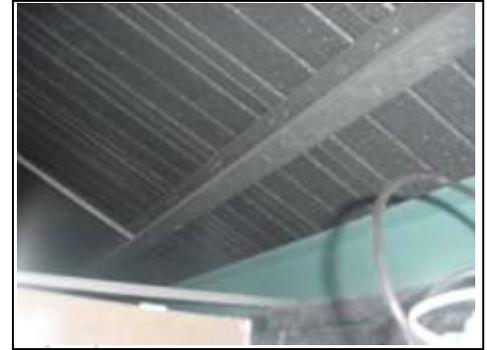
1.1) Metal sheet construction.

There is a metal sheet beneath the roof (rather than a protective underlayer) which could lead to condensation and/or interstitial condensation.

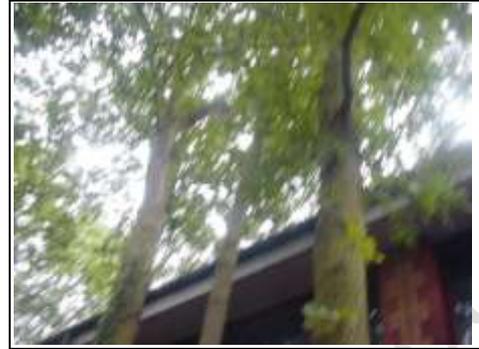
This building has been built particularly close to the trees. From our discussions with the neighbour all the trees have tree preservation orders (which we believe you suspected). You literally have trees hanging over the top of your roof and they are certainly within what we would term as influencing distance with regard to the roots of the trees going under the property.

Trees close to property at rear

ACTION REQUIRED: We feel it is essential that you understand how the foundations are built. This information should be obtainable either from the present owners and/or the managing agent and/or the Local Authority. Your legal advisor needs to carry out investigations on this matter and provide us with a set of drawings for us to comment further upon.

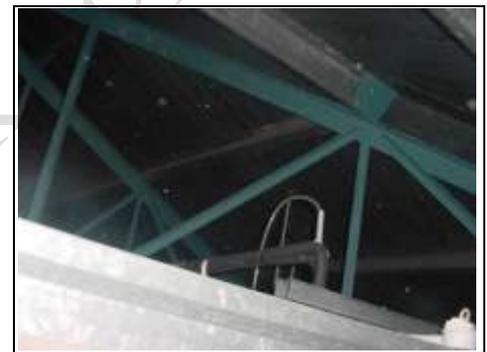
Void above roof – you will be heating Basildon!

Our main concern is the roof void, which is directly above a fairly thin suspended tile which does mean you will be heating the entirety of that roof void (and we would only see heating bills going upwards).

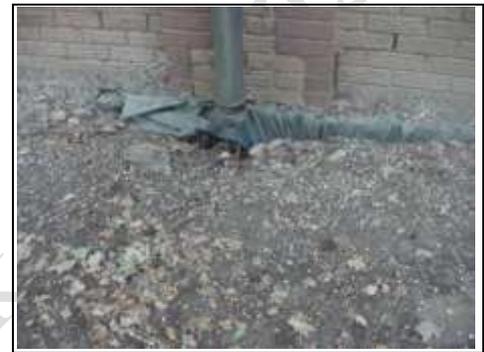
During the latter part of the survey, when it was raining the rear downpipe was not discharging any rainwater indicating that it is blocked and will be discharging into the structure. Interestingly, the front right hand downpipe was discharging water a resin like substance during the entirety of the

Downpipe no longer connected and seems to be blocked

ACTION REQUIRED:
Regularly clear gutters and downpipes which is easier said than done as we think you will need to have a cherry picker or some sort of similar lifting device to be able to manoeuvre around the trees to get to the gutter. We therefore would recommend provision is made for easier future gutter and downpipe clearing as it will be hard to actually access the gutters due to the trees being in the way on the right hand side and on the rear (all directions given as you face the property)

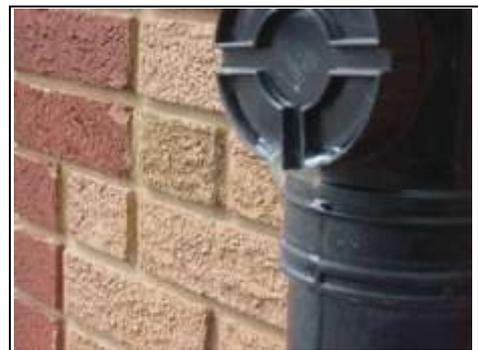
Residue discharging from front downpipe which we can only assume is from leaves and other debris in the gutters

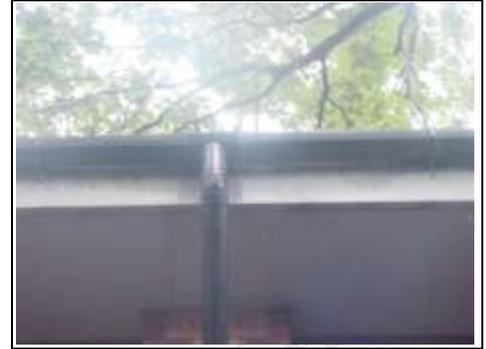
Close up of rear gutter and downpipe, staining to fascia board which indicates leaks. Note the tree hanging directly over this guttering

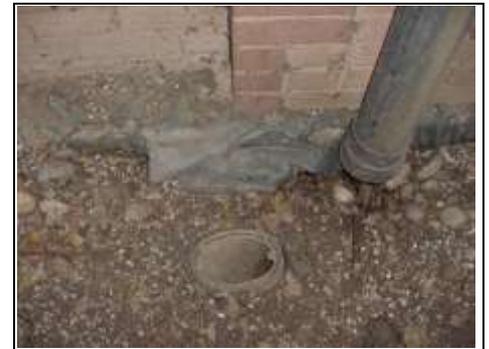
Our concern is that the swan neck pipe fitting that is missing does not normally come loose and it looks like it may have been removed due to the drains being blocked.

Rear downpipe not connected

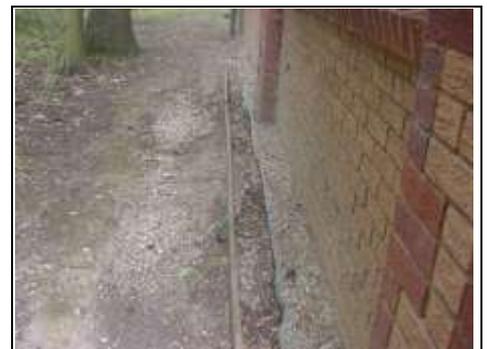
Ground adjacent to rear downpipe sinking

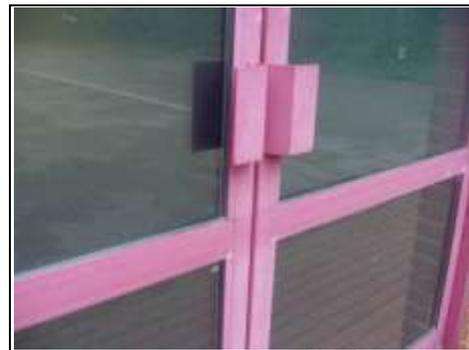
The finish/protective coating on the windows is starting to deteriorate and fade giving a poor quality look.

Front door paintwork fading

ACTION REQUIRED: We would recommend budgeting for replacement windows.

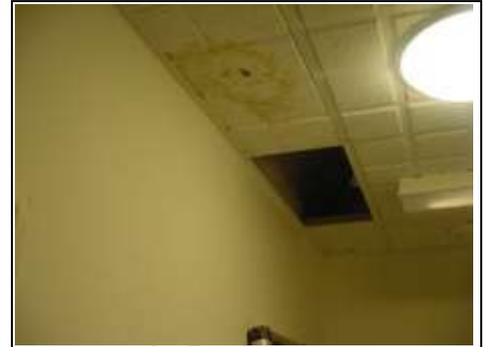
We noticed some dampness staining to a variety of the ceiling tiles which we think can relate to two things:-

Plumbing leaks particularly where the stains are on the ground floor ceilings but on the first floor level we think they may also relate to condensation problems which we have mentioned; please see our comments with regard to the roof.

Signs of water leaks in ceiling system

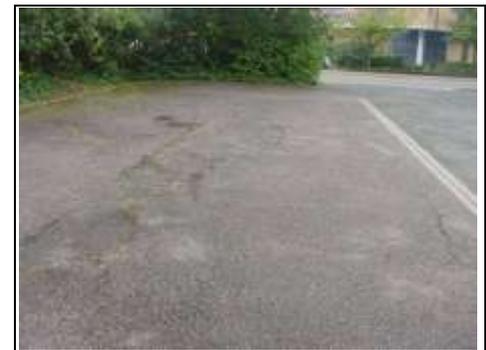
The car park top surface is deteriorating and there are also signs of root penetration from the nearby trees. There also seems to be a lack of drainage to the property other than the running gully to the centre which we are not sure if the car park runs towards?!

Car park unmarked and deteriorating

ACTION REQUIRED:
Discussions to take place with the owners of the trees generally as they are starting to cause damage to the car park. We are advised by the adjoining owner that the trees are managed by Glenny who carried out your original report.

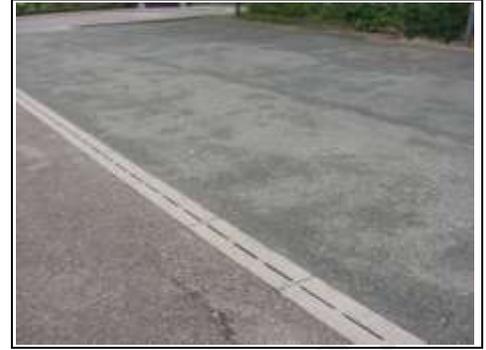
Central running gully to car park area

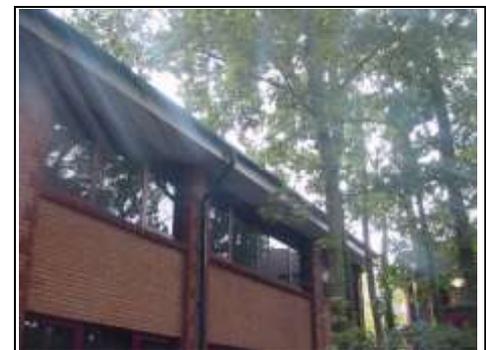
The combination of trees close by and clay soil we would say is always considered a high risk purchase. We mentioned the trees in some instances are literally hanging over the top of the property. Having said that we spoke to the adjoining property owner who advised that in 20 years he was not aware of any major movement to his property.

Trees close to building

ACTION REQUIRED: We would recommend requesting from XXX an arboriculturist report on the trees, if they have one and this is assuming that XXX are managing the trees. We would add that we have found in the past it is worth having your own arboriculturist report as you can then use this as a negotiation tool to ensure that the trees are managed correctly.

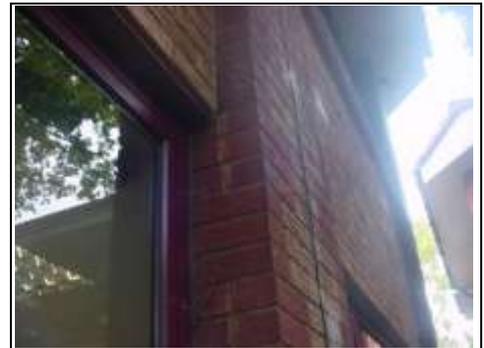
For a property that is so close to the trees we were surprised not to see any cracking damage. We note that there are expansion joints around the plasters and there is what we would term brick panelling between again with mastic joints. It could be that these have been so designed to allow for some movement in the structure which is to be expected with a property so close to trees. We can see that some of the brickwork is not to the best of quality and has what is known as butted up.

Repairs to perpendicular brickwork

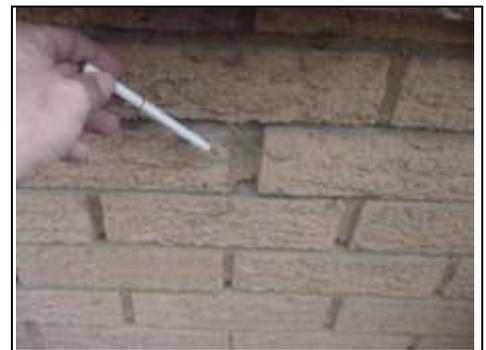
Raking crack to rear brickwork

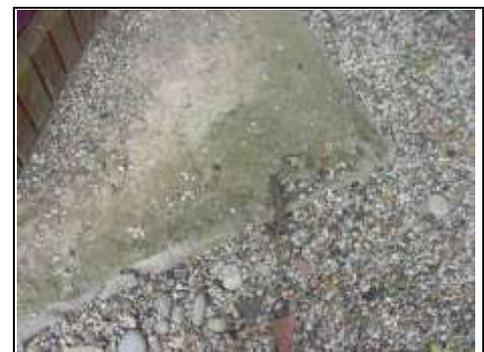
Whilst it could be carelessness we feel that we do need to bring it to your attention.

Reinforcement visible on neighbouring property indicates poor standard of workmanship

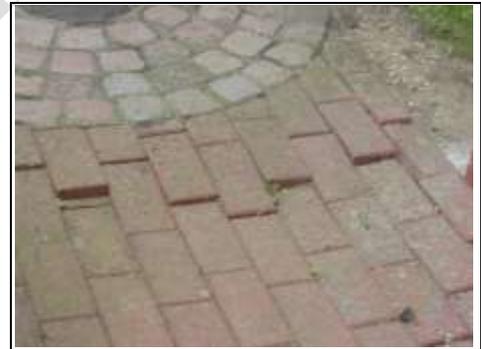
During the course of our discussions you commented above the brick paves appearance around the property which can be quite off putting and the movement in the soil too. Whilst this is partly due to clay soil and the lack of maintenance taking place we have also come across this problem where the soil that has been dug out has then be used around the site and not been compacted properly which then means you get this type of settlement occurring. However this is often known as initial settlement and is very unusual for no maintenance to have been carried out over such a long period of time which needs to be corrected as they are a trip hazard.

Settlement in brick paves at front of property

ACTION REQUIRED: We would recommend that all the brick slip trip hazards are levelled out.

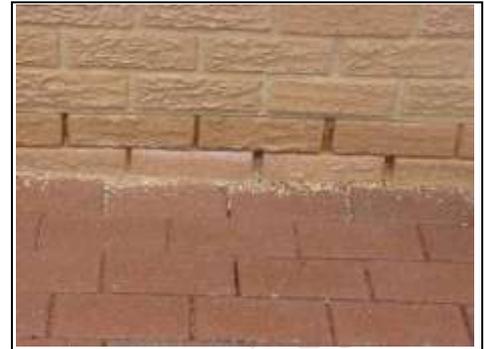
Mortar weathered away

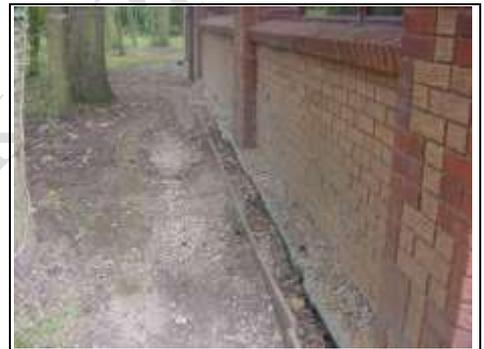
Settlement to rear possible old French drain

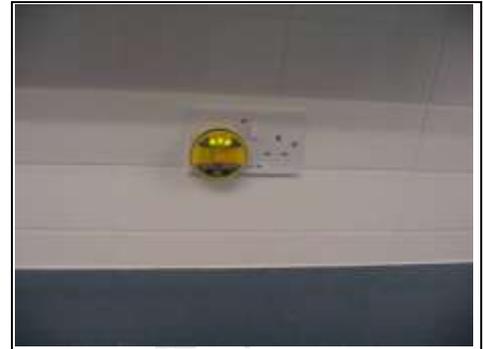
We have carried out an earth test on the electrics which proved satisfactory but we would recommend an Institute of Electrical Engineers test and report by an NICEIC approved electrician.

Earth Test ground floor kitchen

For the electrics we would recommend an NICEIC registered and approved electrical contractor or equivalent carries out an inspection, test and report to Institute of Electrical Engineers standards (IEE).

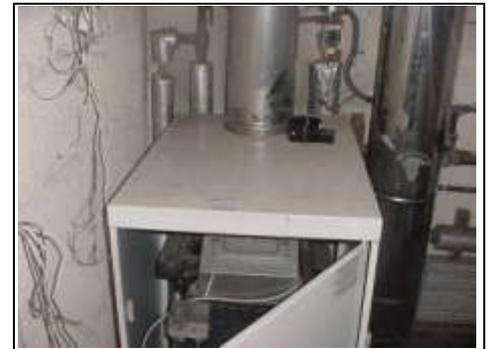
There is a gas fired, floor mounted central heating system to radiators manufactured by Potterton and the make is Kingfisher which was a popular make and parts are still available. The boiler was working at the time of our inspection.

Potterton Kingfisher boiler

The boiler was last serviced by XXX three years ago XXXX and we would recommend that they service the boiler and we would also recommend that they look at servicing the air conditioning units. We have left messages but not had a call back as yet.

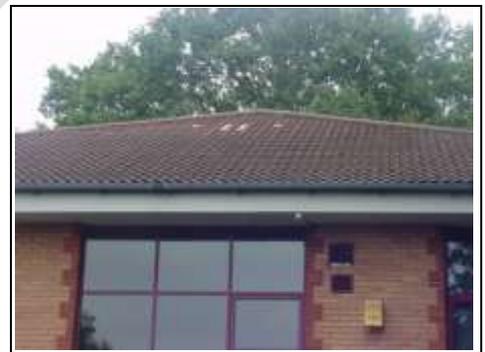
We were pleased to see that vents had been added at high level, although ideally we would like to see them at high and low level to create a better flow of air in the roof. We wonder if these had been added at a later date due to condensation problems in the roof.

Main roof with mushroom vents

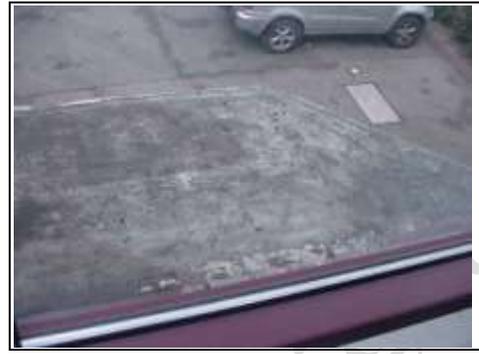
The entrance area roof is a small roof which is starting to deteriorate. Our main recommendation would be to add a gutter around the entrance area, we know that you have plans to improve this area and make it a feature.

Entrance area roof, we recommend guttering is added

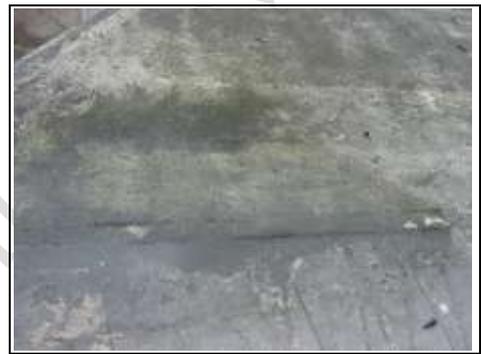
Close up view of entrance area roof

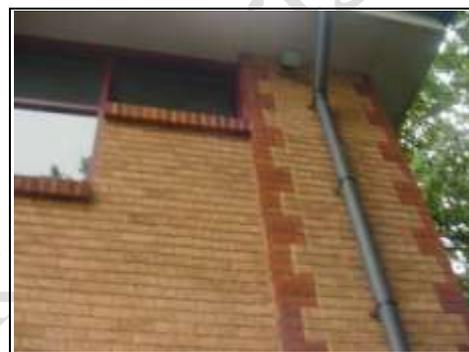
Downpipe

From ground level the gutters and downpipes looked to be deep flow plastic and appeared to be in poor condition with leaks visible at the joints and we suspect they are full of leaves.

ACTION REQUIRED: You will need a cherry picker to access the gutters, they do need regular cleaning. We would always recommend that the gutters and downpipes are cleaned out, the joints are checked and the alignment checked to ensure that the gutters fall towards the downpipes. Please see our comments in the Executive Summary and speak to the next door neighbour who has experience of actually clearing these.

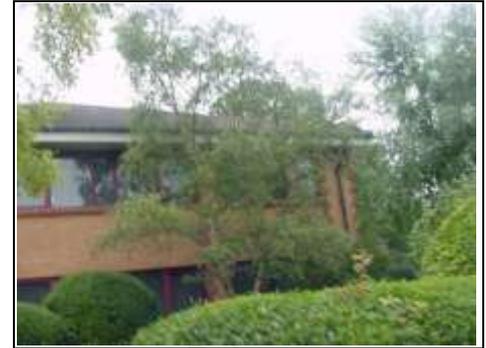
There are trees surrounding the property particularly to the rear and right hand side (all directions given as you face the property) many/most are within influencing distance of the main property and vegetation requiring cutting back to allow the sunlight to get to the building to dry it and also air to circulate around it.

Trees and vegetation close to property

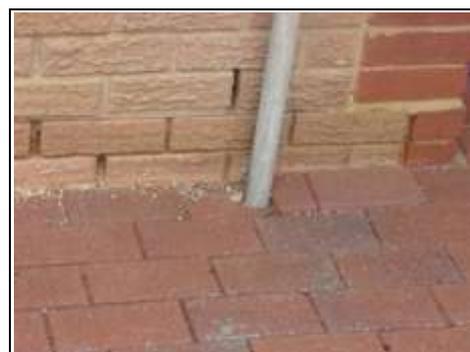
Weathering to the bricks and joints, we would recommend a French drain is added

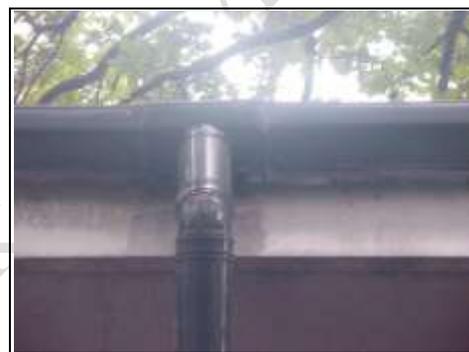
Fascia board stained due to leaking gutter and downpipe

ACTION REQUIRED: Check fascias and soffits when you clear the leaves and debris from the gutters.

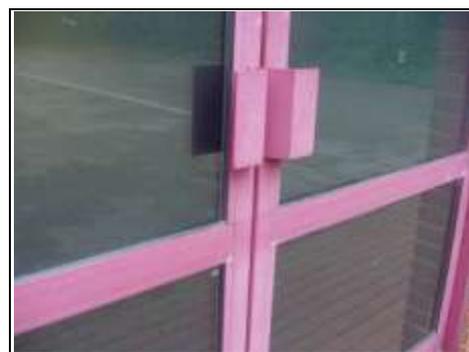
Fading paintwork to metal windows

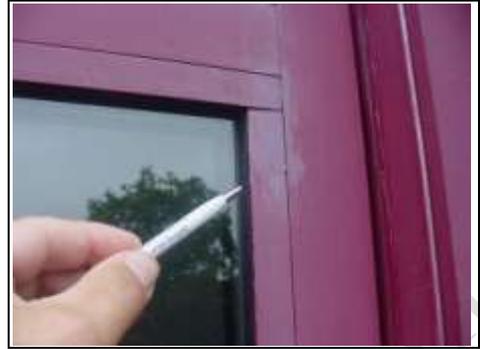
Deteriorating paintwork to metal
window

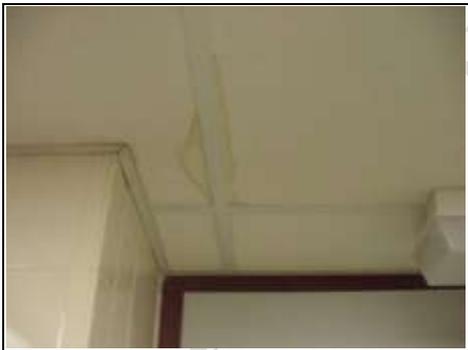
Staining to ceiling leaking from above

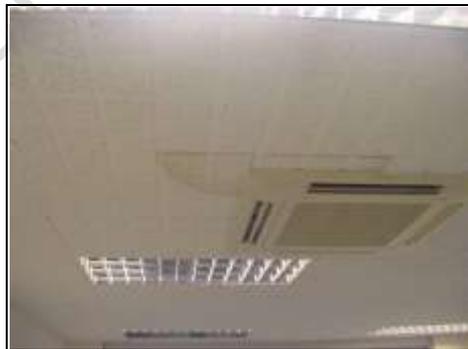
Staining to first floor rectangular ceiling grid system

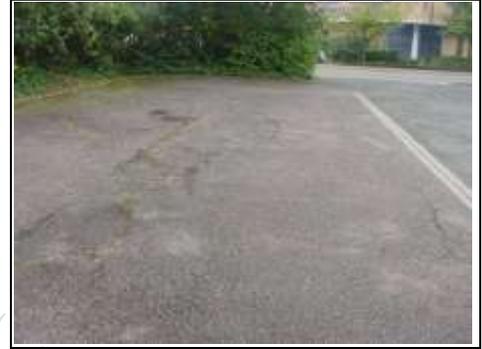
Parking without painted lines

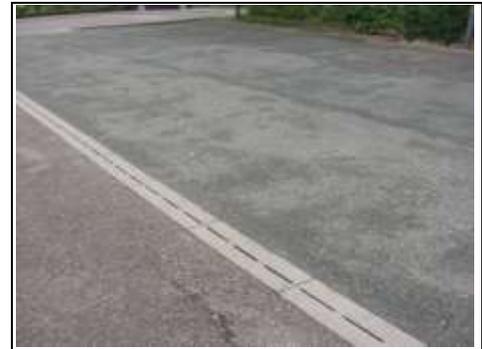
Unsuitable drainage to car park
