PROPERTY REPORT
OF
A Commercial Property,
Grove Park, London SE12

FOR
Mrs T

SCHEDULE OF CONDITION
OF
A Commercial Property
Grove Park, London SE12

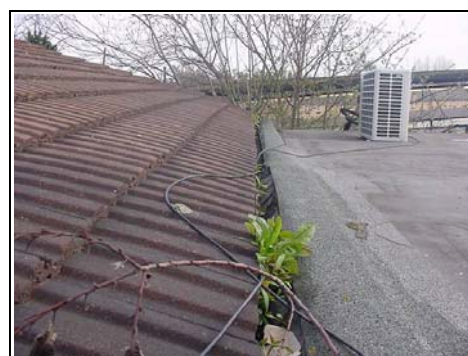
Above the main part of the florist is a hipped roof. Adjacent to this, over the workshop area and the jewellers, is a mono-pitched roof. This abuts a flat roof on the adjoining property. Between the two is an awkward gutter detail, which we believe is allowing water into the property. We cannot confirm this as it was not raining at the time of our inspection.

Awkward roof/guttering detail
to the top

We can, however, see that repairs have been carried out to the roof timbers.

ACTION REQUIRED: Clean guttering. We believe it is likely to be cast iron guttering, in which case we would normally recommend it be replaced. However, in this instance we do not feel it will be possible to gain access to replace it without a great deal of difficulty. Therefore, if at all possible, we would recommend it be repaired. This may be possible with bitumen paint but you may need to replace sections.

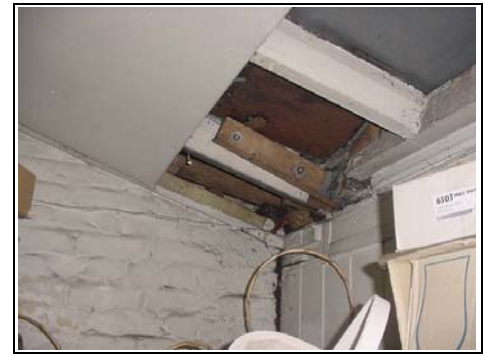
From within the property we can see that one of the rafter feet has been replaced. This normally happens where rainwater has got in and wet rot has occurred. We can also see other areas of timber deterioration and also areas of deterioration of the underlayer.

Deteriorating roof timbers / common rafters. We can also see other areas of timber deterioration.

ACTION REQUIRED: The roof needs to be made watertight. We suggest it is probably the awkward gutter detail that is causing the problem. Once this work has been carried out we would recommend that three to five rows of tiles be removed so this part of the roof can be checked properly. Please see the following section.

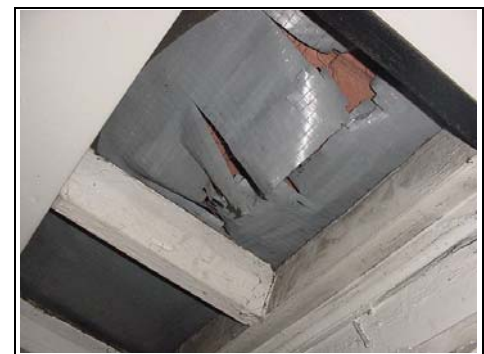
The underlayer will need to be replaced as part of the repair work to make the roof watertight. We noticed that it is a plastic underlayer and this type of underlayer does tend to sweat and cause condensation, although in this case we think it may have been cut, possibly to allow the water to come through from the leaking roof above.

Deteriorating underlayer

ACTION RQEUIRED: Replace underlayer.

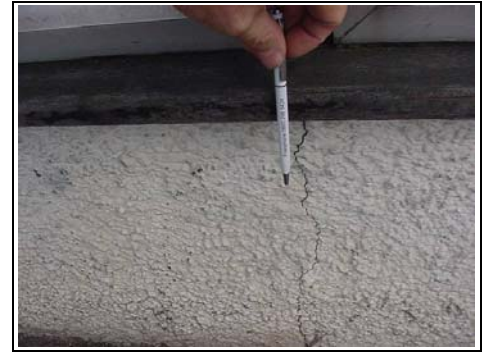
This is probably due to the large span of window to the front of the property and the general vibration that you get from the adjoining railway station.

Vertical crack under window

ACTION REQUIRED: Seal crack and redecorate window.

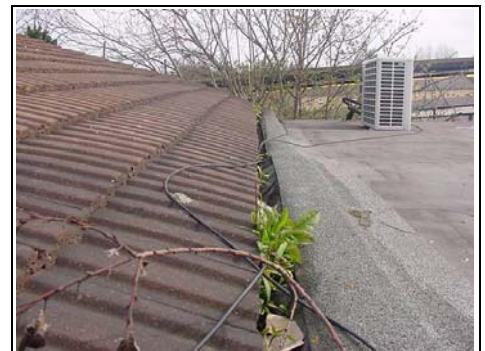
In this case the flashing looks in reasonable condition. Our concern is where the roof abuts the flat roof.

We believe this area has been a problem for some time.

ACTION REQUIRED: General repair.

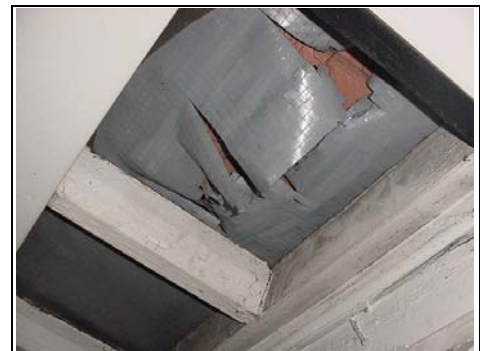
As you can see in the photograph, deterioration has occurred to the plastic underlayer.

This photo shows the common rafters (the ones that form the pitch of the roof) and the dark area between is the underlayer.

ACTION REQUIRED: Replace underlayer.

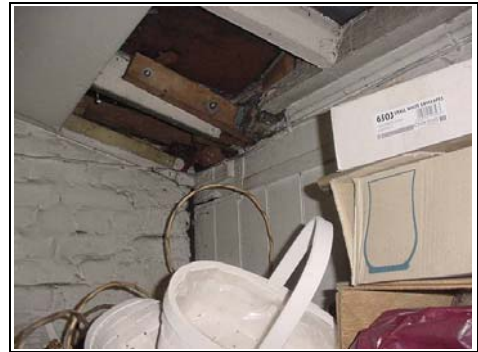
We can see a small part of the common roof trusses to the mono-pitched roof (the side roof over the jewellery area and the workshop area). This shows deterioration has occurred and previous repairs have been carried out. This, we believe, is due to the awkward guttering detail above. Please see earlier within this report.

We believe there to be some wet rot in the common rafters.

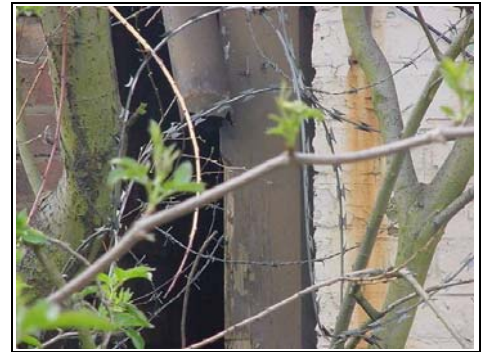
The property has a mixture with replacement plastic gutters and downpipes to the main roof and older cast iron gutters and downpipes to the mono-pitched roof, which are rusting. There is also a very awkward gutter detail between the mono-pitched roof and your neighbour's adjoining flat roof. Please see our earlier comments.

If you look through the tree and the barbed wire you can see a cast iron downpipe that has broken away, is rusting and discharging against the building, no doubt causing dampness.

ACTION REQUIRED: Next time it rains hard you need to watch the gutters and downpipes for leaks, make a note and repair them. This process will need to be repeated many times. We would always recommend that the gutters and downpipes are cleaned out, the joints are checked and the alignment checked to ensure that the gutters fall towards the downpipes.

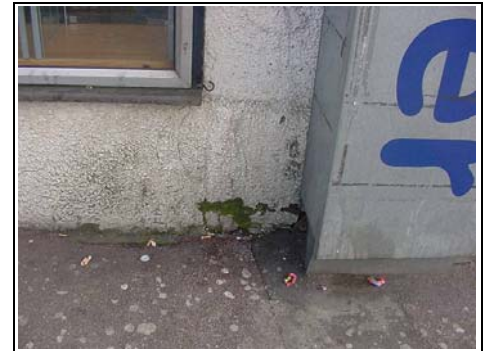
The walls to this property are finished in a pebbledash painted render. They require making good and redecoration. There is also a vertical crack. Ideally a bell mouth detail should be formed to the front of the property to help reduce dampness getting in (see attached sketch).

ACTION REQUIRED: The crack needs sealing and render repairing and redecoration. Ideally add bell mouth detail.

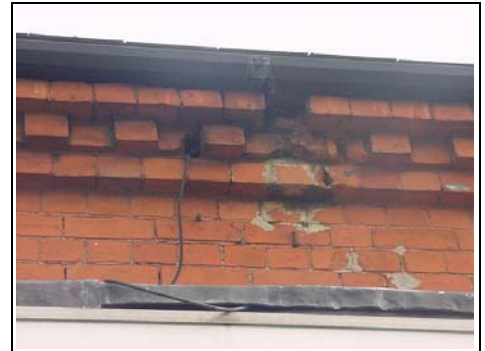
Front Brickwork

The brickwork visible to the front of the property is in a Flemish Bond pattern and would benefit from making good. There is also an area, which you can see in the photograph, where the gutter appears to have caused deterioration into the brickwork. This needs checking. Please see the comments earlier in the report.

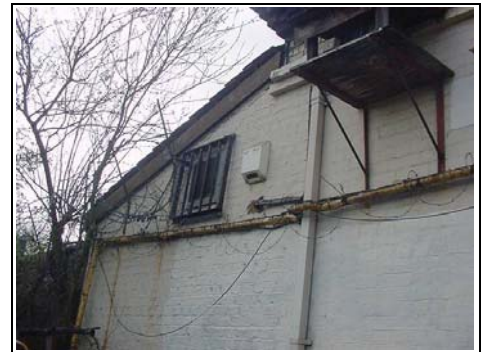
Rear Wall

The brickwork is built in Flemish bond brickwork, which has had the original lime mortar repointed in cement and painted. Often this is carried out to try and reduce dampness.

ACTION REQUIRED: The wall requires redecoration.

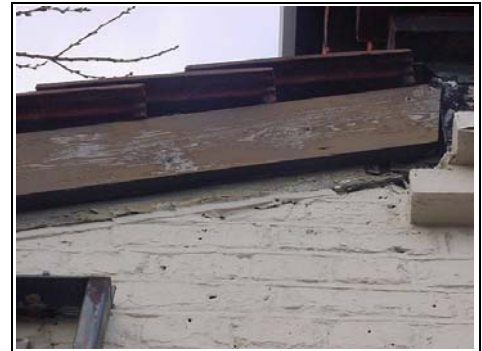
The property has painted/stained timber fascias and soffits; these are in below average condition and need redecoration.

ACTION REQUIRED: Redecorate / repair fascias and soffits boards.

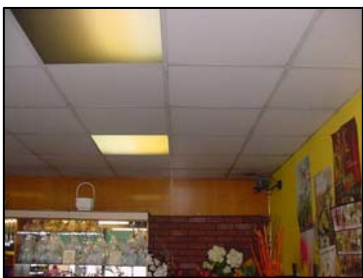
Marked and damaged ceiling	Replace
<p>Original ceiling</p>

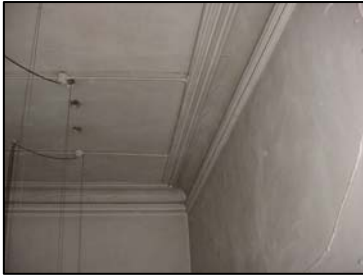
Marked	In need of redecoration.

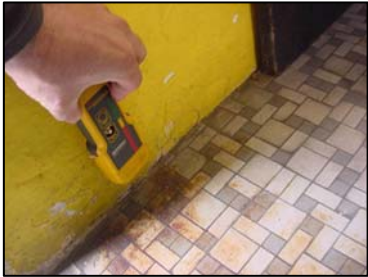
<p>Some dampness found to the front of the property</p>	<p>Update</p>
<p>Floors:</p> <p>Vinyl</p>

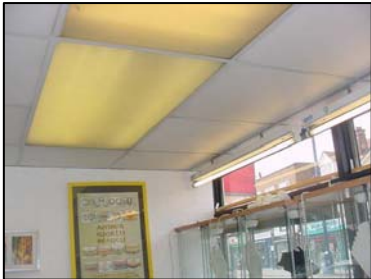
<p>Marked and damaged ceiling</p>	<p>Replace</p>
<p>Walls:</p> <p>White painted with brick effect</p>	<p>Some red coming through white paint.</p>	<p>Redecorate and/or replace.</p>
<p>Floors:</p> <p>Upstand formed in timber with a carpet finish</p>	<p>Average</p>

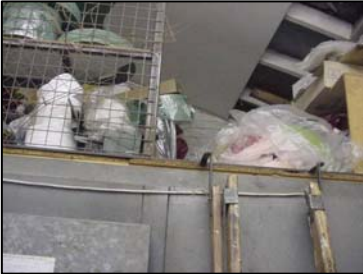
<p>Sections of board missing and holes noted.</p>	<p>General making good and redecoration.</p>
<p>Walls:</p> <p>Painted wood close boarding</p>

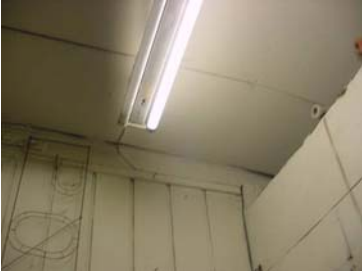
<p>Below average</p>	<p>Repair and redecorate</p>

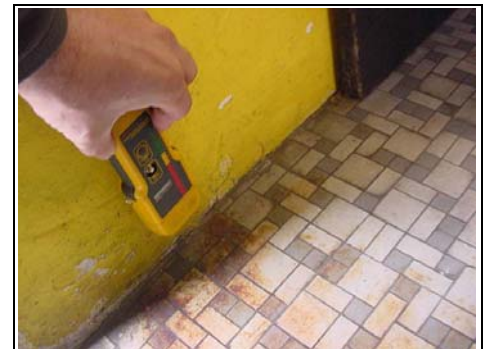
A random visual inspection and tests with a moisture meter have been taken to the perimeter walls and some internal walls. Minor dampness was found. Please see our comments with regard to the render and adding a bell mouth detail.

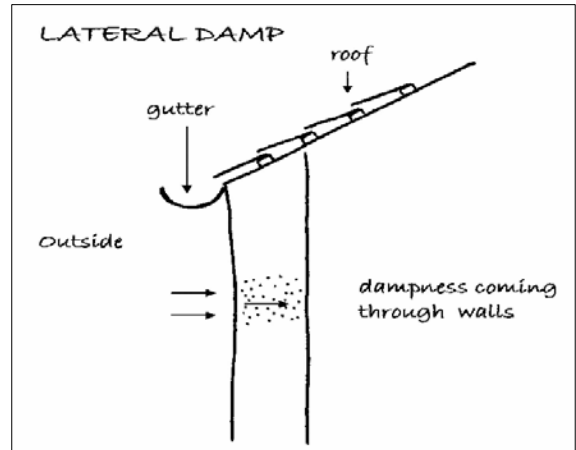
It was not possible to take proper readings due to the boarding. However, we do suspect that there is dampness coming in due to the leaking gutters.
