PROPERTY REPORT

**Unit in Business Park
Hertfordshire**

We have been instructed to prepare a Report and Schedule of Condition.

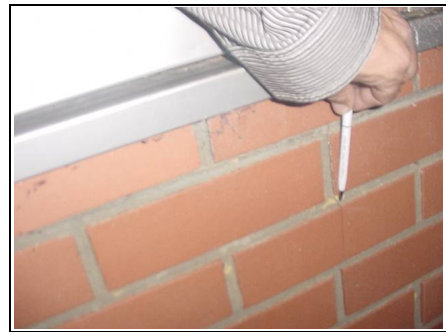
Many buildings have initial settlement. It is establishing whether this settlement is movement and progressive which is difficult from a one-off inspection. To the rear of the property in the first floor there are signs of further settlement. The movement that we can see looks to be initial settlement however we would recommend the following:

Cracking requires further monitoring

ACTION REQUIRED: The existing owner should put in an insurance claim prior to you purchasing the property to limit your future liability. It is essential that this is carried out before you purchase the property so that you can then take over any insurance claim.

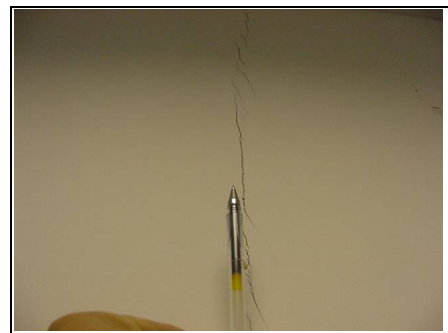
Signs of further settlement on first floor

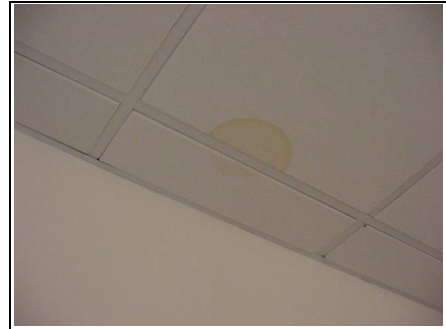
We were unable to see the roof properly and the guttering detail which is unusual gutter detail due to the way it is formed within the roofing and furthermore we are not certain how easy it is to maintain which normally means that it isn't maintained.

We noted the staining to one of the ceiling panels within the office area. When we lifted this we noted above it a roof light.

Marked ceiling tile caused by leak from roof light

ACTION REQUIRED: We would recommend that a roof inspection is carried out prior to purchasing the property which would ideally require a cherry picker over the top of the property.

ANTICIPATED COST: In the region of £250 - £500; quotations required.

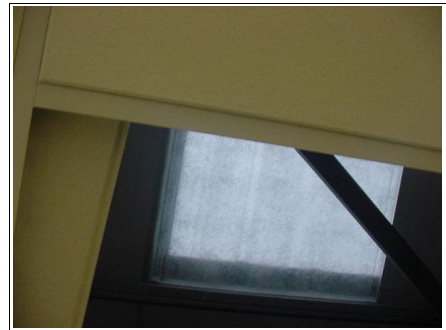
Leaking roof light

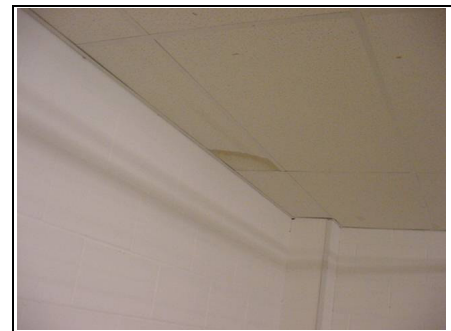
We believe that there has been a leak either from a leaking wastepipe or condensation occurring to a supply pipe from the stained tiles we can see.

Stained ceiling tiles below first floor toilet

ACTION REQUIRED: Either way this is likely to be a minor issue that can be dealt with by day to day maintenance.

ANTICIPATED COST: A few hundred pounds; quotations required.

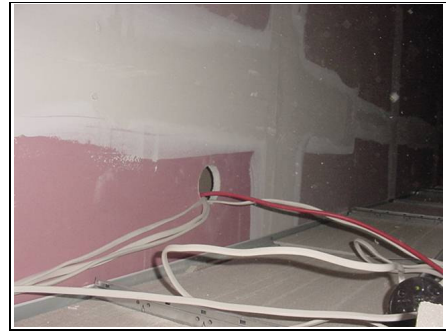
Ironically the fire protection wall for the staircase has been cut for the fire alarm system.

One of two holes we noted that have been cut in the fire protection wall

ACTION REQUIRED: The fire wall holes need filling with a fire resistance material.

ANTICIPATED COST: In the region of £500 - £1,000 due to the awkwardness of the work; quotations required.

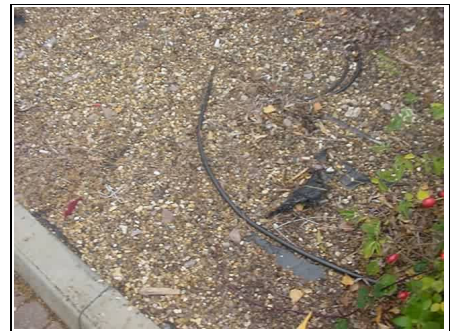
1. The cabling to the lighting wasn't buried as it should be to approximately half a metre.

Cabling to lighting not buried

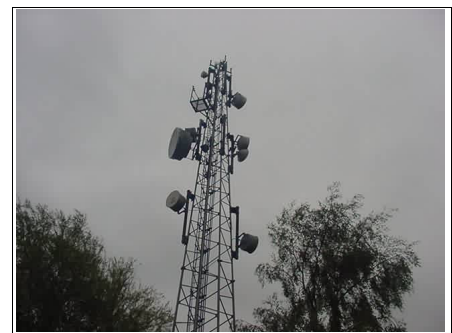
2. We would also draw to your attention the masts to the rear that the jury is still out on as to whether these cause health issues.

Radio mast close by

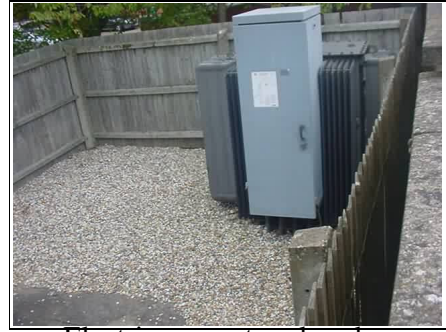
3. There is also an electrical generator as well which again the jury is still out on as to whether they cause health issues.

Electric generator close by

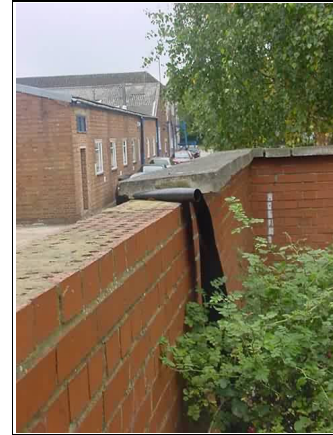
4. We would draw your attention to the boundary wall where the walls are deteriorating and the coping stone is missing in some instances.

Damage to boundary wall

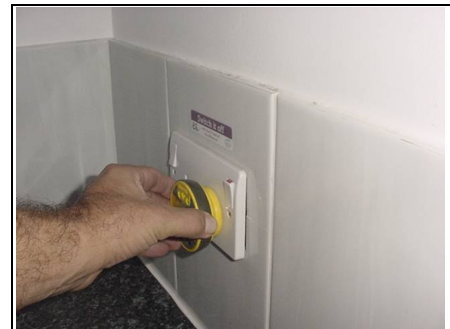
Socket point loose

We noted that the socket point that we did the earth test on was loose at the time therefore some of the property may have suffered from general use and abuse although it has to be said that the electric services and electric cabling were concealed mainly within a skirting.

ACTION REQUIRED: We would recommend that a specialist is asked to test and confirm that all the mechanical and electrical equipment is working. The Institute of Electrical Engineers (IEE) recommends an NICEIC registered and approved electrical contractor carry out an inspection, test and report.
