# **SCHEDULE OF CONDITION**

**Business Park  
Hertfordshire**

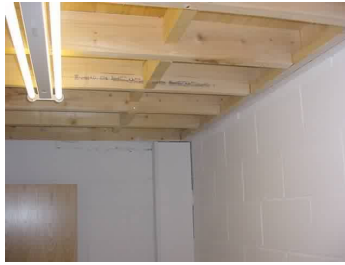
## **Internal Storage Room**

DESCRIPTION	CONDITION	ACTION REQUIRED
<b>Ceilings:</b> Exposed timber		Add ceiling
<b>Walls:</b> Painted block work	Marked	Repair, prepare and redecorate.
<b>Floors:</b> Concrete	Marked	Repair, prepare and redecorate.
<b>Detailing:</b> Doors		Repair, prepare and redecorate.

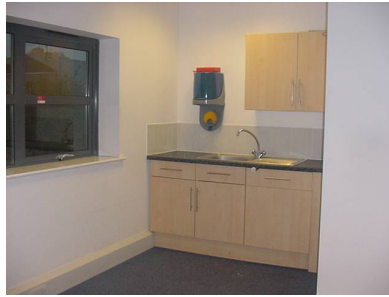
## Kitchenette

DESCRIPTION	CONDITION	ACTION REQUIRED
<b>Ceilings:</b>  Square suspended ceiling system with lights (believed to be category two)		
<b>Walls:</b>  Painted	Marked	Repair, prepare and redecorate.
<b>Floors:</b>  Carpet	Worn	Clean and/or replace
<b>Detailing:</b>  Aluminium double glazed window  Door	Average  Marked	Clean.  Clean and make good.
<b>Kitchen Equipment:</b>  Kitchen units	Average

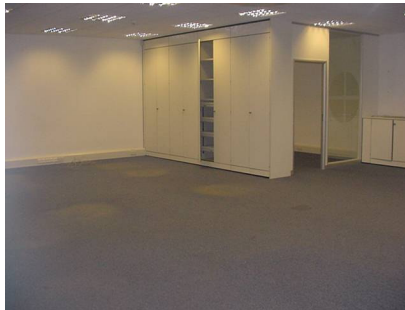
## Internal Office

DESCRIPTION	CONDITION	ACTION REQUIRED
<b>Ceilings:</b> Rectangular suspended grid system

Marked	Repair, prepare and redecorate.
<b>Walls:</b> Painted plaster	Marked	Repair, prepare and redecorate.
<b>Floors:</b> Carpet tiles		Replace
<b>Detailing:</b> Door Small partition to rear left hand side with computer	Average	Clean

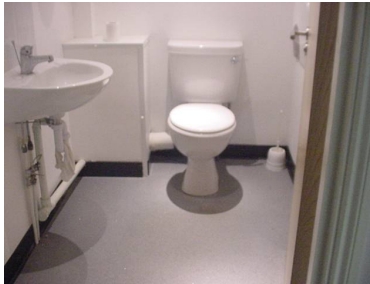
### **Internal WC**

DESCRIPTION	CONDITION	ACTION REQUIRED
<b>Ceilings:</b>  Square suspended grid system with flush mounted lights	Average	
<b>Walls:</b>  Painted plaster	Average	Redecorate to freshen up.
<b>Floors:</b> Altro style flooring	Ingrained dirt	Deep clean
<b>Sanitary Ware:</b> WC and wash hand basin  Extract fan		Deep clean  Clean
<b>Joinery:</b>  Doors		Clean.
<b>Services:</b> See Services section
