PROPERTY REPORT

Of a Restaurant In Hertfordshire

We have been asked to inspect and prepare a Report and Schedule of Condition for a Restaurant in Hertfordshire.

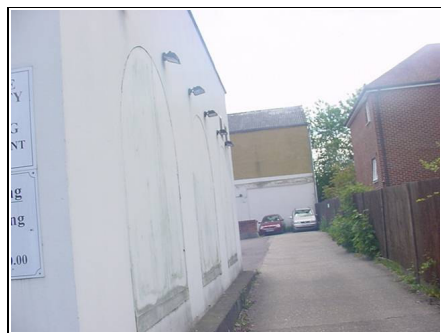
Blocked up windows to rear

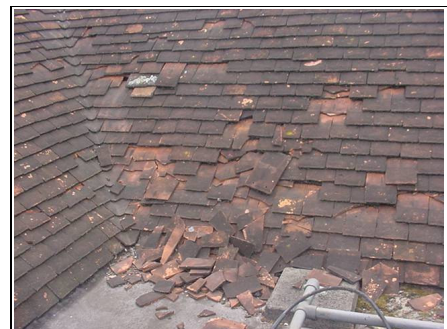
1) Pitched tiled roof in poor condition

Approximately 25% of the nibbed tiled is damaged in the areas that we can see; we could see only approximately half of the roof. We were unable to access the rest due to health and safety.

Damaged tiles

ACTION REQUIRED: We recommend the other half of the roof is

accessed using a cherry picker before the lease is completed. We would estimate a similar amount of damaged tiles.

ANTICIPATED COST: In the region of £10,000 to £20,000 as this is high level work. Please obtain quotations.

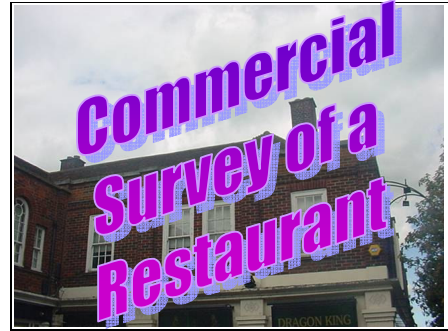
2) **Box guttering detail flawed**

To the front of the property a Georgian style has been used, including the parapet wall, with, we believe, a hidden box gutter (we have not been able to see this). We can however see the dampness getting into the property internally within the rooms.

Hidden box gutter behind top of wall

ACTION REQUIRED: Repair box gutter.

ANTICIPATED COST: In the region of £5,000 to £10,000; please obtain quotations.

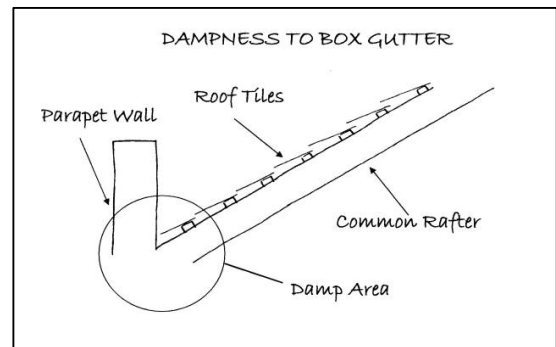
3) **Lateral dampness, particularly to right hand side**

Generally throughout the property there is lateral dampness. We believe this is a mixture of the failed box gutter and also deterioration to the render, which looks to have been painted over in some areas.

ACTION REQUIRED: Repair the rendered areas and redecorate. We are assuming the box guttering work is carried out.

ANTICIPATED COST: In the region of £5,000 to £10,000; please obtain quotes.

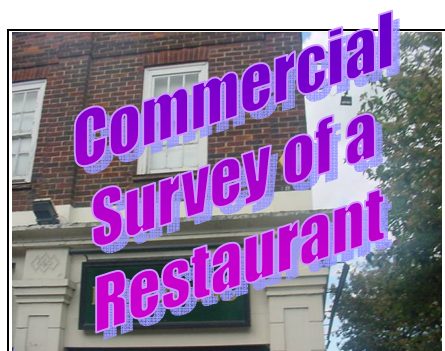
The property has a Georgian style sliding sash windows to the front and sides, metal style Crittle windows to the side of the property and rear, and casement timber windows. In most cases these are allowing in dampness. Some cases may relate to the box gutter above or to condensation caused by small inadequate shower areas. However, we also believe there is some deterioration to the windows and mastic around them.

Georgian style window to front

ACTION REQUIRED: General overhaul of all windows.

ANTICIPATED COST: In the region of £15,000 to £20,000. Please obtain quotes.

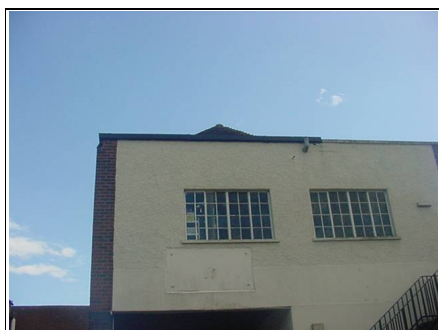
Metal style window

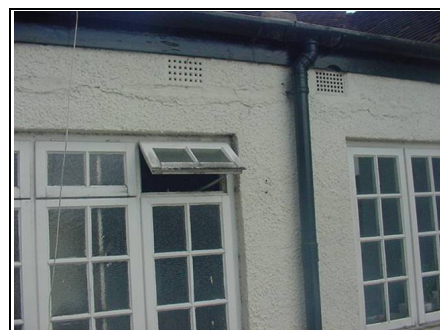
Timber casement windows
to rear

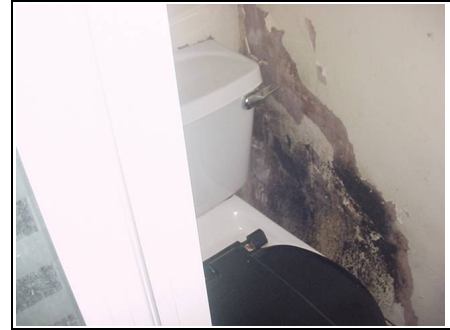
There is extensive mould in all the staff bathrooms / shower rooms / WCs.

Mould and dampness around WC

ACTION REQUIRED: Generally you need to add extract fans which are humidity controlled. Also ensure that any windows close by are openable (obviously not relevant in the internal shower areas).

Then the whole areas need to be redecorated, including the walls, and made watertight. We recommend an altro style floor finish to the areas in general. A good clean of the sanitary ware is required and in some areas it would be better to replace it.

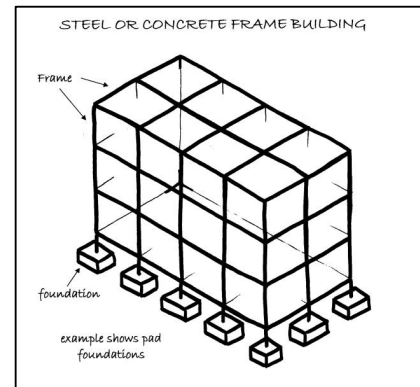
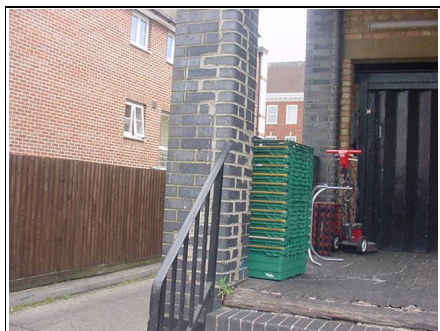
There is no other way to say it really! We believe this to be either a concrete or metal framed structure with pre-cast concrete floor. Our concern is that some of the pre-cast concrete floors are showing their reinforcement and there is cracking around the column to the rear of the property which may indicate the steel frame is rusting.

Repair and cracking around steel frame to the rear

ACTION REQUIRED: We recommend the structure is opened up to examine the frame of the building to see its condition. We also recommend that any responsibility in relation to the structure and the floors is excluded from the lease, as this is very onerous, to the point that any problems may mean it is most cost effective to rebuild the property.

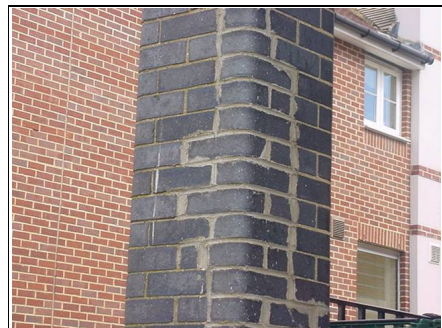
Close up

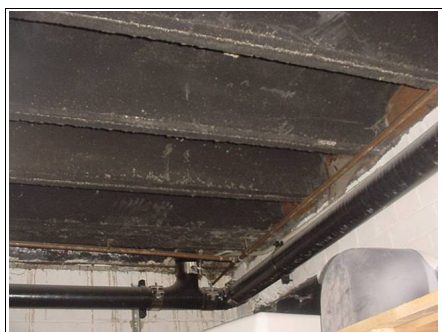
Barrelled pre-cast floor

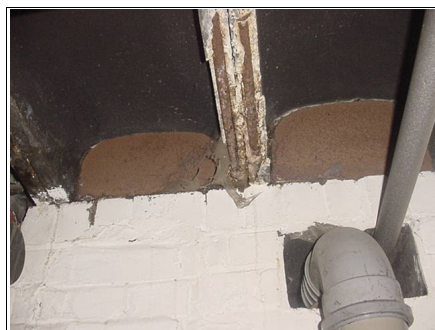
Looking at the rusting
exposed reinforcement
