COMMERCIAL BUILDING SURVEY

Of A Hotel In Norfolk

FOR
Mr C
Property Development Limited

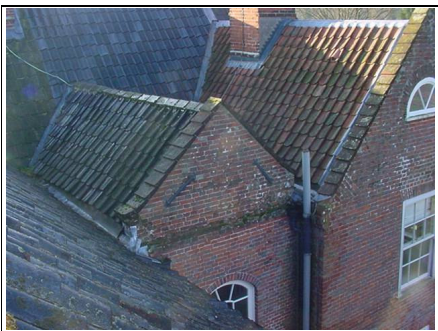
Allowing water to leak into Lady Betty's room en-suite area.

Awkward valley gutters

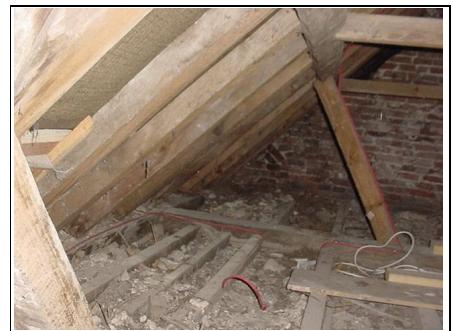
Grass and moss in the valley gutter and also the lead needs checking

Dampness in the roof space beneath the awkward valley gutter

ACTION REQUIRED: We recommend that roof lights are added, (accessed via Bernard's Room, formed within the roof space) where there is an access panel to enter the roof void. This will allow viewing of the valley gutter and also access to it. We note at the present there is literally grass growing from both of the valley gutters.

ANTICIPATED COST: To fit roof light and remove grass, etc, in the region of £2,000 to £4,000, depending upon the condition of the valley gutter. We recommend you obtain quotes.

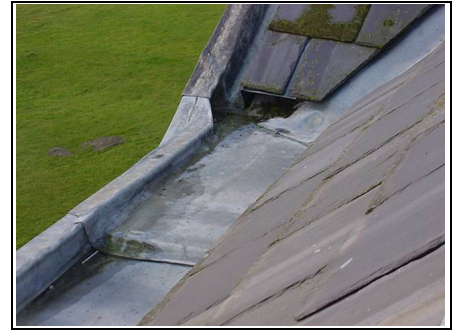
Lead box valley gutter

We also found some dampness getting into the box lead gutter to the front of the south elevation on both the far left and far right hand corners. We believe this is a roof defect you will chase forever and a day.

ACTION REQUIRED: We normally find that mastic prolongs this area, but ultimately it will need to have the lead lifted and checked.

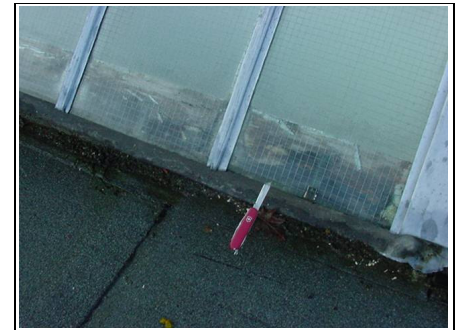
We would also draw your attention to the timber formed roof lights that are present in the pitched roof area adjacent to the flat roof, near the entrance, which will need attention in the next few years and are starting to rot.

Timber roof light adjacent to flat roofs

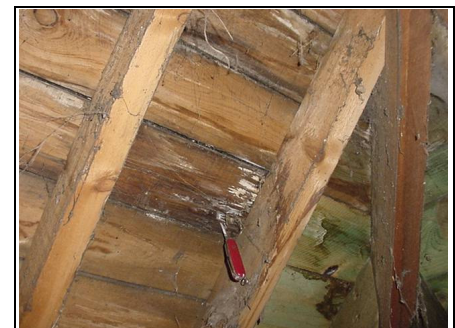
This is a close boarded timber roof. We noted areas of rot.

Areas of rot

ACTION REQUIRED: We would suggest generally that a roofer is given one to two days to overhaul this area and other sections of the roof. There is no immediately urgency as close boarded roofs are strong, however we would have the work carried out before the winter of 2011.

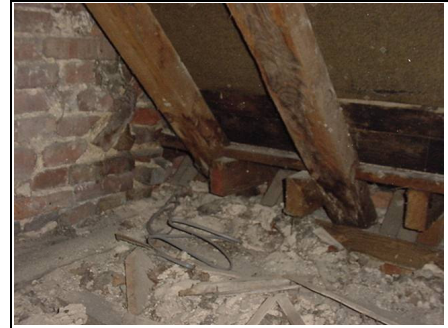
We have mentioned the valley gutters allowing water in and we can see rot in the timbers adjacent to these valley gutters.

The darker areas are the deteriorating timber

ACTION REQUIRED: These need to be repaired once the valley gutter has been cleared. Please see earlier point 2.1.

ANTICIPATED COST: We would expect costs in the region of £2,000 to £4,000; please obtain quotes.

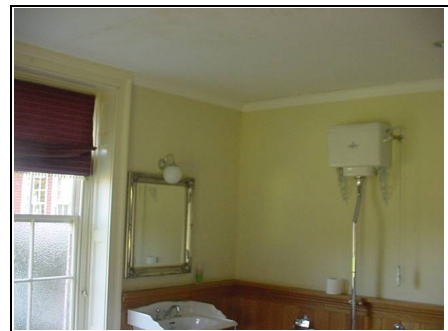
Leaks in corner of room come from the valley gutter above

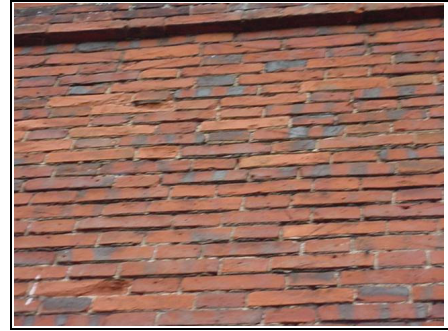
Deterioration to soft red bricks

The predominant factor with this property is the soft red brick that has been used to the main Queen Anne property and some of the east and west elevations. This is deteriorating and is leading to lateral dampness (dampness coming through the walls, coming into the structure).

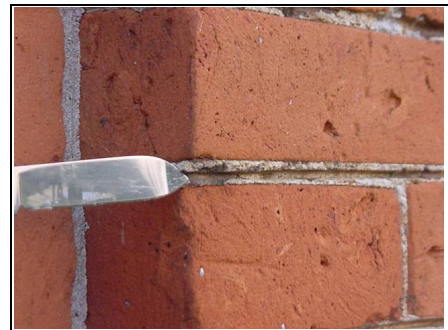
An example of pinch pointing that needs re-pointing

We can see that ad hoc repair has been carried out to a poor standard. We recommend a meeting with the Local Conservation Officer and an agreed programme of works is carried out. Whilst you probably could do the work without meeting with the Local Conservation Officer we feel that if you wish to have future work carried out, such as the Coach House, it is best to show them that you have an understanding of properties of this age and era.

ACTION REQUIRED: Re-pointing to the brickwork in an appropriate lime mortar. You may need to repair some bricks, although we recommend you keep the original if at all possible.

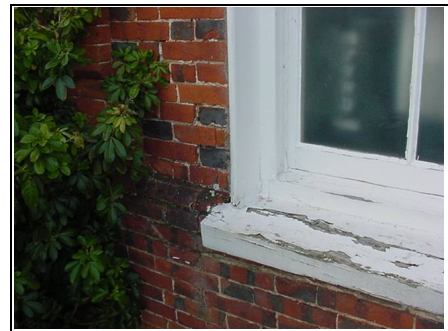
The windows are in need of work generally and are in a variety of different conditions. A programme of maintenance needs to take place. We have found in our experience budget wise it is best to work elevation by elevation, one at a time to ensure the work is carried out correctly and learning lessons about the windows as you progress.

General view of deteriorating sliding sash window

ACTION REQUIRED: General easing and adjusting of windows, repairing by cutting in of new timber, filling and redecoration.

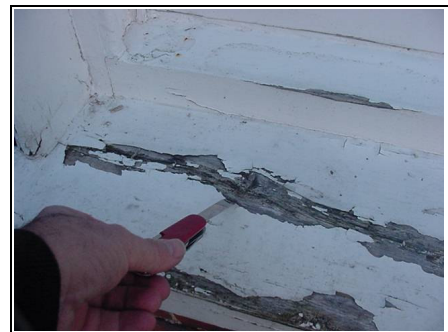
Close up where the rot is not as bad as we expected when tested with a knife sliding sash window

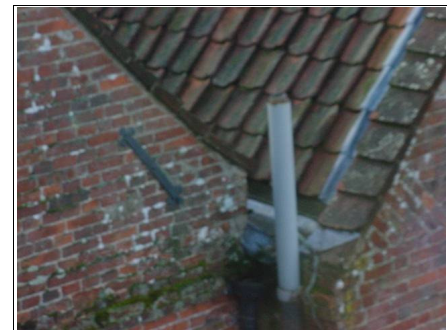
Tie bar

With reference to the differential movement that we have mentioned we would draw your attention to the tie bars that have been used in the structure. These were commonly used around the war years, or earlier, and they were used to strengthen walls where lateral has been lost. This the sort of thing that can cause differential movement in a property as these rear roof extensions on the south side of the property where once additions to the property (as we can see from the different brick bond that has been used) and therefore has put different stresses and strains on the property, which has ultimately meant that tie bars have been added.

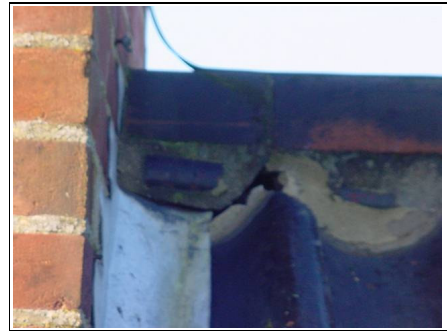
Damage to the side of the chimney which needs repair

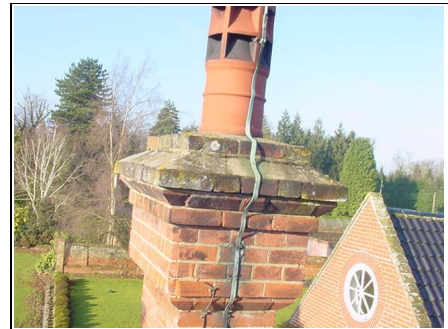
Top of chimney five

This chimney is brick finished with one chimney pot with lead flashings. It is in slightly below average condition and needs some repointing work.

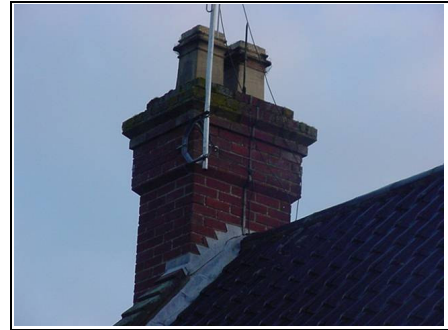
Chimney six – ballroom

This chimney is again brick finished with four chimney pots with a lead flashing. There is lots of moss to the top, indicating that dampness is starting to get in. We would comment that the aerial attached to it is quite high. It may damage the chimney and you need to check that the wire is not cutting into the brickwork.

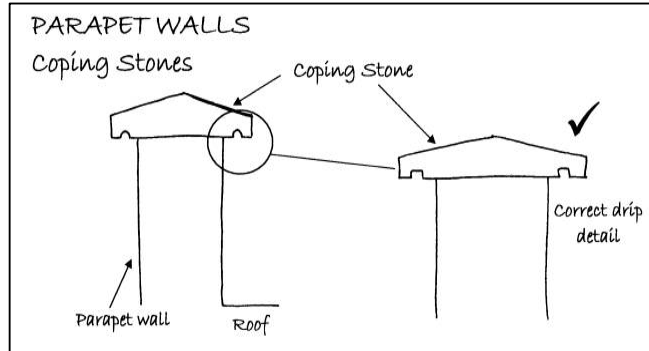
The brick parapet walls are finished with a coping stone. In this particular instance the coping stone detail is too small/incorrectly positioned.

ACTION REQUIRED: Replace existing coping stones and add a lead flashing and also check the condition of brickwork and repair if necessary.

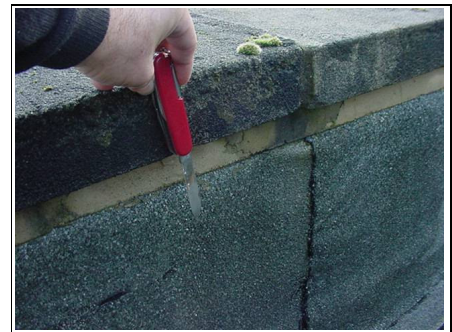
Parapet wall without suitable drip

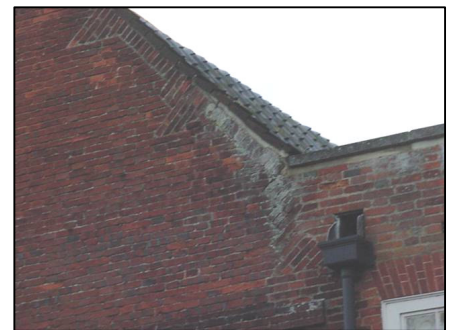
Damage to brick parapet wall

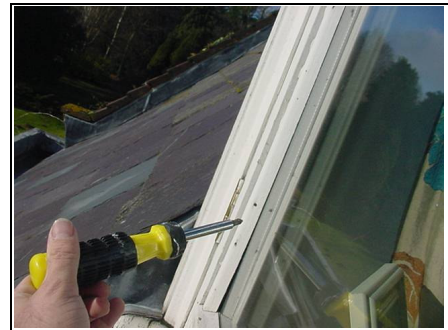
Quadrant beads to the dormer windows are not the best of jobs.

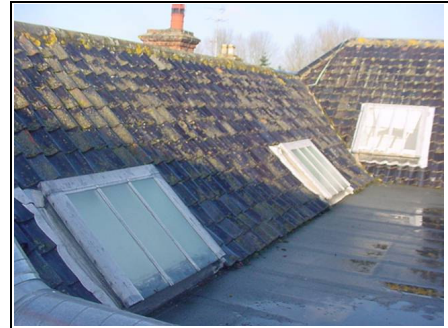
Purpose made roof windows

There are three purpose made timber roof windows with a lead finish, considering the age, they are in reasonable condition, with some attention due to wet rot. They are in average condition and some wet rot is starting to take place, particularly at the base.

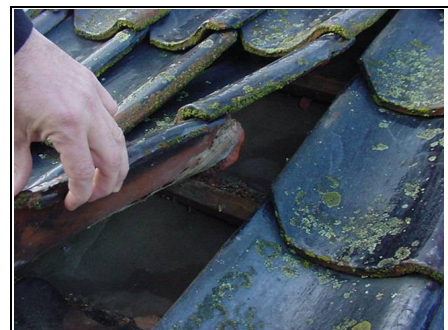
Close up of pantiles

ACTION REQUIRED: Please see our comments in the Executive Summary. You need a general maintenance upgrade of the roof. We have noted dampness getting in on the west elevation and east elevation and that leaks are occurring to the awkward valley gutters.

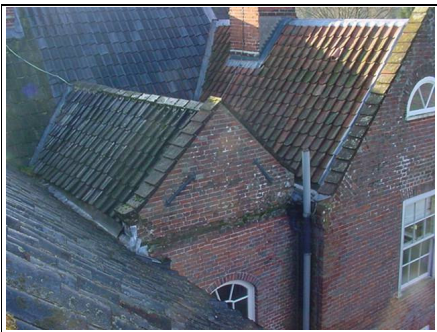
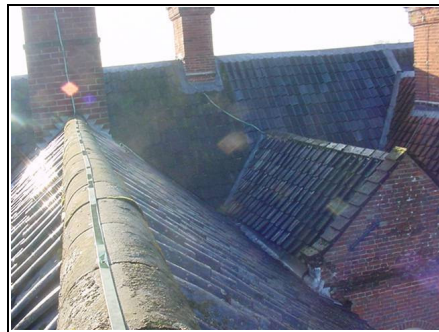
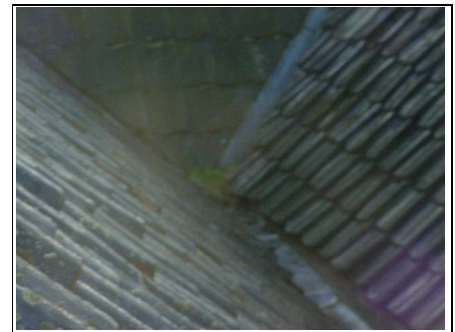
There are high level valley gutters to the rear of the south elevation. Dampness is being caused within the property and also down the walls.

Awkward valley gutters

ACTION REQUIRED: The valley gutters are leaking and damp and rot can be seen work is required immediately.

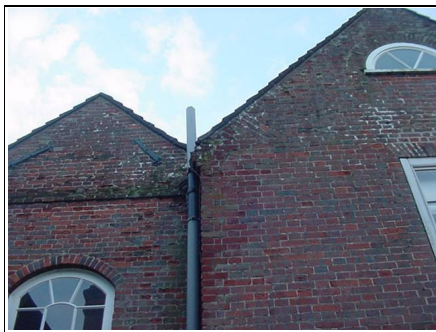
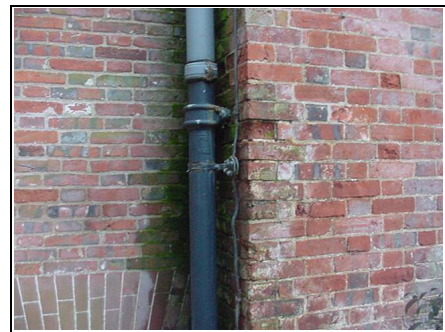
Dampness on the walls

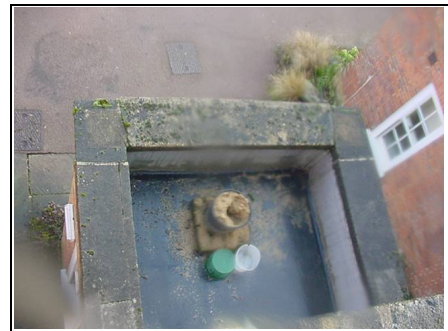
Flat roof over entrance porch

This roof looks to have had some leaks; the sort of leak that you can chase round forever. We spoke to the maintenance man about this who advised they had considered using fibreglass on it. We would not recommend this as we believe it is too hard a material.

ACTION REQUIRED: We recommend that ultimately this area is re-roofed with a modern high performance elastomeric felt.

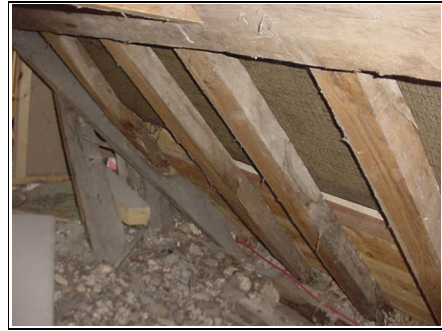
Staining to the timbers indicating dampness getting in.

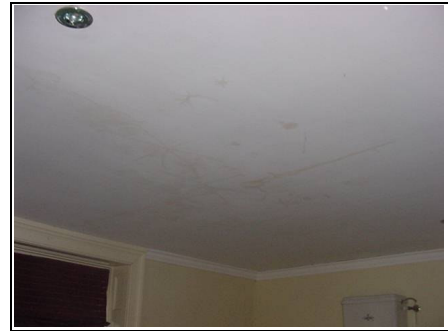
Leaks to Ceilings in Lady Betty's Room
(FF South Elevation)

Visible leak to ceiling

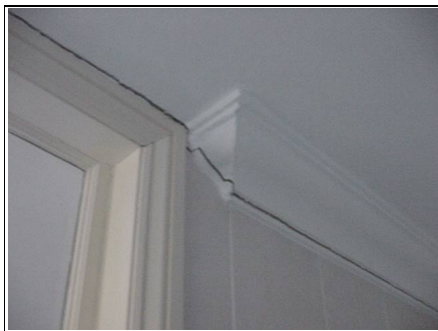
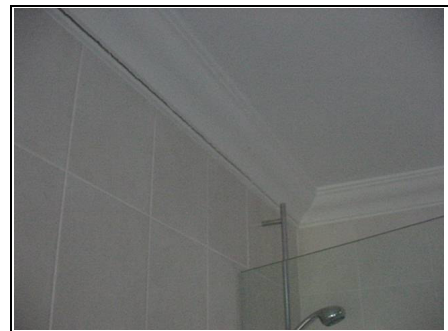
Differential movement in Andrew's Bathroom
- further investigation required
