# COMMERCIAL BUILDING SURVEY

Reading, Berkshire. RG1

We have been asked to inspect and prepare a Report and Schedule of Condition for XXXX Reading, Berkshire. RG1

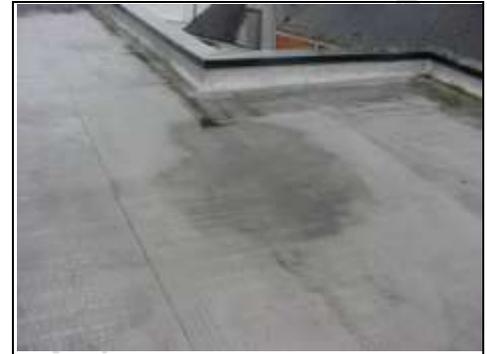
When we opened up the suspended ceiling system we noted that rainwater was getting in via various places for example the drainage outlet point and an internal point.

We noted there had been a replacement of suspended ceiling tiles in the offices indicating that this is likely to have been a long term problem.

Water sitting on roof

**ACTION REQUIRED:** We would recommend the roof is excluded from the Lease. There is a substantial repair liability associated with repairs of this type of roof.

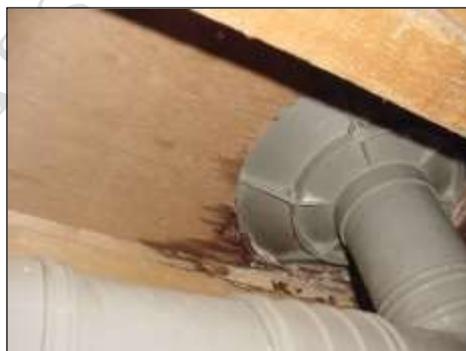
Leak around downpipe drain from roof

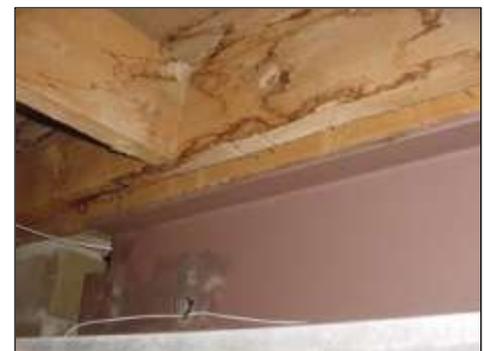
Damp in timber Left hand side starting to affect steel beam below

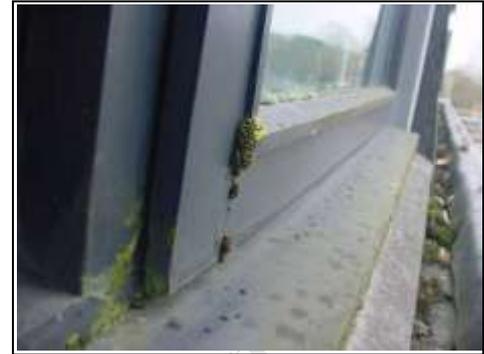
There is a general lack of painting externally for example we could see moss growing on the majority of windows. We believe they have not been painted due to the difficulty of painting them and high level access being required for example to paint the upper windows of this property a large amount of expensive scaffolding would be required as far as we can see.

Moss to window frames

**ACTION REQUIRED:** Complete redecoration externally and internally would be a normal Landlord's requirement under a standard Full Repairing and Insuring Lease.

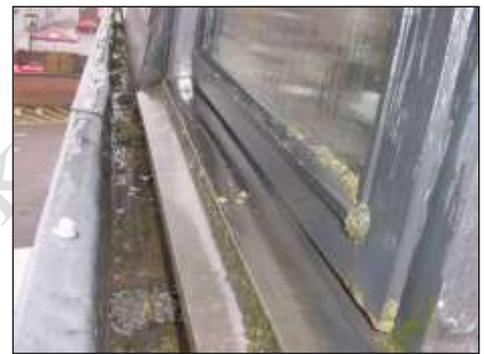
Moss to window frames

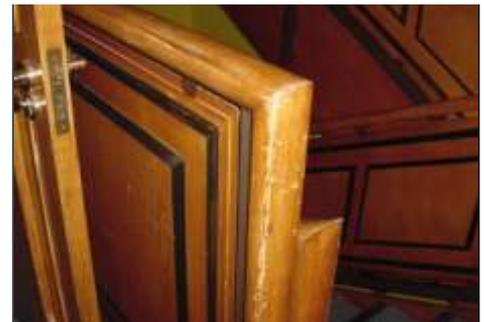
Damage to joinery on the staircase

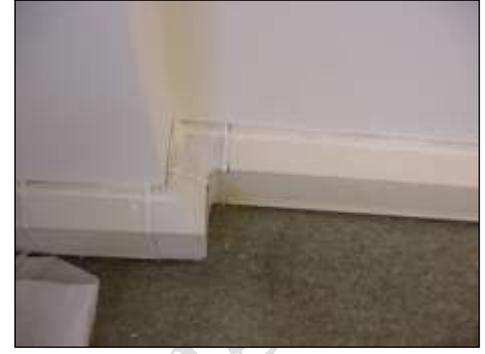
Badly painted walls where paint is onto skirting

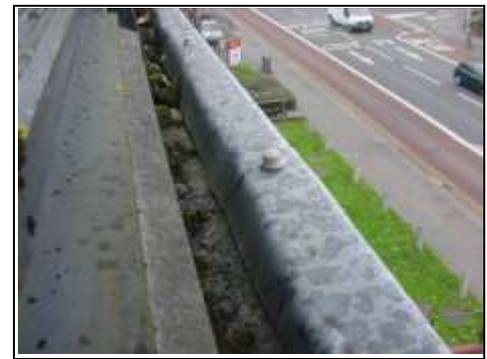
There is a defective box gutter means that rainwater is discharging down the walls as well as into the walls.

This is causing pattern staining externally and dampness to get into the property in some areas, particularly where there is a lack of sunlight which appears to be at the rear of the property. There are spot areas of dampness typically with readings of double what we would normally expect.

Box gutter

**ACTION REQUIRED:** You need to exclude the dampness from the Lease.

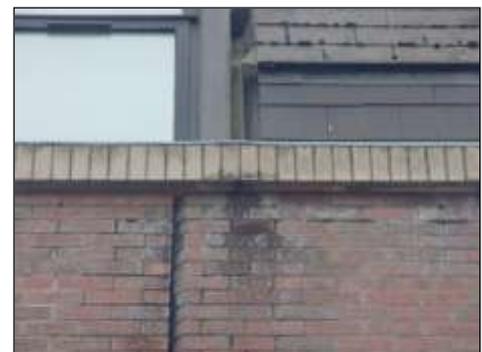
Pattern staining/ leaking box gutter

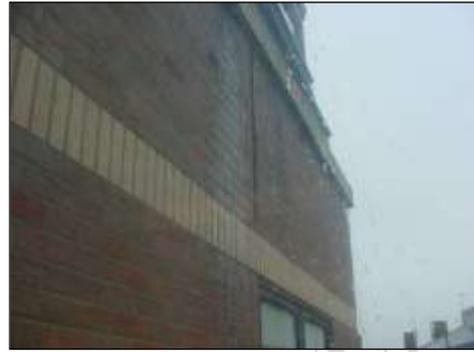
Pattern staining/dampness from a leaking box gutter, photograph taken during rainfall

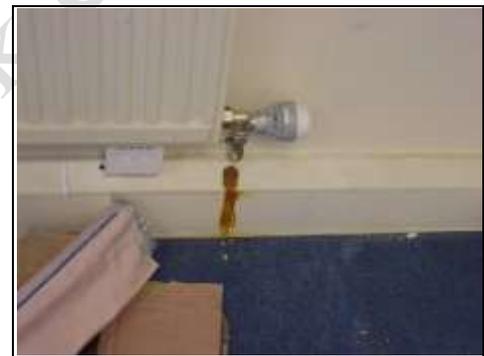
Leaking single panelled radiator

**ACTION REQUIRED:** These all need to be provided in working order by the present tenant/landlord and excluded from the Lease

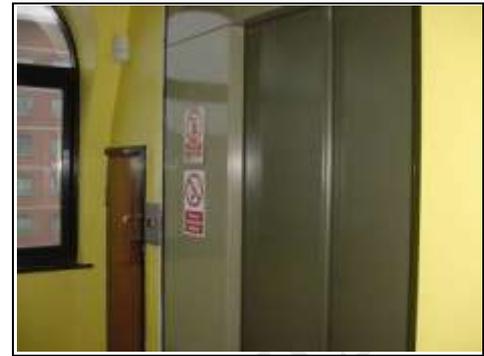
Lift not able to access and not working at time of inspection

We would recommend you to set aside a sum of money to bring the lift back into working order.

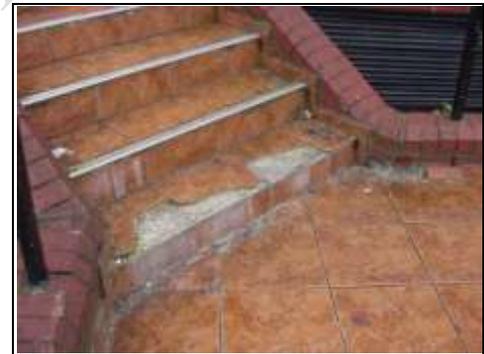
You have a very slippery entrance staircase and ramp that has used what we believe to be, an internal tile, which is very slippery and not correct to be used for a Public building. From our experience, on the day of the survey when it rained was that the tiled area became very slippery when wet, we would class this as a big Health and Safety hazard.

Slippery steps and ramp, damage to tiles.

**ACTION REQUIRED:** We would recommend all the tiles are replaced with a more appropriate less slippery tile before the property is used by the Public.

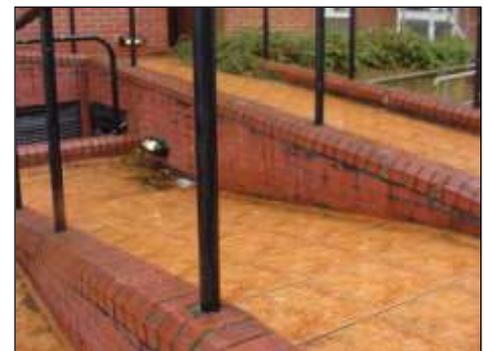
Slippery tiled surface to ramp at entrance

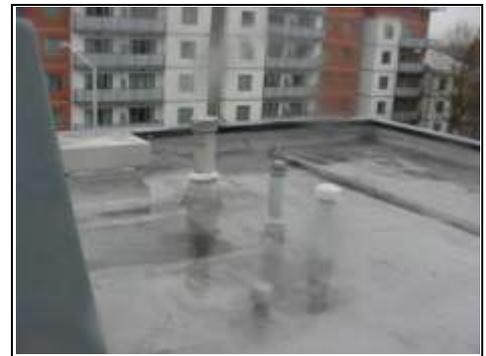
Ponding on the roof, photo taken during rainfall

The problem with this flat roof is that it is too flat and there are areas where water is sitting on it known as ponding. We could see that there have been various repairs to the roof over the years yet from our view internally we could see that the roof is still leaking. This roof is a considerable liability.

**ACTION REQUIRED:** We have recommended that this flat roof is excluded from your Lease.

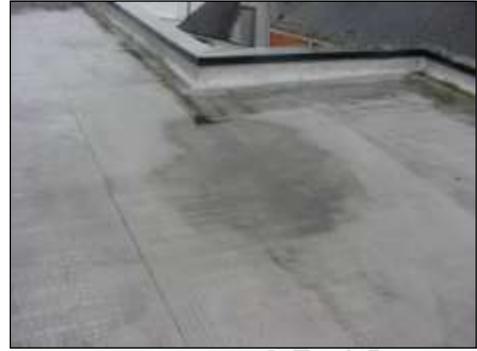
General view of roof with ponding

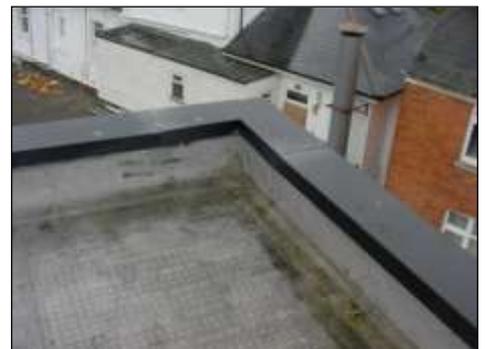
Around the perimeter of the roof there is a parapet wall with a metal copping. We could see that this is defective in several areas with metal copping joints opening up. We could also see old repairs in some areas and repairs to the parapet wall itself.

General view parapet wall

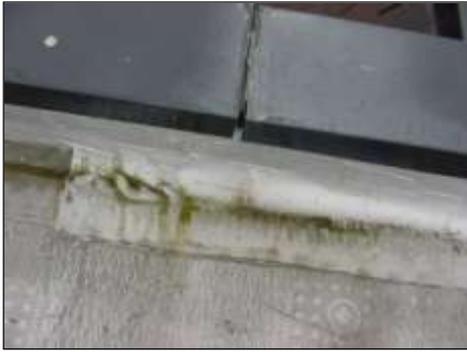
Repair to the parapet wall

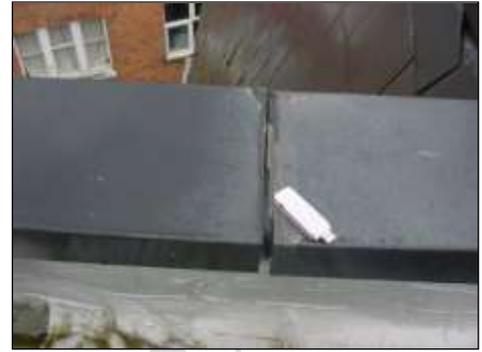
Close up parapet wall – opening up of joint between the copping

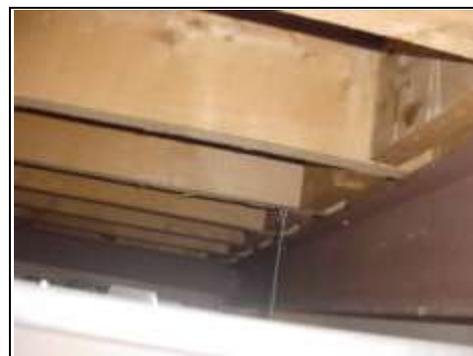
We found the roof timbers generally in slightly below average condition considering their age mainly due to the dampness. We have inspected the roof structure for:

Roof timbers

**ACTION REQUIRED:** We recommend adding ventilation. The only way to be 100 per cent certain is to have the roof cleared and checked.

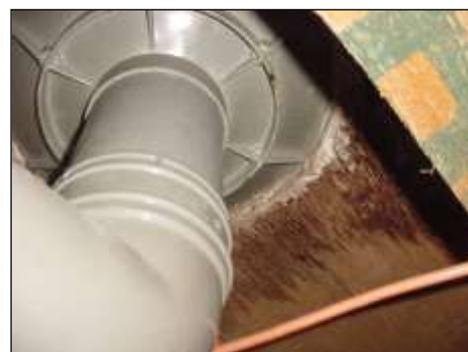
Our examination was limited by the general configuration of the roof and that we were viewing it via the ceiling roof lights. As mentioned what we could see was generally found to be in slightly below average condition due to the rainwater leaks from the asphalt roof above.

Leak to drainage outlet

The leaks coming through the roof look to be long term leaks and we therefore believe they should be excluded from the Lease. Please see our comments in the Executive Summary.

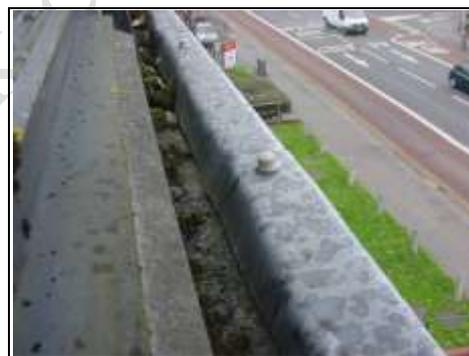
The box gutters are formed in lead and are leaking.

Box gutter

**ACTION REQUIRED:** Please see our comments in the Executive Summary. We would always recommend that the gutters and downpipes are cleaned out, the joints are checked and the alignment checked to ensure that the gutters fall towards the downpipes.

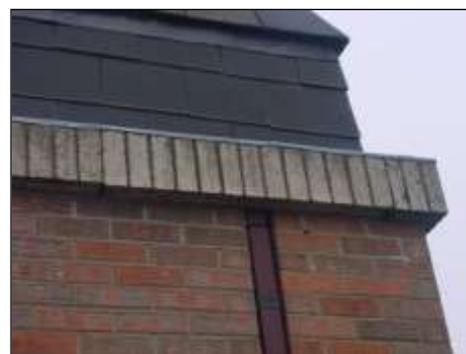
The guttering runs set into the brickwork which is not ideal as leaks can actually come inside the property before you notice them externally

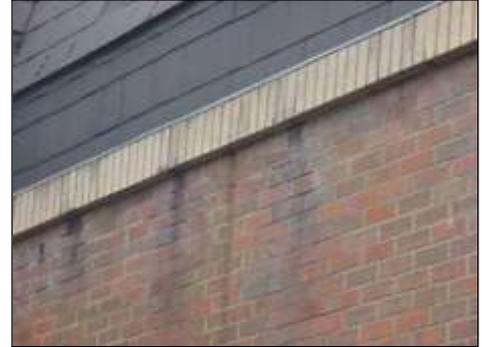
Pattern staining is occurring to the brickwork where there are leaks from the box gutter.

Pattern staining on brickwork

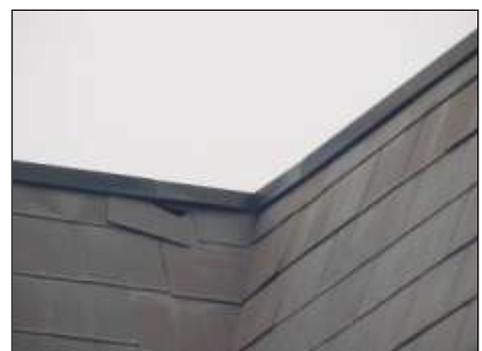
There are a number of loose and missing slates

Loose slate

**ACTION REQUIRED:** Loose and missing slates need to be secured we would also recommend that the moss is removed at the same time as this is coming away and blocking the box gutter.

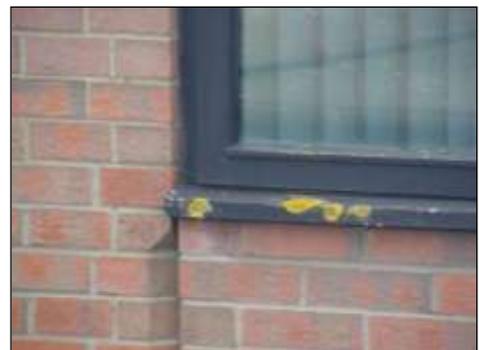
Moss on the windowsill

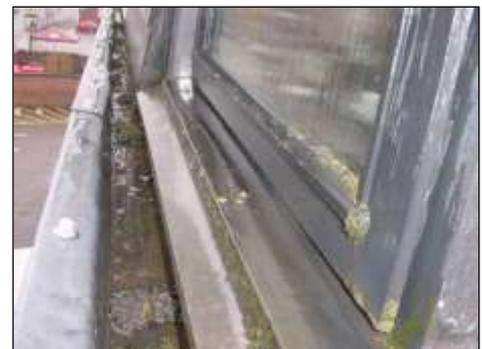
Moss on window

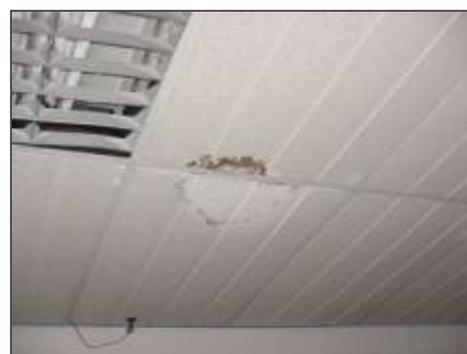
Suspended ceiling system, dampness staining

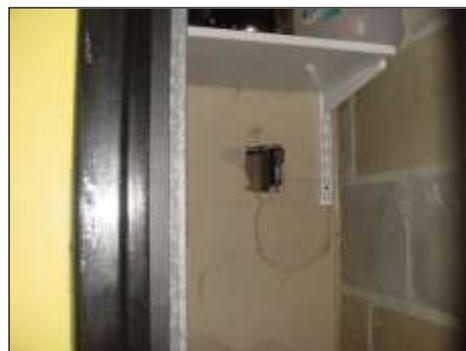
The staircase and lift area should be sealed. We noted that there is a hole in the studwork adjacent to the lift on the first floor this needs to be filled and made fire proof. The property needs to be double checked to ensure there are no other such holes as the staircase/lift area can effectively act as a chimney transferring fire from one floor to the next and therefore requires additional fire protection.

1<sup>st</sup> floor landing hole in studwork partition in cupboard

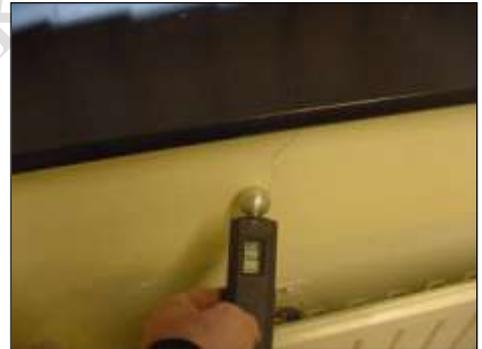
Hairline cracking – photo shows cracking to the front right hand side of the property

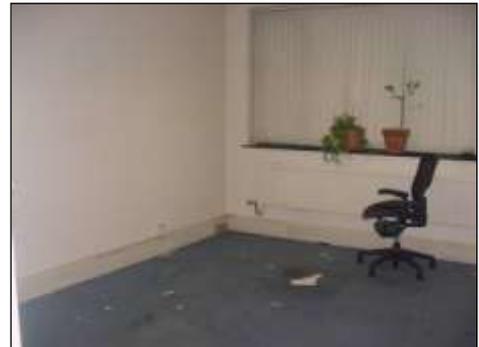
Carpet and carpet tiles throughout in some areas this is heavily stained and needs replacing

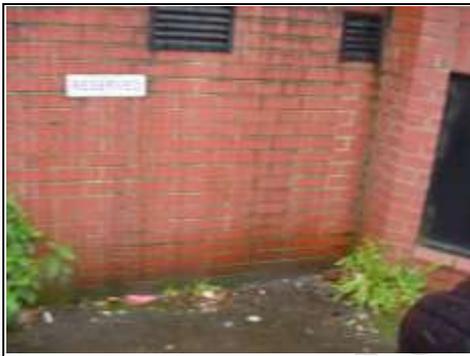
Car parking area, vegetation at base and pattern staining caused when it rains
