PROPERTY REPORT

**17th Century Public House in
Shropshire**

We have been asked to inspect and prepare a Report and Schedule of Condition for a 17th Century public house in Shropshire.

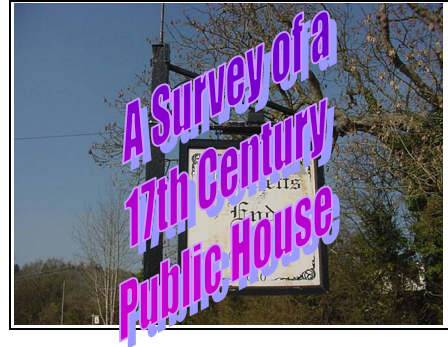
This property is very old and generally this age of property would have been Listed and preserved. It possibly has not been because it has been amended so much over the years. In years gone by we used to build in a different style from that which we have been building in since the second world war. This was a style where the building “breathed”, whereas a modern property is built more like a raincoat, with a protective layer (if you recall we explained this as being like a gortex coat material and a raincoat).

Swing sign showing 1640 date

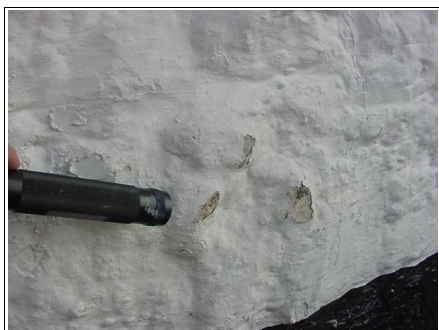
You have rising damp. This we believe is being caused by the car park discharging rainwater against the property, together with the ground levels being high and also some of your gutters and downpipes discharging onto the base of the property. There have been various paints added to the property, which unfortunately are plastic based, which means the walls cannot breathe.

The plastic paint with the lime wash, or distemper, beneath

We would also ultimately re-paint with a breathable paint, such as a lime wash or a microporus paint.

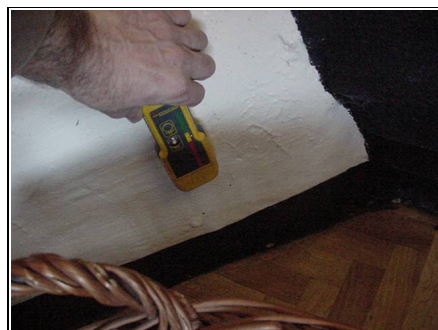
Dampness found internally

We can see the original lime wash beneath the plastic based paint. This is an older style paint and would have allowed the building to breathe had it not been painted over. We also noticed internally that gloss paint has been used and this affectively seals any dampness into the structure meaning it cannot get out. The result will be that the paint will deteriorate and you will have staining. At this point you then need to repaint in an appropriate paint.

French Gully

We would suggest adding a French gully around the property to enable the water to be moved away from the base of the property. In the Appendices within this section we detail how to prepare a French gully properly to make sure it doesn't become a French pond!

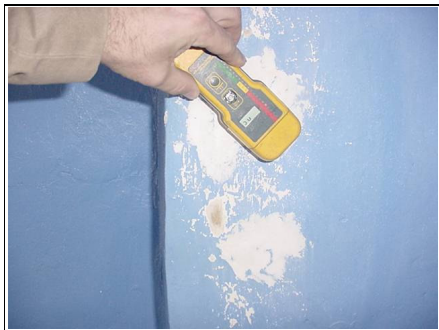
We also found dampness coming through the walls to the top floor and first floor. This we believe is partly due to the reasons mentioned overleaf, with the obvious exception of the car park, however this has been “replaced” by a faulty flashing. We noted areas where re-plastering had taken place, which we feel may have added to the problem, as often in this situation a builder that does not know how to deal with older properties uses a cement based mortar rather than a lime based mortar.

Meter readings being taken in
right hand bedroom

ACTION REQUIRED: Again the problem comes partly from the paints that have been used on the property in not allowing the walls to breathe any more, and partly it is a characteristic of the property. As some dampness will get in you will have to redecorate more frequently. We would also recommend that the flashings be replaced in lead.

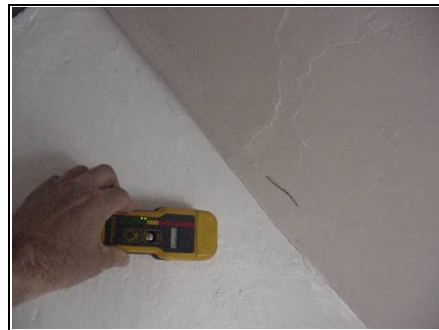
Meter readings being taken in
Left hand bedroom

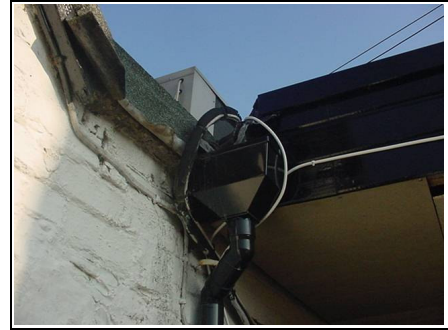
We noted the hopper head was leaking to the right hand side, next to the flat roof.

Hopper head on right hand side

ACTION REQUIRED: This needs amending; probably a larger style box gutter needs to be added.

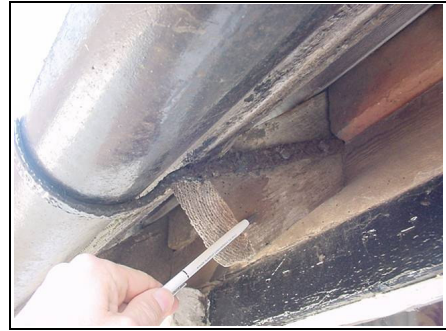
We noted that there is extensive woodworm throughout the property. The areas where we have seen woodworm we can see that it is not active, but we have not had access to a large portion of the roof and the general damp conditions that we mentioned earlier are a good breeding ground for woodworm, although it has to be said it does take a lot of woodworm to structurally affect a property.

Signs of woodworm to
exposed rafter feet

ACTION REQUIRED: We recommend that the roof is examined closely by a woodworm company. We hesitate to recommend them as they are, after all, trying to sell their products, however, if you advise us when this is carried out we can either come and be there at the same time or alternatively we would be happy to review a copy of their report if you e-mail it to us. We recommend this is carried out before the lease is taken on.

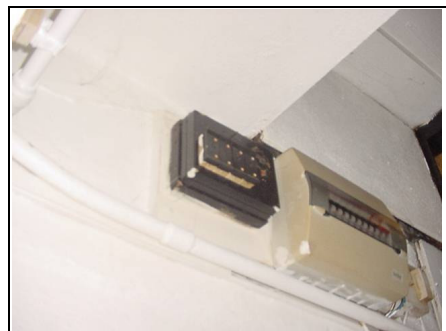
Fuseboard

The electric fuses and consumer units range from the 1960's to the 1980's and looked dated.

ACTION REQUIRED: We would recommend they be replaced where they are dated and that an NICEIC test and report be carried out.
