SCHEDULE OF CONDITION OF

17th Century Public House in Shropshire

FOR

Ms S

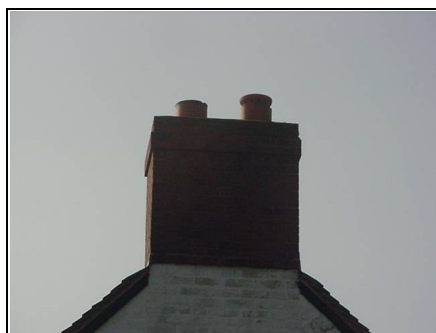
This chimney is brick finished with two chimney pots with lead flashing. From what we could see the chimney looks in average condition. However, dampness is getting in around this area, so there is a defect somewhere. Unfortunately we were unable to see the top of the chimney known as the flaunchings, we therefore cannot comment upon them.

ACTION REQUIRED: Resolve dampness in the area.

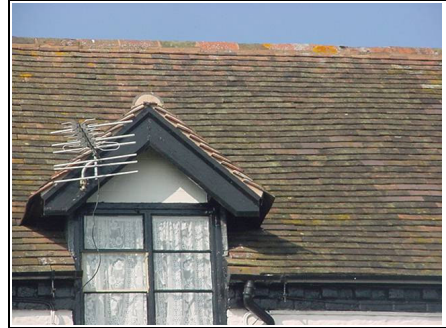
Both dormer windows have a pitched roof with concrete tiles. The pitched roof is in average condition as are the sides, as viewed from ground level. There is a limited view of the pitch of the roof and therefore we cannot comment on it. Unfortunately, we were not certain what was to the sides, as the roof pitch was difficult to view. There are no visible signs of dampness getting in internally.

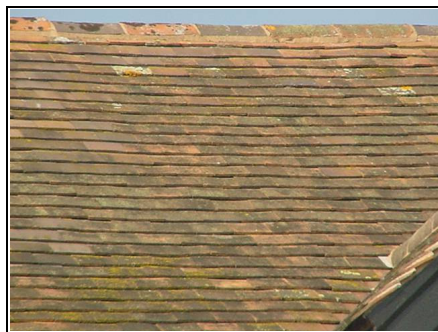
The main roof is pitched and clad in a small nibbed concrete tile. From what we could see the concrete tiles are lying level and true and look in reasonable condition. We could see that some tiles have been replaced and we could see an element of moss on the roof.

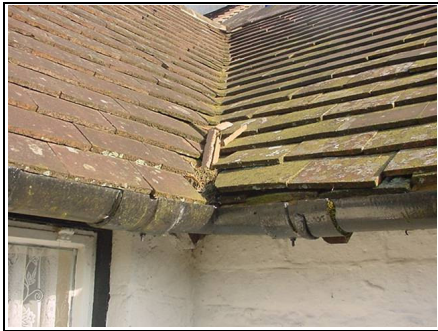
There is a step in the roof, which is a weak area. It looks to have had tiles on edge placed in it previously. We would expect some dampness coming in this area, but unfortunately we were unable to access it.

Mortar coming out of the ridge
on the valley gutter

ACTION REQUIRED: We would recommend that the cement flashing is replaced with lead. Repairs are needed to the ridge.

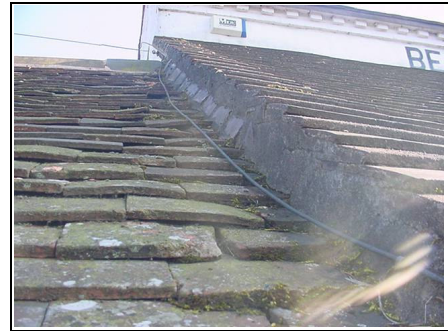
Step in the roof

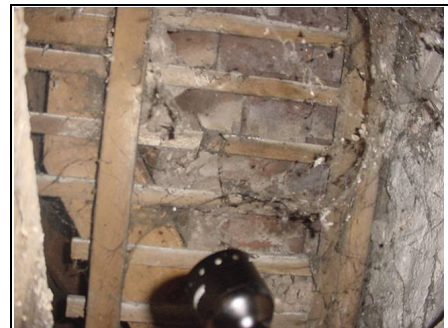
Front Side Roof

Within this roof we could see that there is no sarking felt and we could see the exposed side of the tiles. This means that if any dampness does get in it will come through very quickly. If you note, this is the area where the ridge is deteriorating.

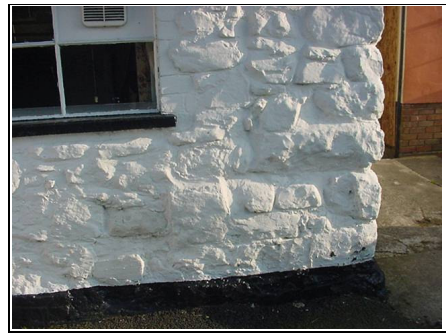
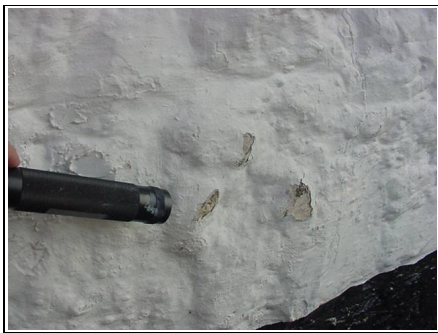
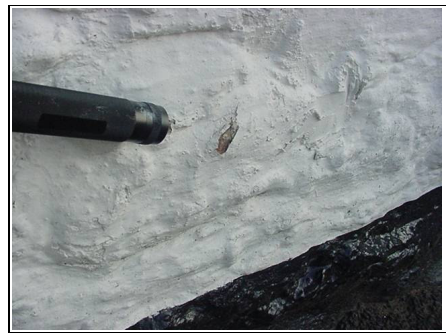
There is a problem with dampness in the property. This, we believe, has been caused by a plastic based paint being added to the wall, also, the ground level being high and the water discharging from the car park. All of these should be noted as “characteristics” of the property and no improvements be required under the terms of the lease.

Dampness starting to come in

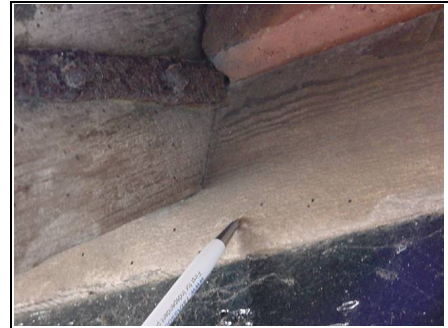
There are some painted timber fascias and soffits. They range from in average condition to needing redecoration. We also noted there are exposed rafter feet, where we can see woodworm.

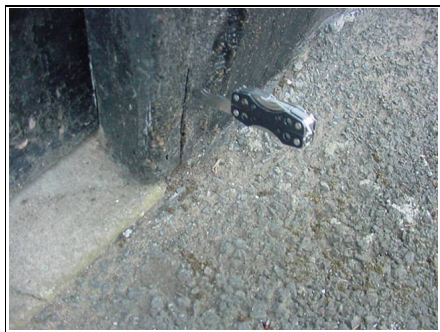
A selection of metal windows, set within timber. Some have rot, we would estimate this as being approximately 25% of the windows and doors.

Checking the base of the door frame

ACTION REQUIRED: Cut and splice in new timber. We would recommend in most cases that the existing windows are saveable.

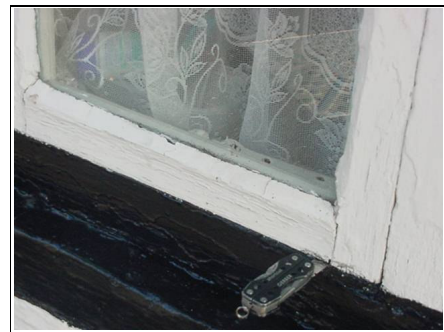
Checking the windows

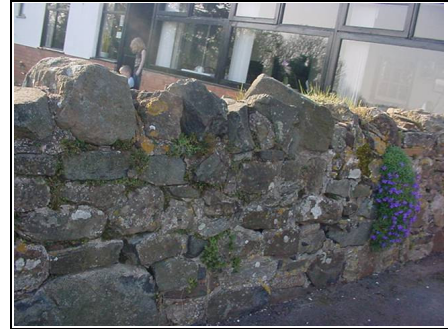
We have walked the boundaries and a general repointing is needed and some realignment.

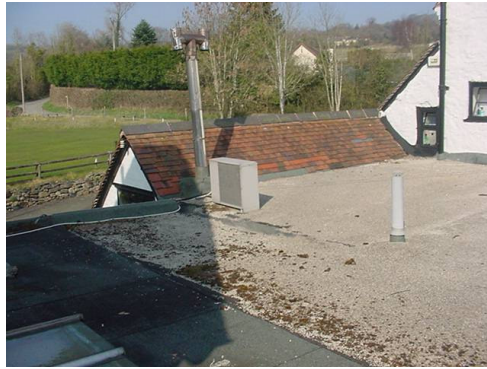
FLAT ROOF

<p>Flue to oil burner in restaurant – ideally should be a metre above roof level. We would always recommend a double lined flue</p>	<p>Flue pipe to right hand side requires a lead flashing</p>

<p>Pen indicates blister in roof</p>	<p>Ad-hoc repairs and replacement of the flashing with a lead flashing.</p>

<p>Base of wood burning flue in front bar</p>	<p>Add lead flashings to base of both flues and have a minimum flue height of one metre above roof level.</p>
<p>Flat Roof:</p> <p>L-shaped flat roof, felt with chippings with a mineral felt flashing</p> <p>Upstand where chipping roof meets the mineral felt roof.</p>

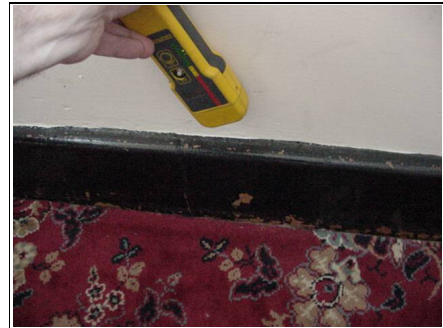
A random visual inspection and tests with a moisture meter have been taken to the perimeter walls and some internal walls. Dampness was found. Also the car park discharges onto the walls and an inappropriate paint has been used.

ACTION REQUIRED: Lower the ground level and add a French gully and redecorate.

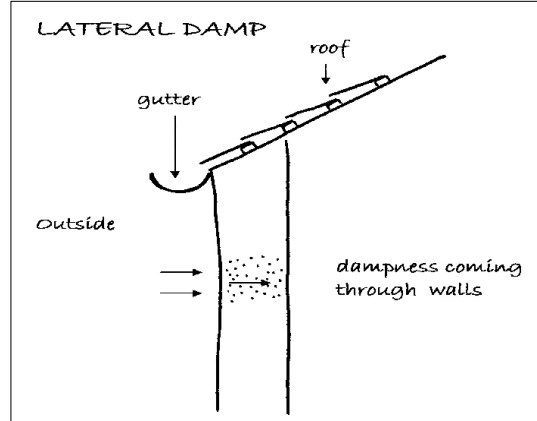
Tests were taken with a moisture meter at random points to internal walls, floors and other surfaces. We get high readings in some areas.

ACTION REQUIRED:
Redecoration required. In some areas we believe a new flashing is needed.

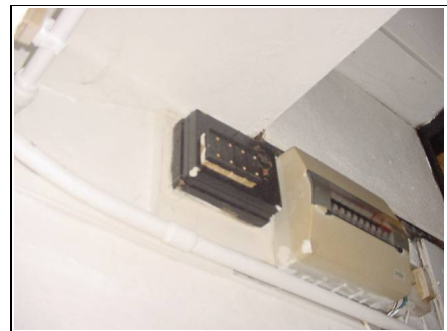
The electric fuses and consumer units range from the 1960's to the 1980's and looked dated. We would recommend they be replaced.
