**COMMERCIAL BUILDING SURVEY
OF
A Public House in Somerset**

Mr N

Firstly, may we thank you for your instructions; we have now undertaken a Commercial Building Survey (formerly known as a Structural Survey) of the aforementioned property.

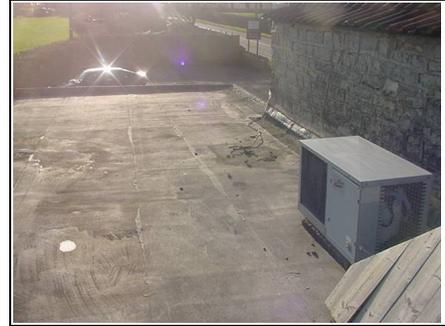
The flat roof to the rear is flat! It should have a fall on it of 12°. We could see where it has been repaired quite extensively in the past.

ACTION REQUIRED: Ideally we would recommend complete renewal of the flat roof with a high performance felt, ideally with an insulation cut to falls directly underneath it to reduce the thermal efficiency loss.

ANTICIPATED COST: Quotations required, but we would expect in the region of £2,500 - £7,000, depending upon the condition of the decking beneath the roof. We would recommend that the stored items on the roof are removed immediately.

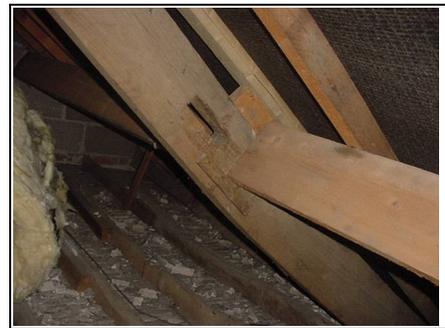
In the older part of the roof there looks to have been movement in the supporting common rafters (the ones that form the pitch of the roof).

ACTION REQUIRED: We recommend propping to the purlins (these are the horizontal timbers that run across the roof) in the older part of the roof.

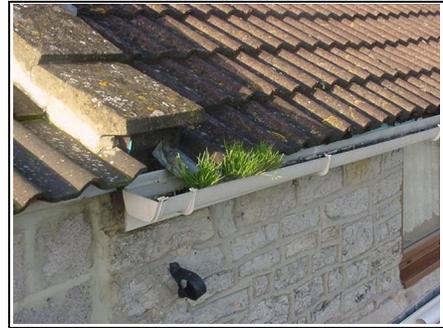
The plastic guttering has been added on with little thought and has several awkward details. When we inspected the guttering we generally found that it was not falling towards the downpipes and this has led to debris sitting in the gutters, for example we could see grass growing out in some areas.

Grass growing from the gutter.

ACTION REQUIRED: Replace and repair guttering.

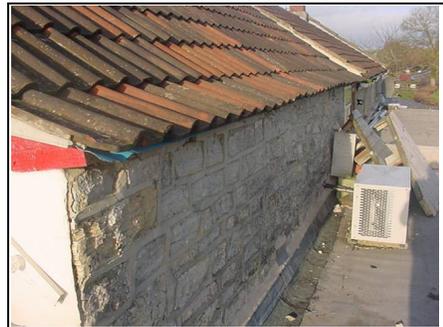
There is also an area to the rear right hand side (all directions given as you face the property from the front) where there is no guttering at all! Upon closer inspection, to the rear gutter, we could also see that the felt was not tucked into the gutters properly, which means that the water could be running behind it.

Missing gutter

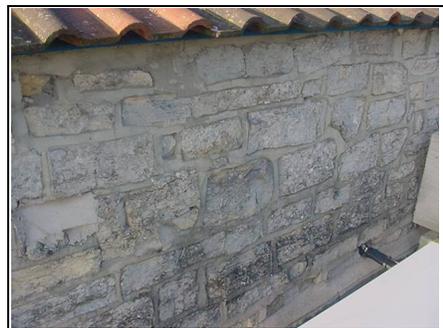
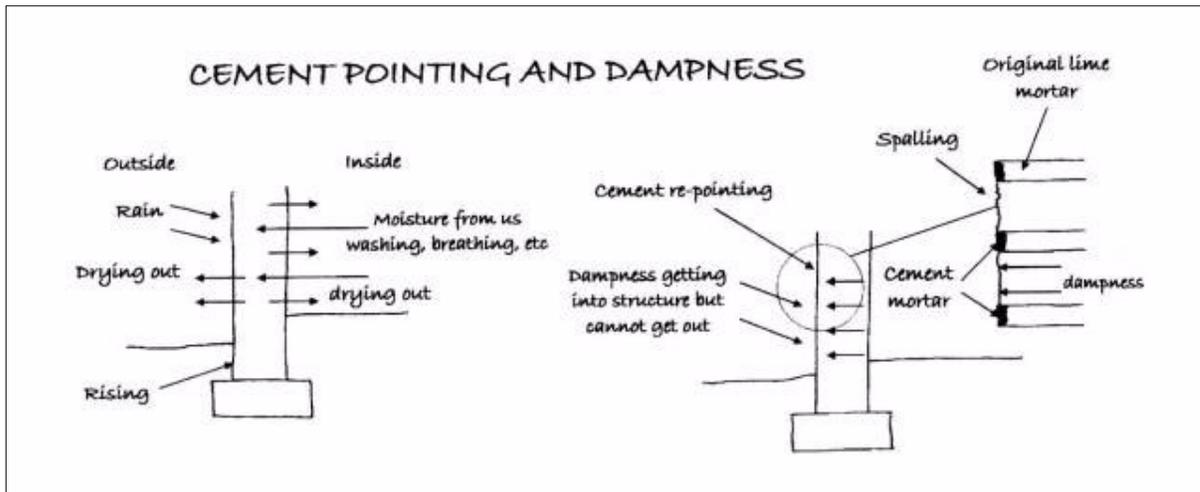
This property has Blue Lias stone, which is relatively soft, and originally it would have been bedded in a soft lime mortar. This lime mortar has been replaced by a hard cement mortar and is causing damage and deterioration to the face of the property, as well as lateral dampness, which is particularly important as the property looks to have timber lintels.

ACTION REQUIRED: In summary we recommend that a soft stiff brush (as we don't want to damage the face of the Blue Lias stone any further) is used on the property every six months to remove any loose cement mortar and re-point in a lime mortar. Using lime mortar will limit further damage to the brickwork, which is almost impossible to repair successfully. However, we would add that many, if not most of the properties that we visit that are re-pointed are re-pointed wrongly; it is only in recent years that we have discovered the problems that can occur from it.

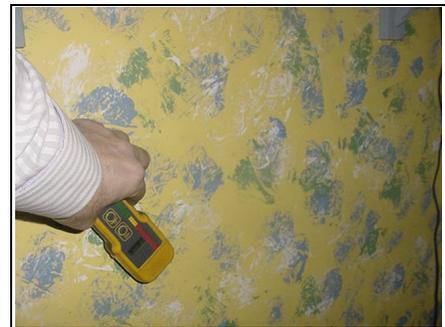
Due to the face of the Blue Lias stone deteriorating, lateral dampness is coming through the walls in some areas and this is causing blistering to the plasterwork (hollow areas) and also could be rotting the timber lintels above the windows and any binding timbers.

The lateral dampness coming through is the 'effect'; the 'cause' is the cement mortar that we have mentioned above and also the general poor guttering on the property that we have also commented upon.

ACTION REQUIRED: You need to deal with the 'cause' rather than the 'effect'. Please see our comments with regard to the Blue Lias stone above.

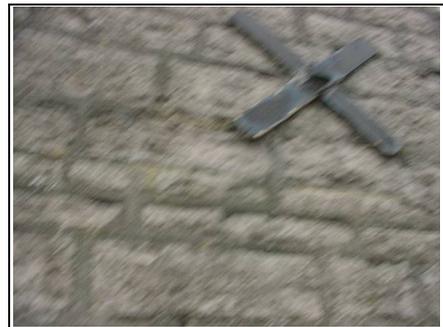
Just to explain further the extent of the damage that the lateral dampness can cause, there has in the past been deterioration to the floor timbers at first floor level, which has resulted in tie bars being required. Please telephone us if you wish to discuss this further.

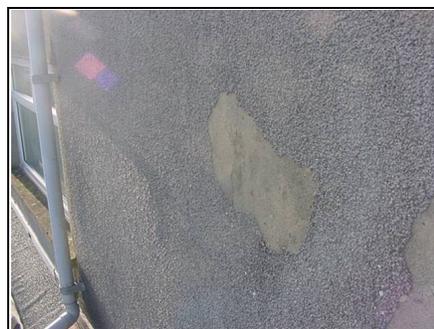
The applied finish to the render is starting to come away (sometimes known by the trade name of Tyrolean). This is a protective layer to stop dampness getting into the property; unfortunately it is also difficult to repair without it standing out; nevertheless it needs to be repaired to seal the render.

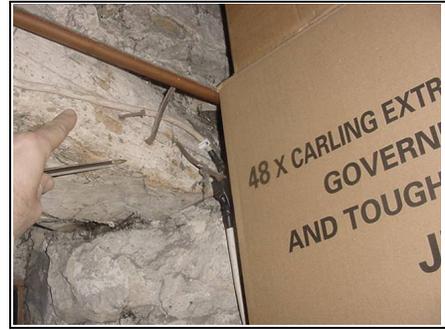
We found woodworm in the property. We cannot be 100 percent certain whether it is active; we don't believe it is (in the areas viewed), but often it is lurking underneath the insulation in the roof for example around the perimeter of the roof.

ACTION REQUIRED: Please see our comments in the Timber Defects Section of this Report.

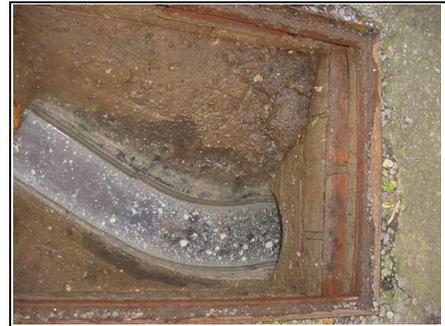
There was water sitting in the manhole closest to the septic tank (left hand corner of the property). This led on to discussions with both yourself and the owners; from this we would confirm as discussed that we believe it is probably a brick septic tank, or more correctly a leaking brick septic tank, which during the dryer months seeps into the surrounding ground and brook and in the wetter months, due to the increased water table level, back floods.

ACTION REQUIRED: You may require a new septic tank. If found out you will of course be fined for discharging into a stream.

ANTICIPATED COST: A new septic tank would be between £10,000 - £20,000, maybe more. The only way we know of checking the condition of this is to actually have it completely emptied and inspected; alternatively you could ring the company that is emptying the unit to ask for their comments on its condition.

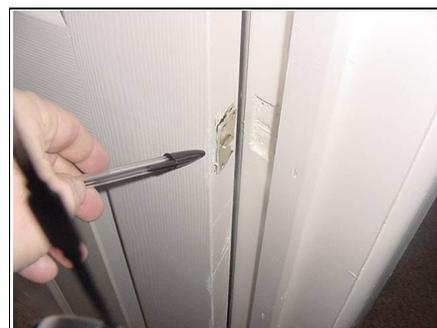
Fire doors are required to be half hour fire resisting with an intumescent strip, which these doors do not have, and also should have door closers and appropriate frames.

Missing door closer.

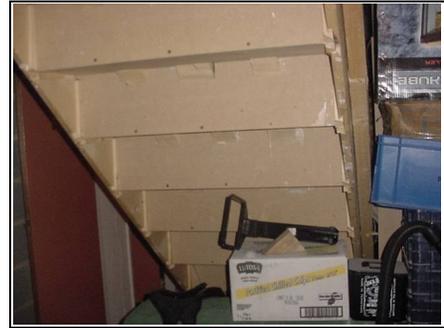
Lined staircase

We believe you will need new doors, fire extinguishers and signage, one additional window to allow for escape, plasterboard lining to the stairs, ideally some sort of alarm system which indicates where the fire is occurring, which is accessible both in your bedroom and the bar, and the addition of fire / heat detectors to each room.

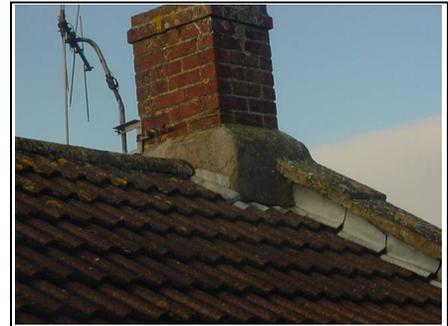
This chimney is brick finished with no chimney pots. From what we could see there looks to have been various repairs / repointing over the years. This chimney is allowing dampness in. Unfortunately we were unable to see the flashings or flaunchings, we therefore cannot comment upon them.

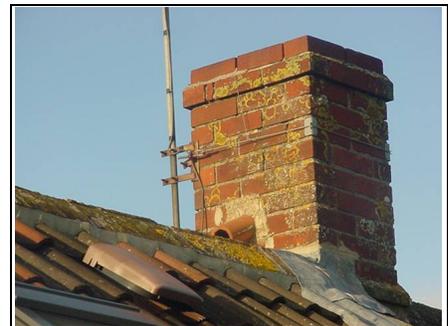
Chimney Two – Located to the Middle

The only thing we would add is with regard to whether the chimney is working; we have never come across one with a pot at low level previously. If you look in this photo you will see at the very base of the chimney there is a pot inserted into the wall.

ACTION REQUIRED: We recommend that you ask a chimney sweep to come and have a look at the chimneys before you use them and explain what the pot is for (and then give us a call and explain to us!).

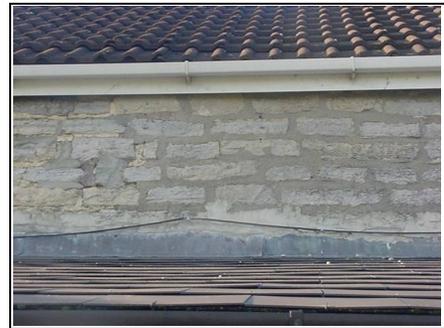
The roof over the kitchen has a shallow single pitch and is clad with manmade slates that should sit very flat and true, as they do in this case. However, as the slates are thin and light, the wind can catch them, so it is important that the slates are fixed at the perimeter and do sit flat.

We are concerned that the angle is too shallow, 22.5° is typically what is required by most manufacturers and this roof looks to be a borderline case. What this means is that wind blown rain can get up behind the slates and cause rot and damage, as well as dampness. We are advised that the roof is approximately five years old.

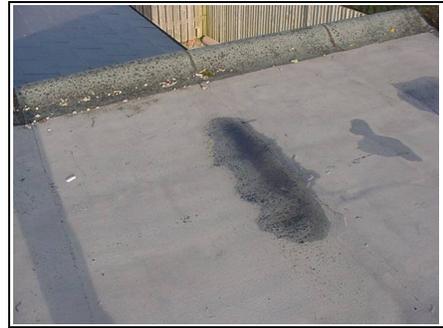
The flat roof is in a poor condition, the original felt has been repaired and all the felt has had a bitumen covering. It is only a matter of a few years before it needs replacing. It could leak at any times.

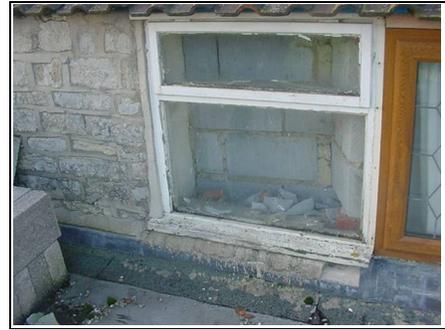
The mystery timber window was noted from the flat roof. This is a very strange detail.

Bricked around window to Guest Room One shower area.

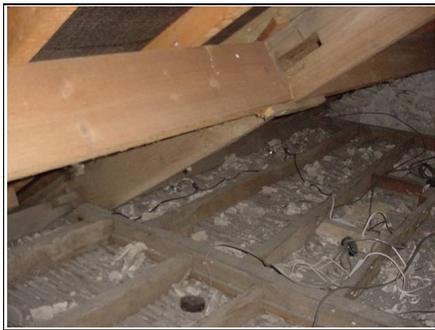
Lath and Plaster ceiling

From within the roof space we could see that some of the plaster had lost its key with the laths; this is what is termed as 'live' and could in theory come away at any time, however we have known these type of ceilings to last for ages.

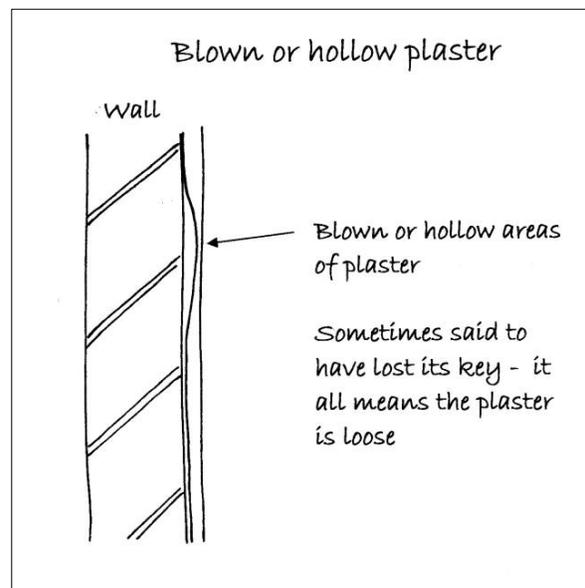
To the perimeter we found some areas of blown plaster, which is not uncommon in properties of this age, particularly around the window and door openings and around the chimney area; also generally as the Blue Lias stone is allowing dampness into the property (due to the cement mortar). When redecorating you may have to do some re-plastering or use lining paper.

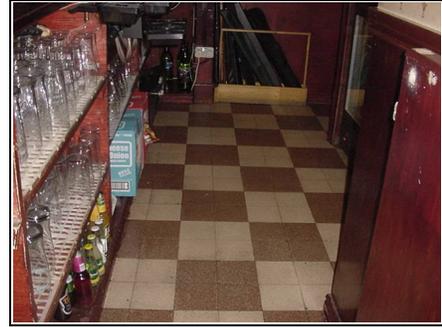
There is a tiled floor behind the bar. Tiled floors are very unusual behind bars; it is normally a requirement to change this for a safety floor, often known by the trade name 'Altro'. We asked the owner at the time of the survey if the Environmental Health Officers had any problems with the tiled floor and, if you recall, the owner brought out the latest Environmental Health document which did not advise of any issues.

Tiled floor behind the bar.

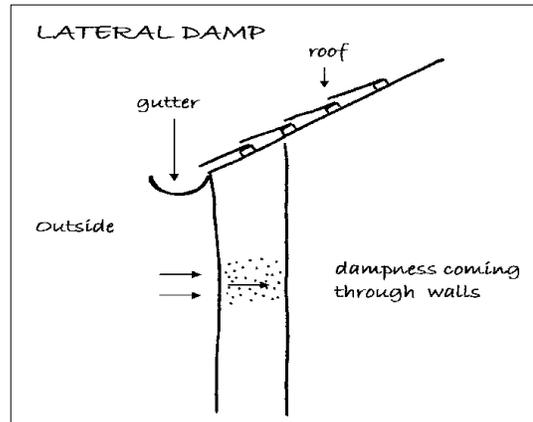
We noted some areas of damp, when testing with the electronic damp meter, for example in the left hand bedrooms.

ACTION REQUIRED: Please see our comments in the Executive Summary.

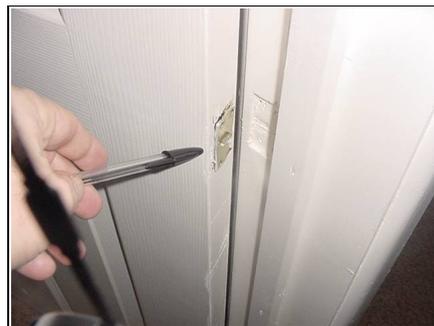
Missing perco door closer
