PROPERTY REPORT

A Public House In Surrey

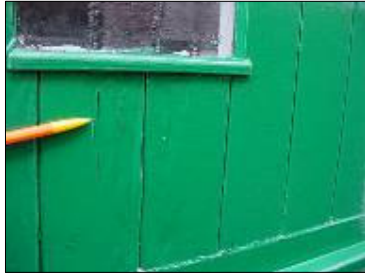
We utilise photographs and sketches to illustrate issues or features. In some photographs a pencil has been used to highlight a specific area.

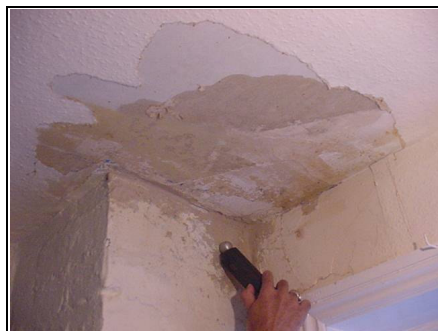
Damage that has been caused within the building from the leaking large rear chimney

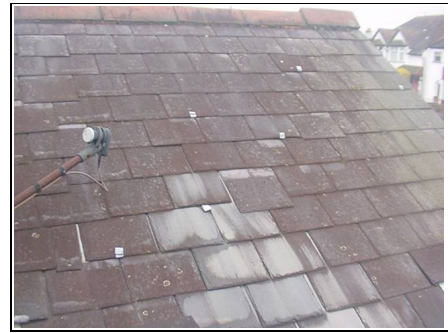
Lead tingles on slate roof

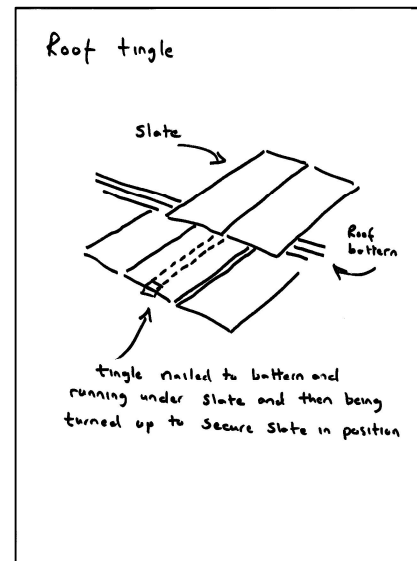
Please see the Roof Section of this Report.

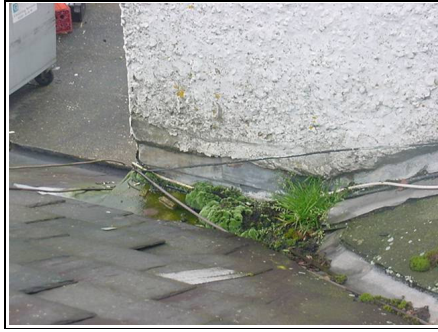
Left hand side valley gutter full of vegetation

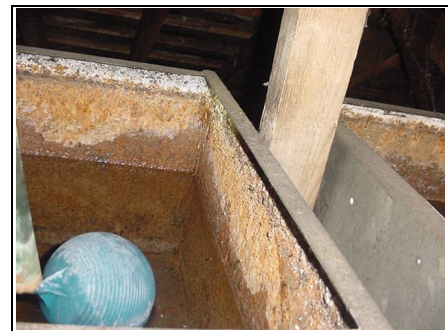
Please see the Roof Section of this Report.

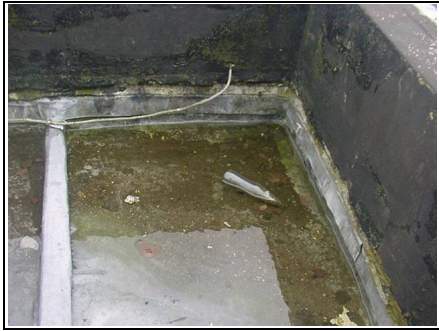
Flooded front left flat roof

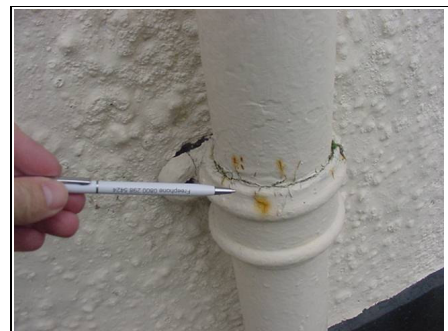
We notice there is a mix of cast iron and plastic gutters and downpipes. These are rusting and the rust has been painted over rather than repaired.

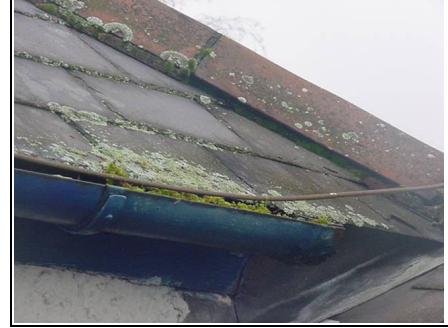
ANTICIPATED COST: In the region of £1,000 to £2,000. It really does depend upon how much rusting has been hidden by the recent painting. Please obtain quotations.

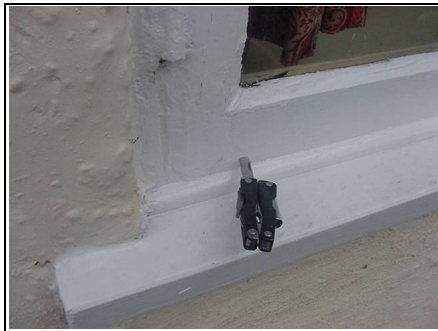
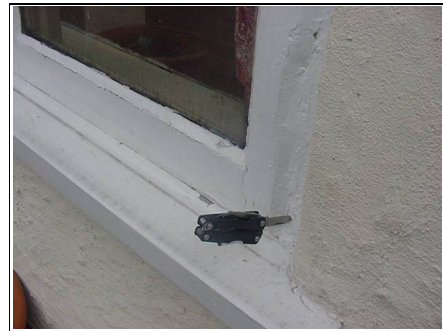
Deterioration to timber windows

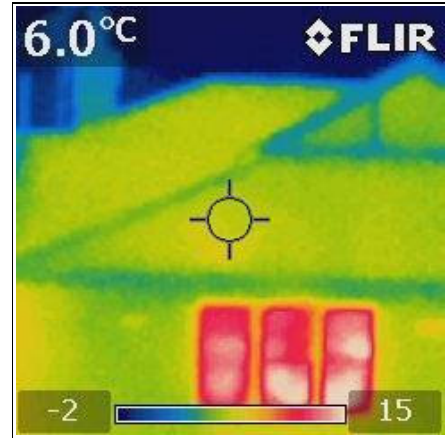
Red shows heat loss from windows

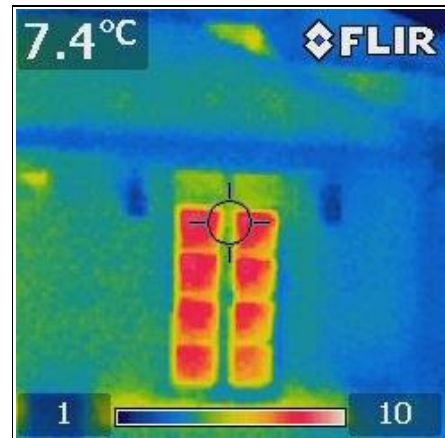
Heat loss through the French doors to right hand side

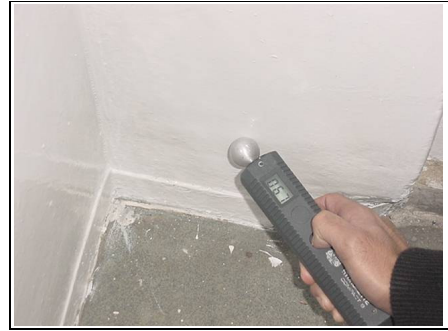
Checking for rising damp

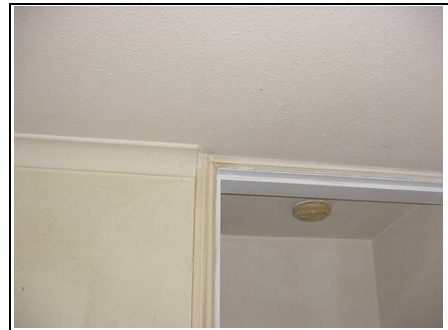
Nicotine staining to left of photo

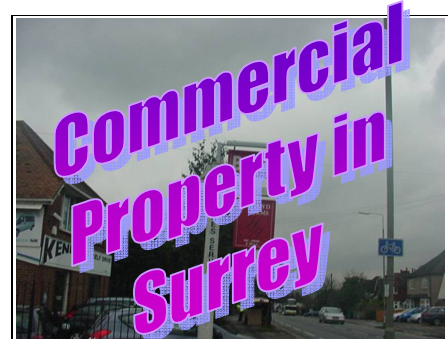
As discussed and noted by yourself, we feel there are opportunities missed by the signage and lighting. You mentioned that the gable end would benefit from additional signage and lighting. We would add that remote signage would also be good. The signage does need to be written for the speed of traffic, i.e. 30mph or 60mph, as it acts as a good pre-warning that food and accommodation are available, etc.

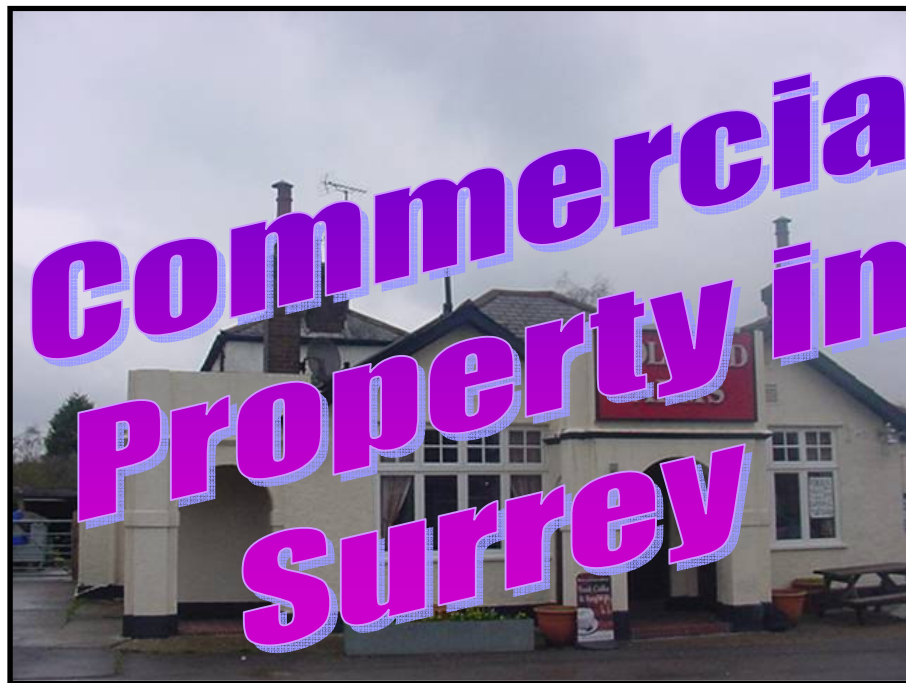
Independent Chartered Surveyors

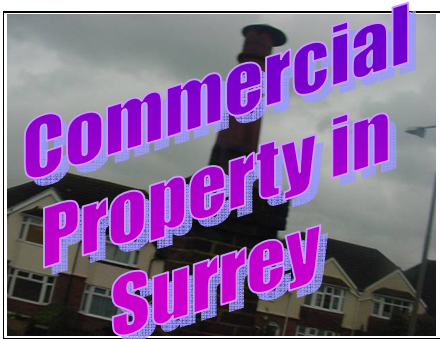
Front left hand chimney

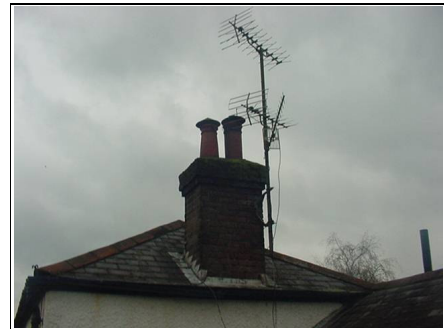
This is a good size brick chimney. We can see two chimney pots and a lead flashing with moss growing around the top and the pointing is starting to weather.

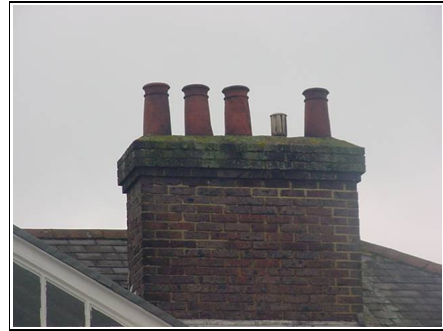
Rear right hand side chimney

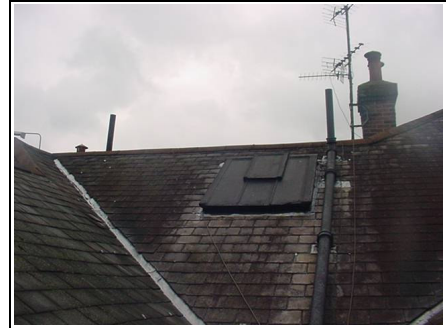
Tarred over skylight

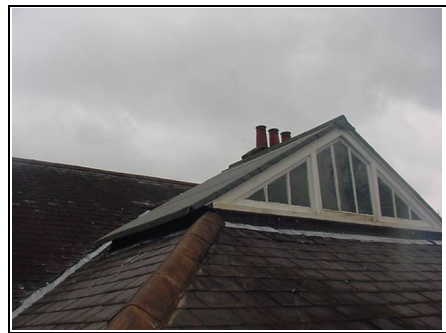
High level roof window

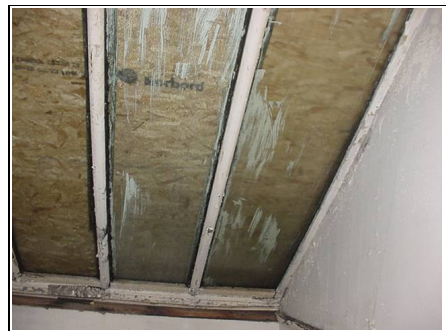
The underside where you can see the timber that has been put over the roof window

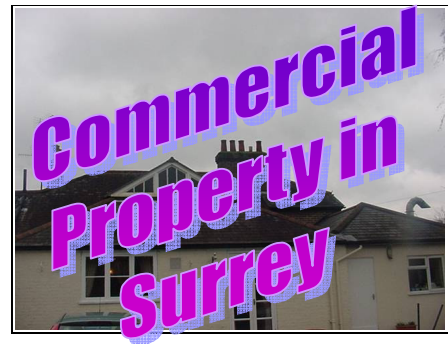
General view of high level roofs

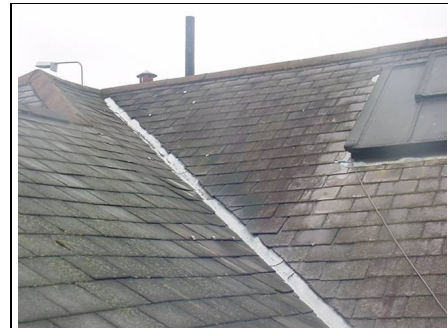
Close up of high level main roof.
Note lead tingles and our comments on these.

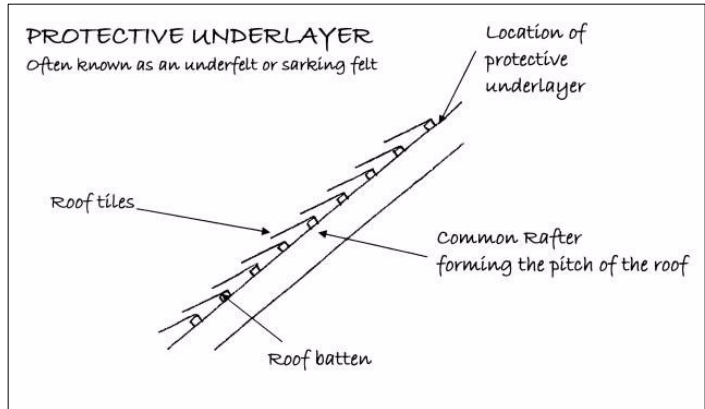
There is no protective underlayer.

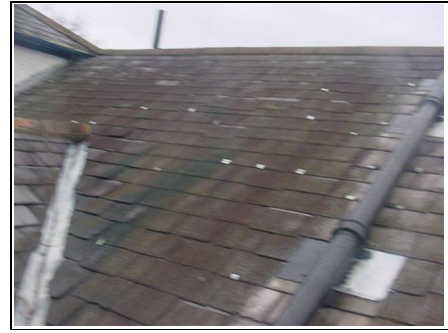
Front left hand flat roof

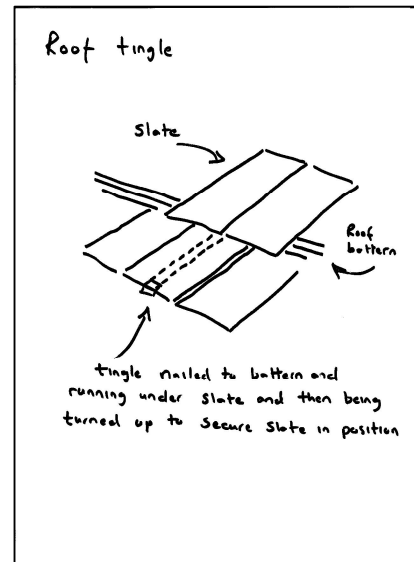
Please see our comments in the Executive Summary and the costings for the roofs. This is a major cost and in our opinion a major stumbling block to taking on this lease.

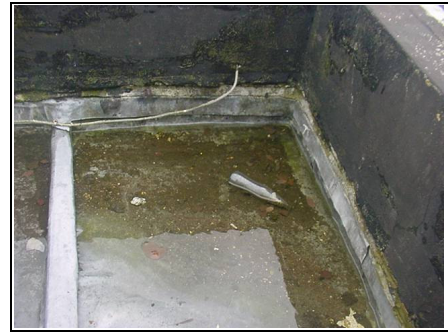
Front left hand flat roof

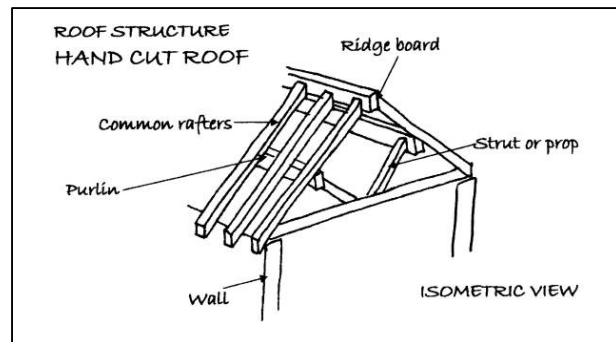
This type of roof structure has, what is known as, a cut timber roof, which is a roof that is purpose made and hand built on site. Without the original design details we cannot categorically confirm that there are no defects; however it is in line with what we typically see.

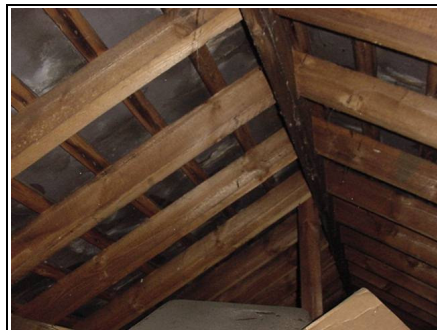
We have inspected the main roof structure (high level pitched roof) for:

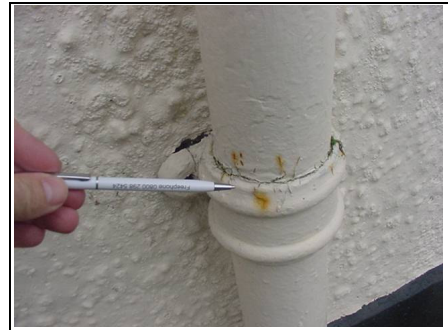
Rust to cast iron gutters and downpipes

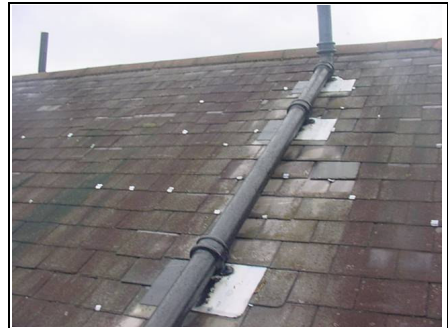
The property has cast iron and plastic soil and vent pipes. The cast iron pipes rather unusually run over the roofs. This is to allow them to get to one metre above the ridge height which is a Building Regulation requirement.

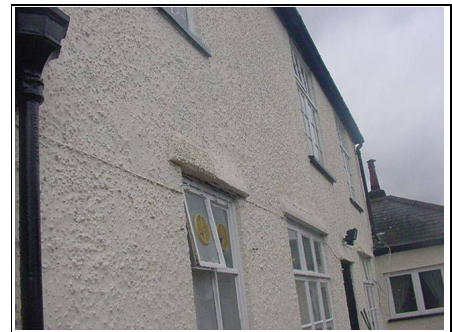
Rough cast (pebbledash) render

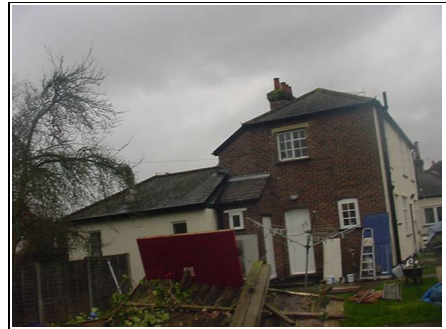
Brickwork rear right hand side,
with smooth render to rear
left hand side

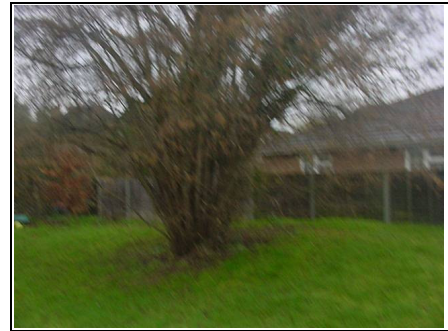
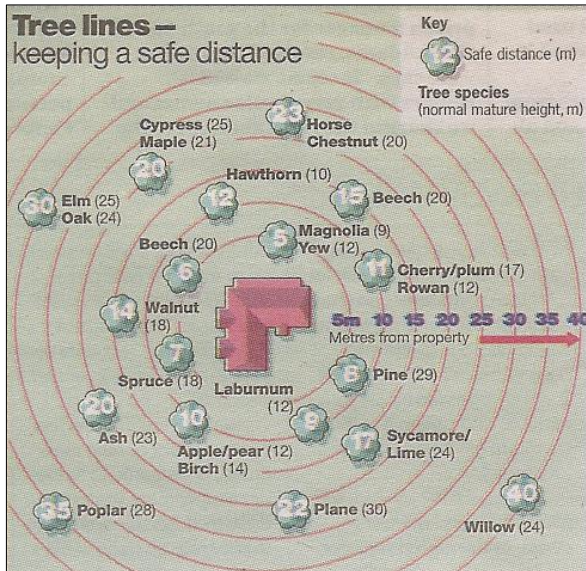
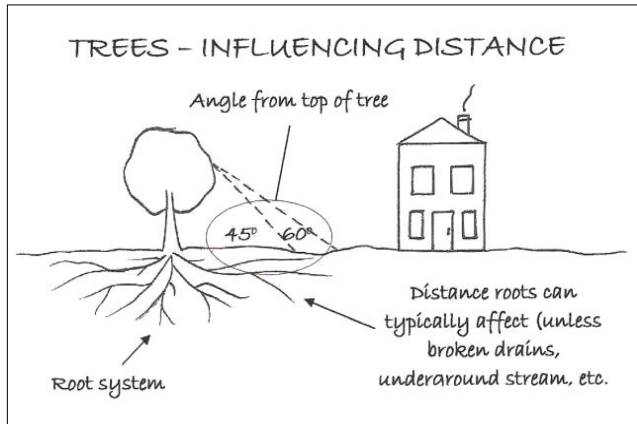
Influencing Distance Defined

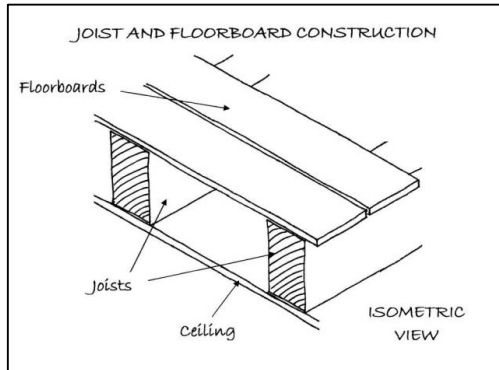
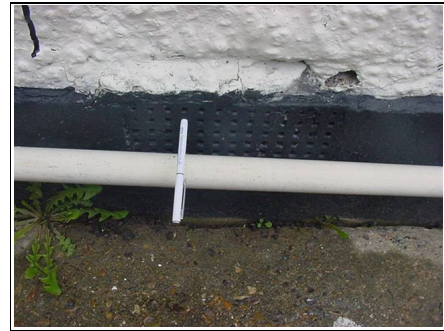
Air vent to left hand side

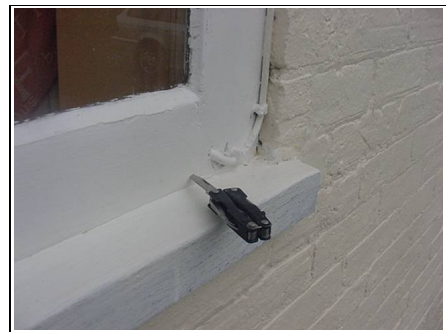
Penknife going into window

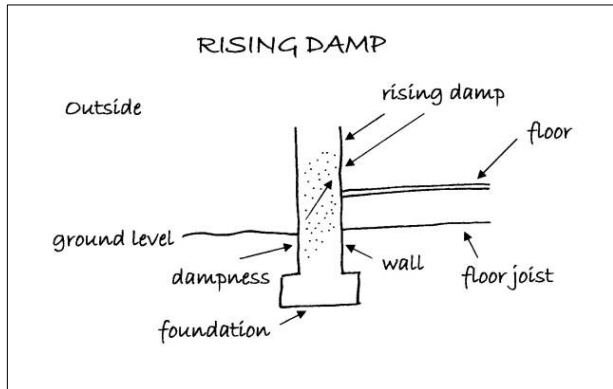
We carried out tests with an electronic damp meter and found dampness, which possibly could be condensation.

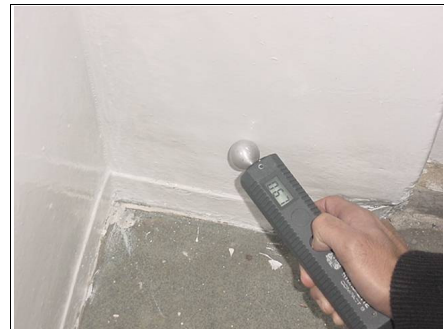
Checking for rising damp

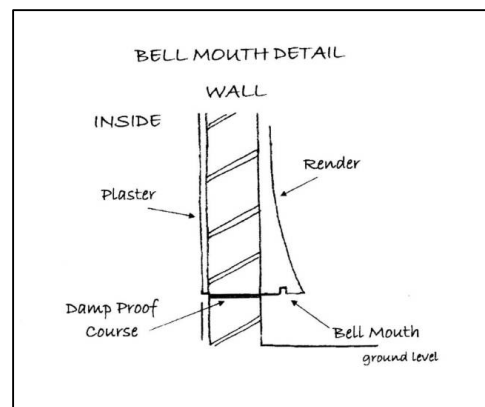
Lateral or Penetrating Dampness

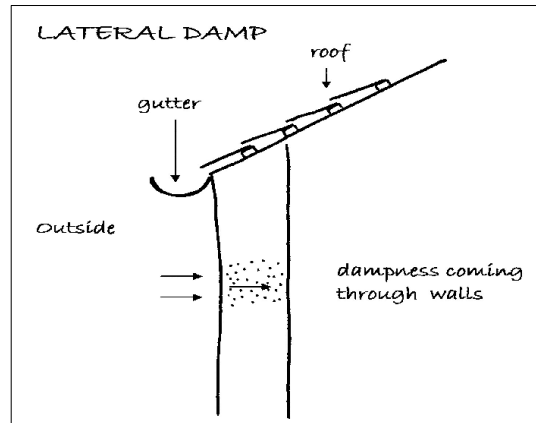
ACTION REQUIRED: Repair the chimneys and the valley gutters, as explained elsewhere within this report and the dampness should be reduced. However, in a property of this age there will still be an element of dampness, as there should.

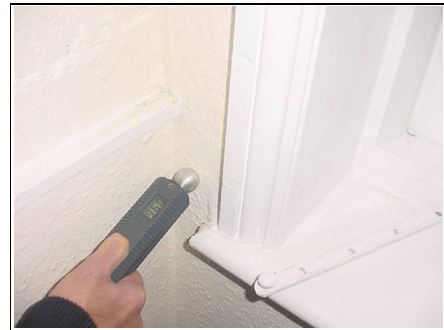
Checking for lateral dampness

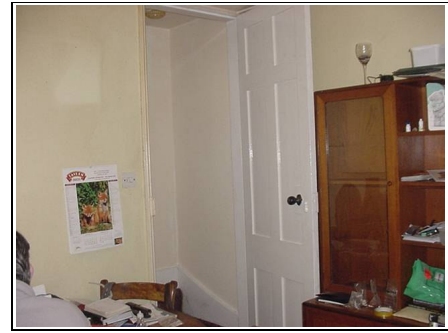
The property has painted panel doors and flush doors which have been redecorated. Unfortunately, in many cases the nicotine and old paintwork is grinning through and will need to be prepared, repaired and redecorated.

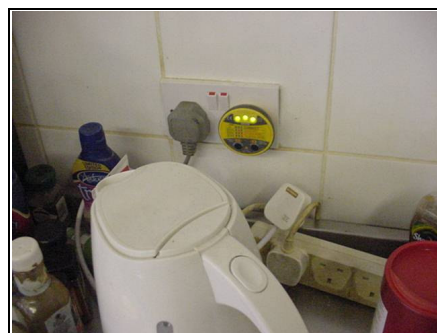
ACTION REQUIRED: If there is no record of an electrical test having been undertaken within the last five years, it is recommended that the installation be tested by a competent electrician (NICEIC registered) and all recommendations implemented. Thereafter, the installation should be re-tested every five years.

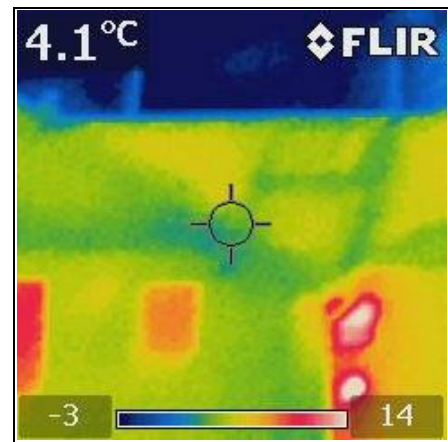
Thermal imaging photo
