# PROPERTY REPORT

**A Georgian Commercial Property, Westminster,  
London W2**

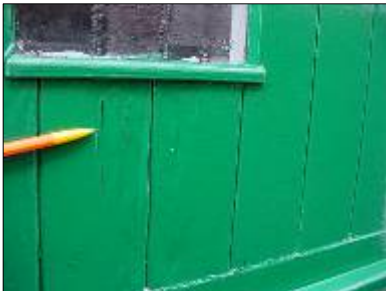
We utilise photographs and sketches to illustrate issues or features. In some photographs a pencil has been used to highlight a specific area.

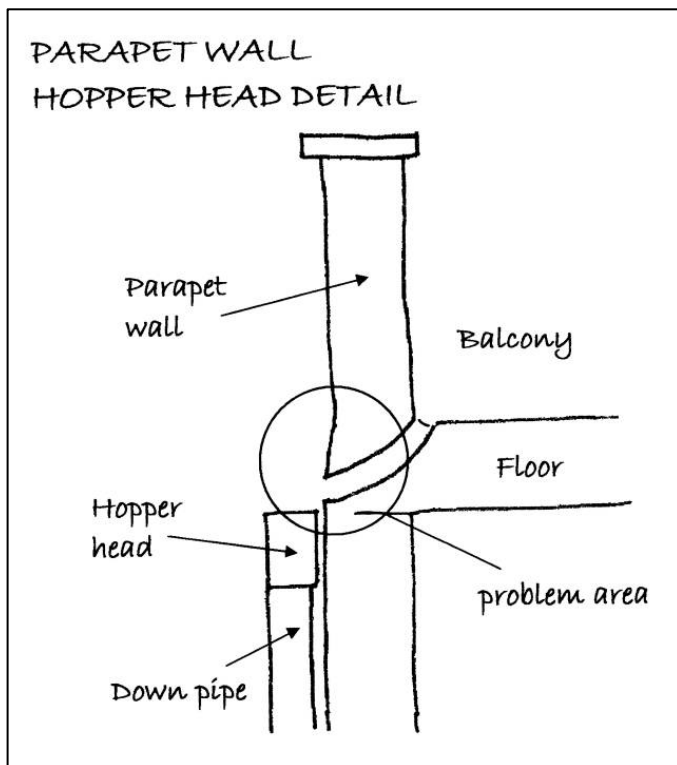
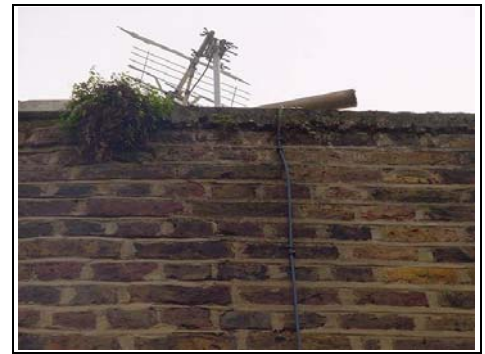
Plants growing out of parapet wall on next door's property

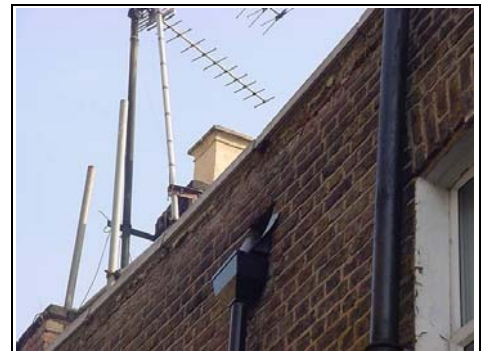
Spalling underneath the parapet capping stone

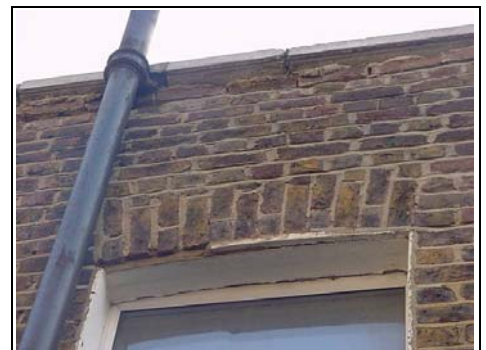
Close up of parapet wall showing repointing and some spalling to the brickwork at the top

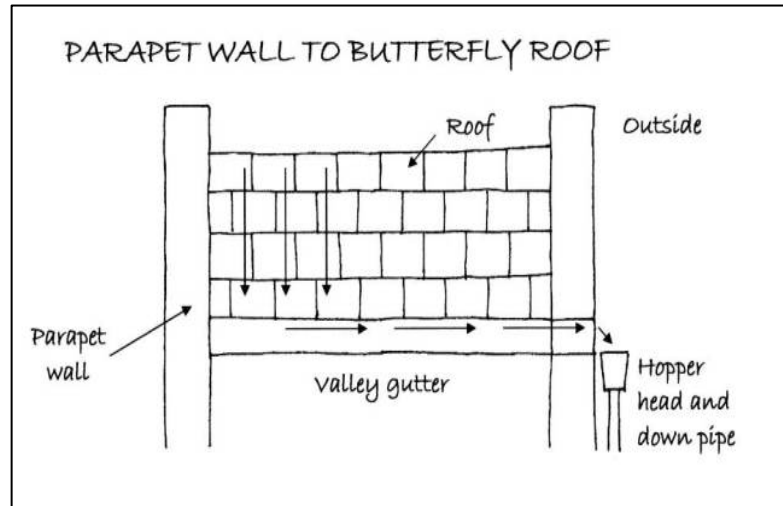
**ACTION REQUIRED:** The condition of the roof needs to be confirmed with the owner.

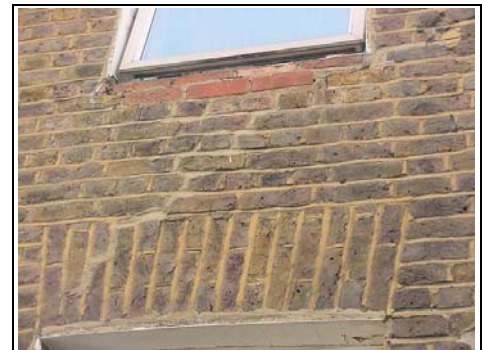
**ACTION REQUIRED:** Your legal adviser needs to ensure that the present owners confirm and accept that there is movement within the property and are happy to return the property in this condition and/or are prepared to make a claim under their insurance policy for monitoring and repairs to be carried out.

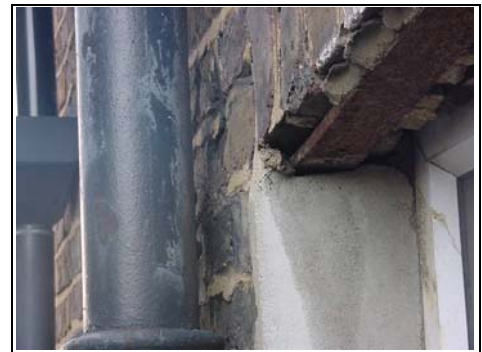
Repairs to one of the windows due to movement

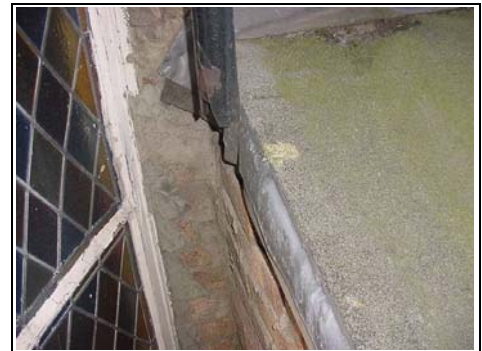
We can see a mass of pipes to the rear of the property

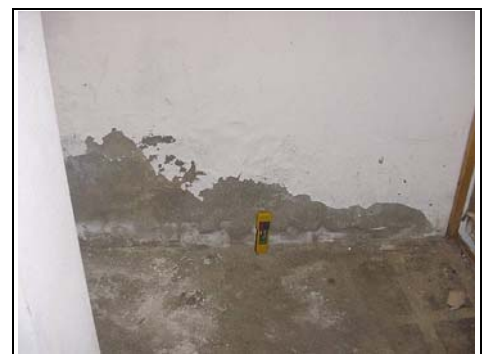
Testing for rising damp

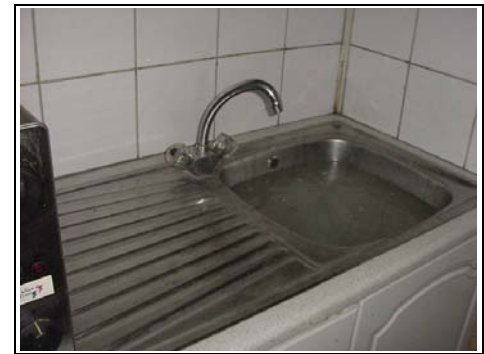
As part of our tests we ran the taps in the basement and the sink was blocked and this was not running away. We lifted the front of the two manholes (the other one was cemented down) and there was no water running through this, so we were mystified so we were unable to establish where the drains from the WC or the sink go.

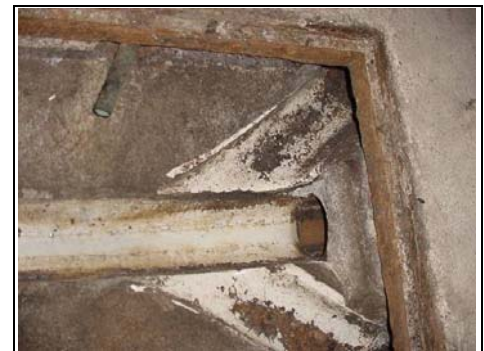
**ANTICIPATED COST:** This should be carried out by the existing Leaseholder.

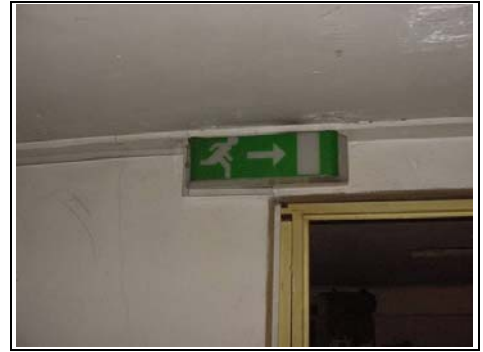
**ACTION REQUIRED:** The existing Lessee to provide appropriate documentation and to bring the property up to the appropriate standards.

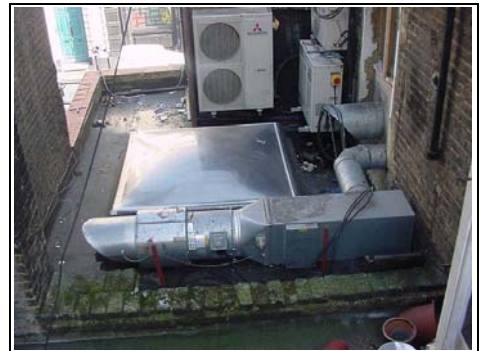
2. Disability Discrimination Act

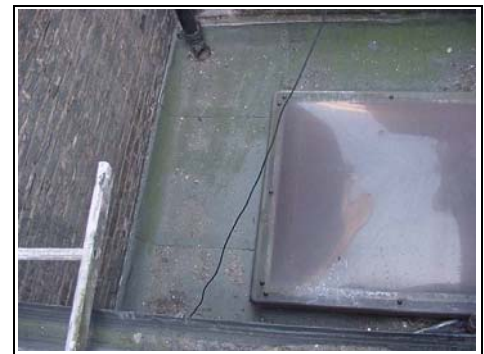
Skylight and discharging downpipe

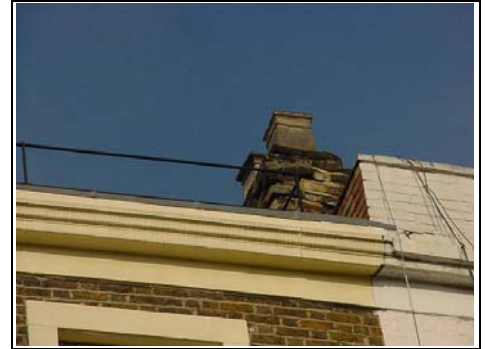
It was very difficult to view the chimney stacks to the main building properly. What we could see of the right hand chimney looked to require re-pointing. We expect to also find this to the left hand chimney to the rear. There are two chimneys which are in reasonable condition, although there is a crack to the flaunchings.

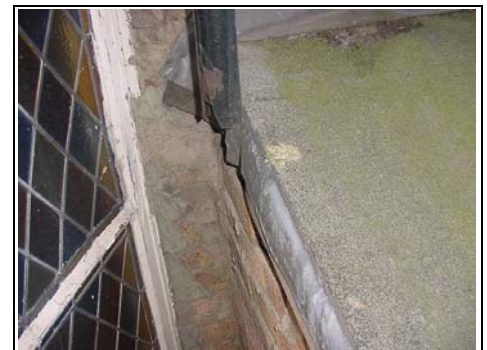
We can see a mass of pipes to the rear of the property

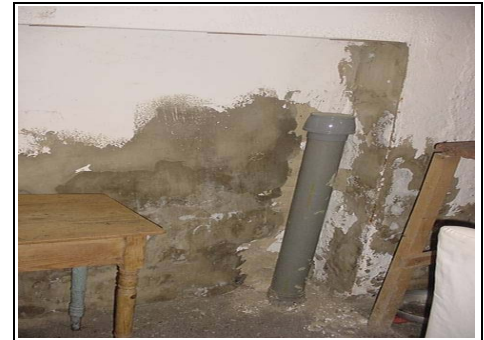
The soil and vent pipe is on the right hand side

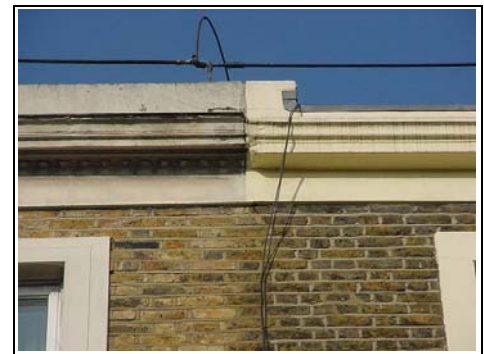
Brickwork to the front of the property built in a yellow London stock brick

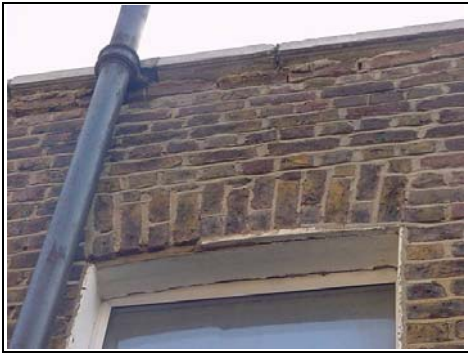
Repointing and deterioration above the window onto the parapet walls brickwork and associated pointing

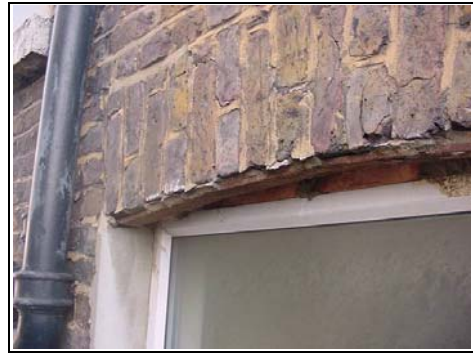
This photo shows lintel repairs in the form of a metal plate lintel

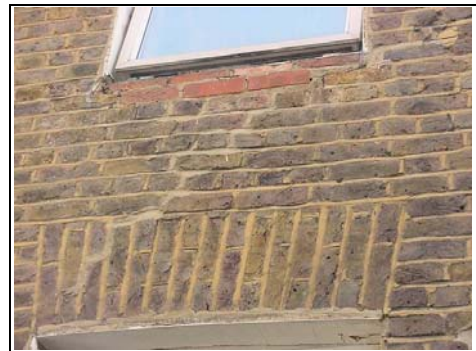
There is cracking over some of the windows to the rear, where we can also see repairs have been carried out and amendments to the window. In the adjoining photograph, for example, you can see a diagonal crack and also some red bricks to the base of the window where amendments have been made.

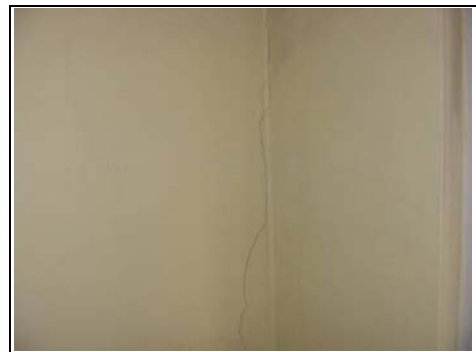
Hairline cracking internally

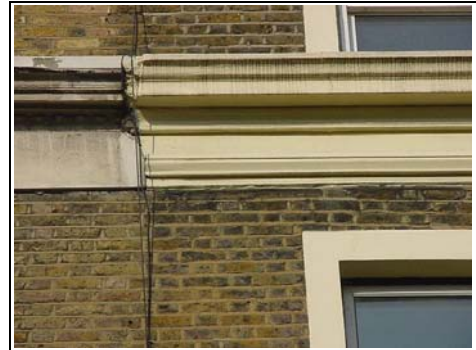
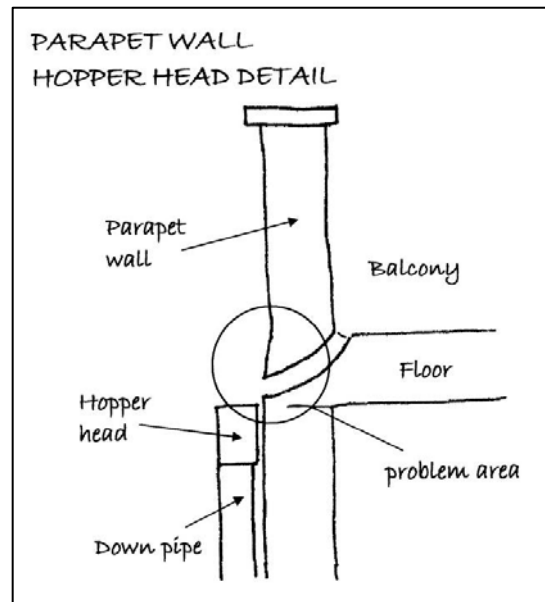
### Windows and Doors

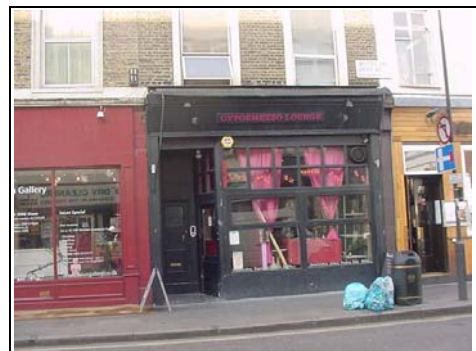
Regarding the windows to the property without seeing the Lease we cannot comment on your repair and liability associated with these. Your legal advisers should confirm.

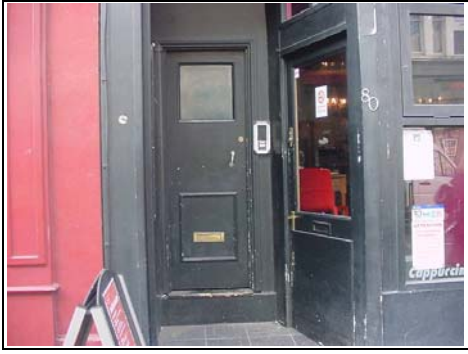
Entrance door with general marks

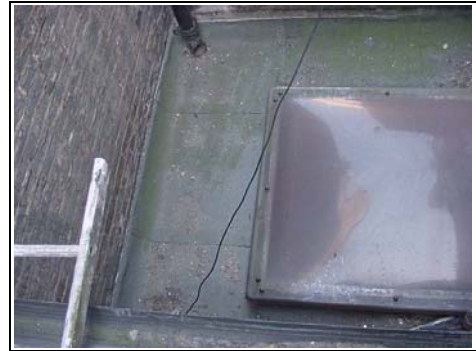
Roof lights have a life of approximately ten years

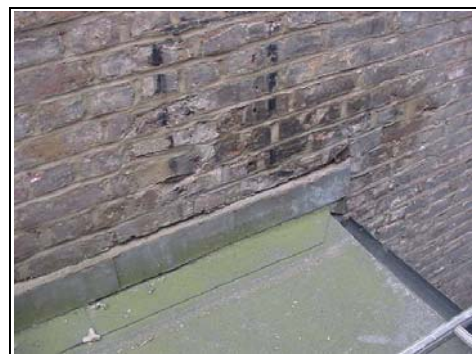
Metal flashing aprons benefit from repointing

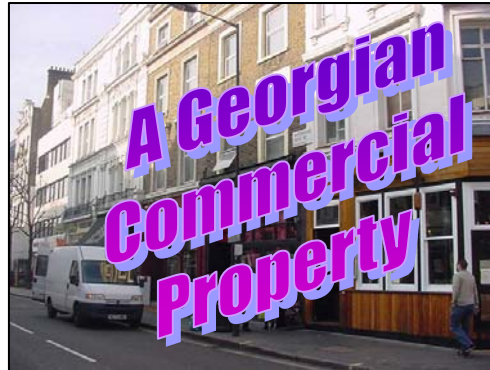
DESCRIPTION	CONDITION	ACTION REQUIRED
<p><b>Chimneys:</b></p> <p>Right hand side brick chimney visible only.</p>	<p>Limited view</p>	<p>Close inspection needed or owner to advise on condition and works required.</p>
<p><b>Roof:</b></p> <p>There is usually a pitched roof behind the parapet wall on this style of property. To the rear there are flat roofs.</p>	<p>No viewing possible.</p>	<p>We can see some deterioration to the parapet walls to the rear of the property, which indicate there are problems to the roof and therefore likely to be problems to front parapet wall also.</p>
<p><b>Gutters and Downpipes:</b></p> <p>Non visible; all to the rear.</p>		
<p><b>Walls:</b></p> <p>Flemish Bond brickwork, finished with some render detailing.</p>	<p>Poor repointed and mortar</p>	<p>Some ad hoc minor repointing.</p>

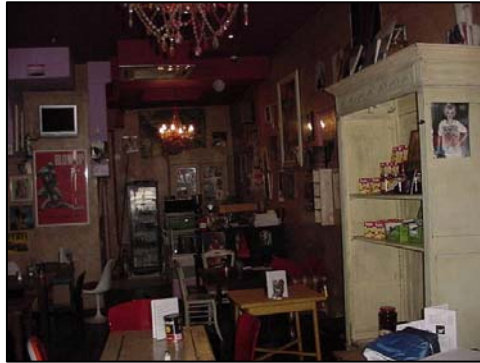
DESCRIPTION	CONDITION	ACTION REQUIRED
<p><b>Ceilings:</b></p> <p>High level painted ceilings</p>

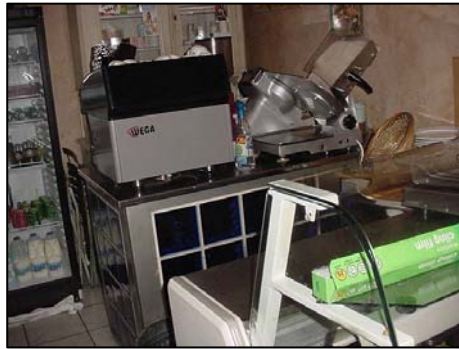
DESCRIPTION	CONDITION	ACTION REQUIRED
<p><b>Ceilings:</b> As trading area</p>		
<p><b>Walls:</b> As trading area</p>

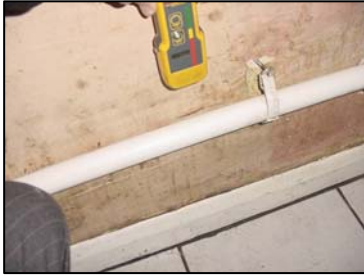
<p>Unfinished plaster</p>

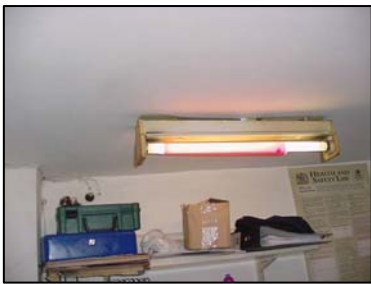
<p>Greasy and dated</p> <p>Missing covers.</p>	<p>Clean and redecorate</p> <p>Replace with appropriate sealed lights.</p>

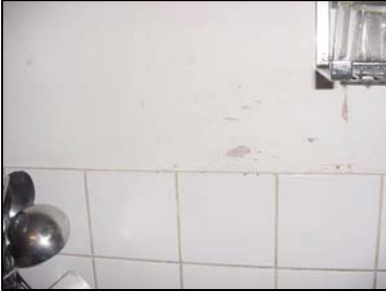
<p>Some marks and some deterioration</p>	<p>Redecorate</p>
<p><b>Floors:</b></p> <p>Floor tiles</p>

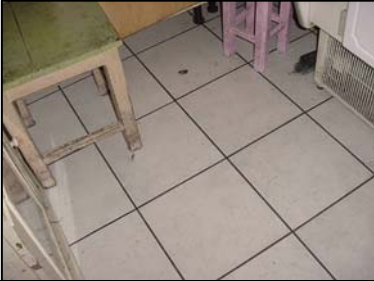
<p>Some marks</p>	<p>Make good.</p>
<p><b>Catering Equipment:</b></p> <p>We have assumed that the catering equipment meets Local Authority approval and is appropriate for use. The catering equipment has not been inspected, as we are not expert in this area.</p>		
<p><b>Services:</b></p> <p>Ductwork.</p> <p>We have not inspected the services, including the ductwork.</p>

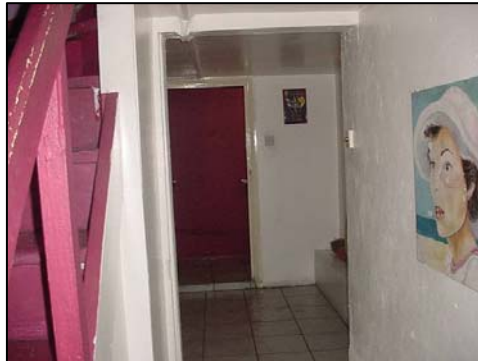
<b>DESCRIPTION</b>	<b>CONDITION</b>	<b>ACTION REQUIRED</b>
<b>Ceilings:</b> Painted	Some marks and dated	Redecorate
<b>Walls:</b> Painted	Some marks and dated	Redecorate
<b>Floors:</b> Floor tiles.		Clean

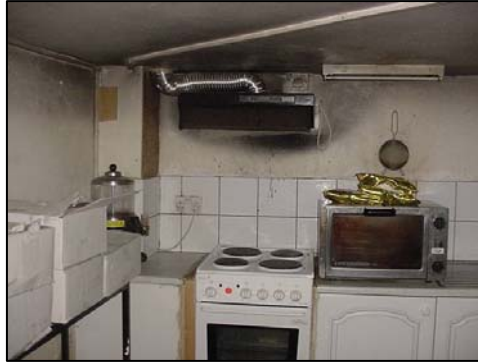
DESCRIPTION	CONDITION	ACTION REQUIRED
<p><b>Ceilings:</b></p> <p>Painted</p>	<p>Aged and stained</p>	<p>Make good and redecorate</p>
<p><b>Walls:</b></p> <p>Partly tiled and partly painted</p>	<p>Aged and stained</p>	<p>Make good and redecorate</p>
<p><b>Floors:</b></p> <p>Unfinished concrete, including an access manhole that we were unable to lift.</p>

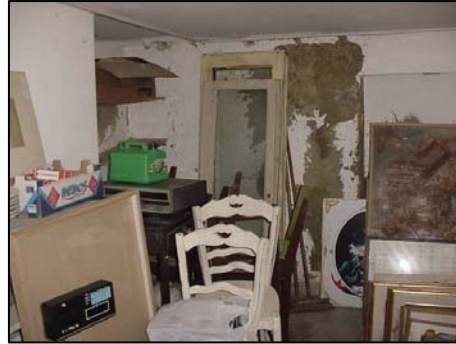
DESCRIPTION	CONDITION	ACTION REQUIRED
<p><b>Ceilings:</b></p> <p>Painted</p>	<p>Some marks.</p>	<p>Redecorate.</p>
<p><b>Walls:</b></p>

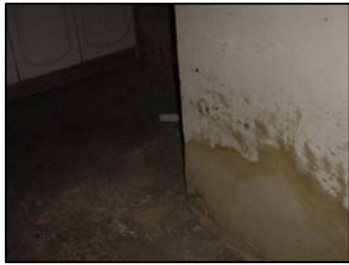
<p>Some marks, rising damp and lateral damp.</p>	<p>Redecorate and resolve damp issues.</p>
<p><b>Floors:</b></p> <p>Unfinished concrete</p>	<p>Rising damp</p>	<p>Resolve dampness</p>

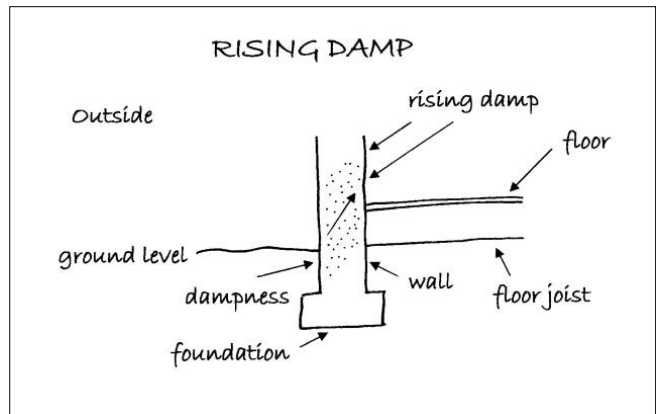
A random visual inspection and tests with a moisture meter have been taken to the perimeter walls and some internal walls.

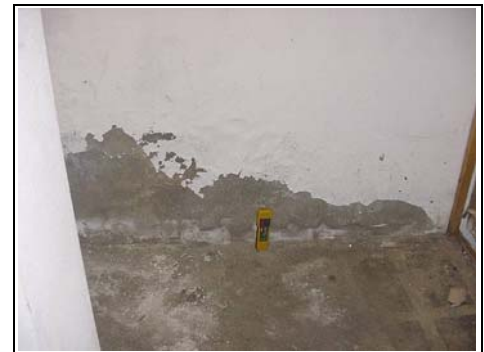
**ACTION REQUIRED:** Please see Property Report.

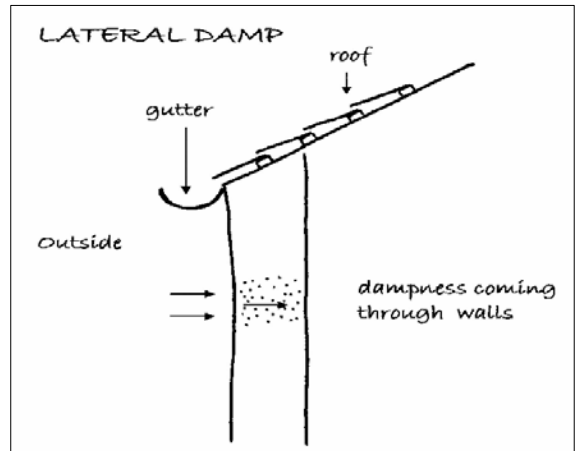
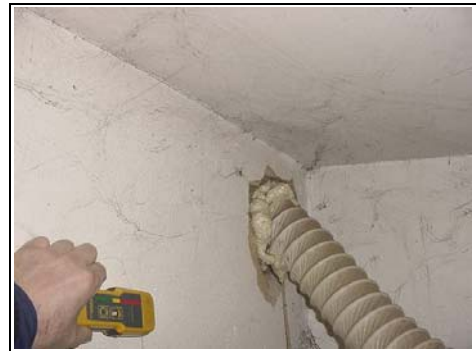
Finally, effective testing was prevented in areas concealed by heavy furniture, fixtures such as kitchen fittings with backboards, wall tiles and wall panelling. We have not carried out tests to BRE Digest 245, but only carried out a visual inspection.
