JOB REFERENCE: PR6/MH/MB

PROPERTY REPORT

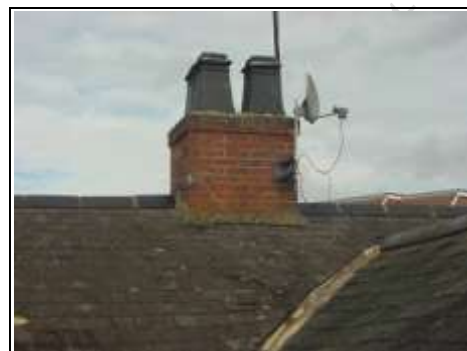
Cement flashings on middle chimney, replace with lead

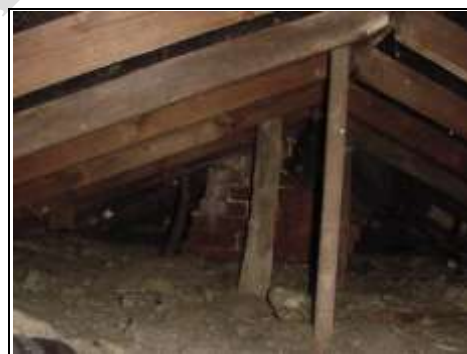
Dampness visible to central chimney

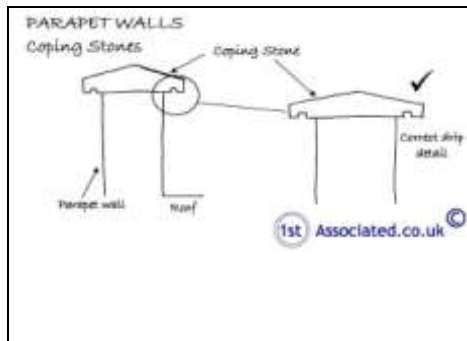
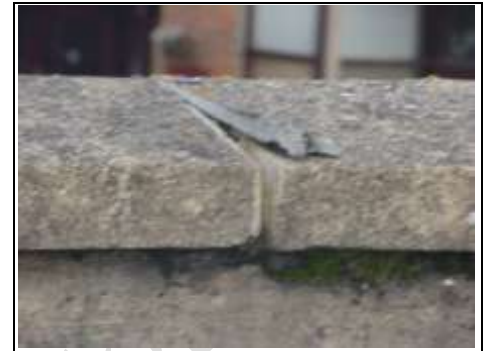
Part of parapet wall coping stones have been masticed in place due to leaks

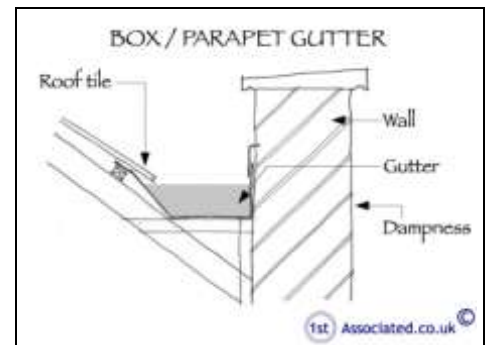
Problematic box gutter to the front of the property

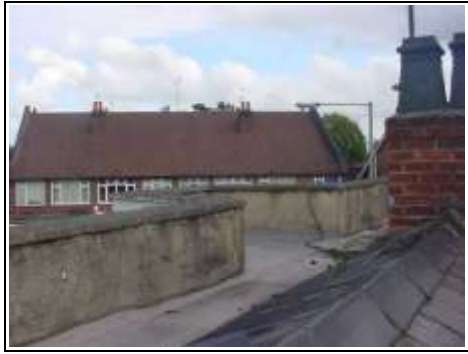
General view of front box gutter

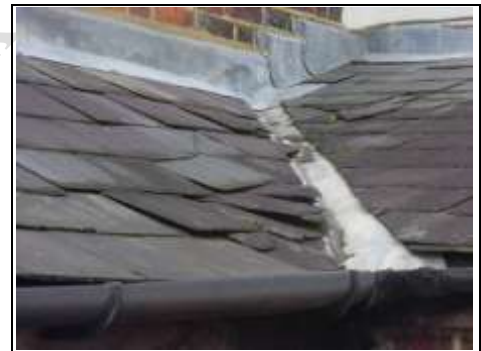
Slates in mess to high level roof

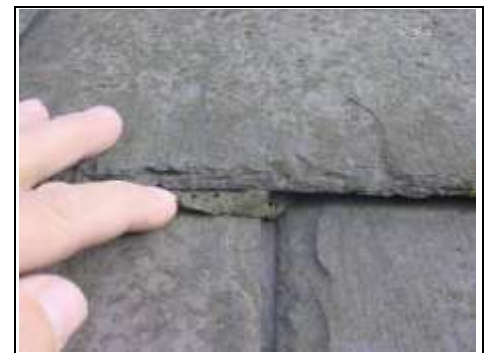
Turnerised/masticed repairs

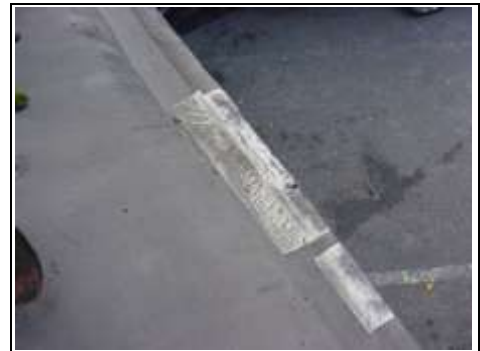
Flashband repair to asphalt roof

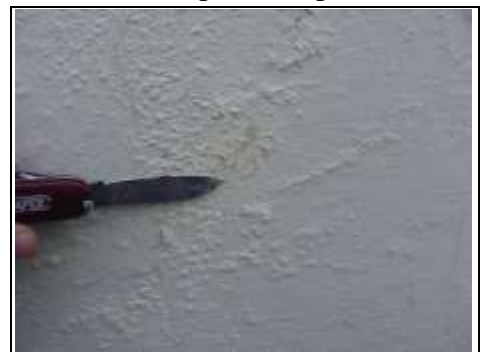
Deteriorating render through dampness

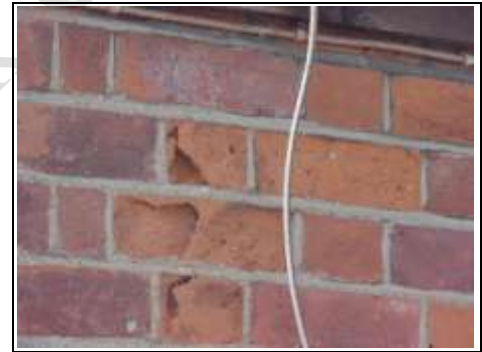
Wrongly repointed in cement mortar

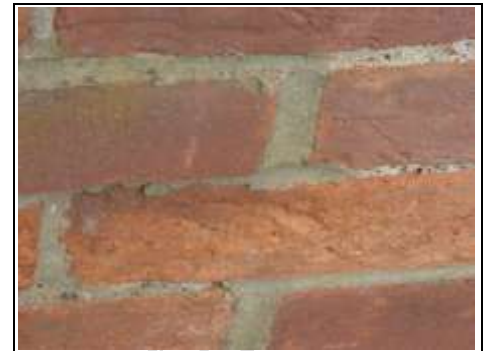
Spalling bricks due to re-pointing in cement mortar

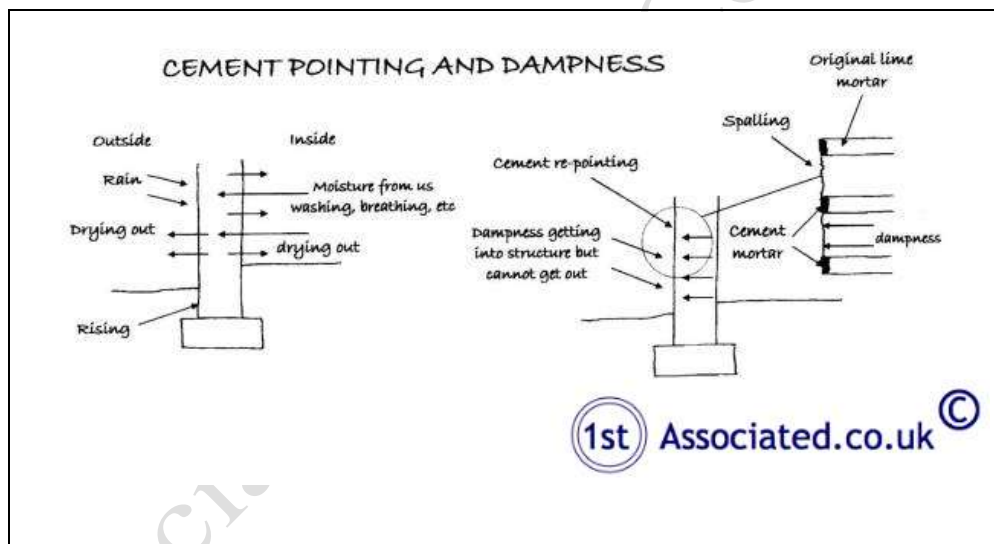
ACTION REQUIRED: Repoint in a lime mortar.

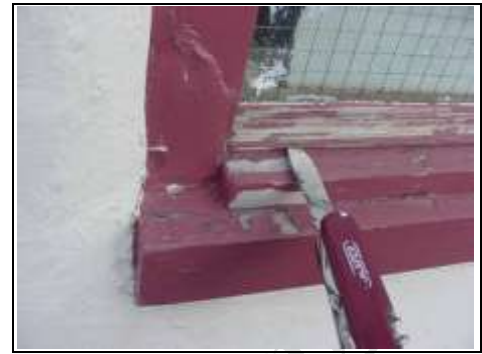
Bare timber visible and some rot to windows

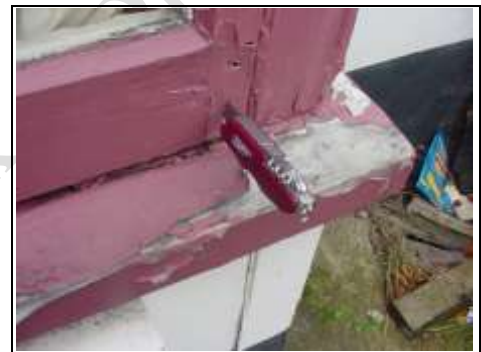
Rot to the window allowed us to push the knife blade completely into the timber frame

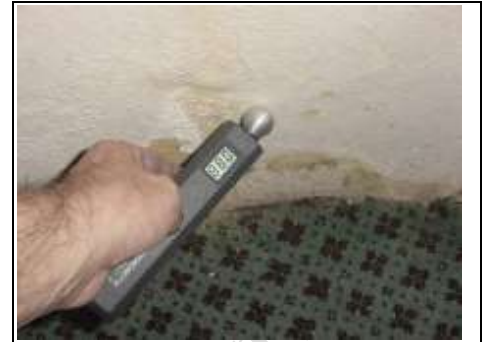
Please see the Dampness Section of this Report.

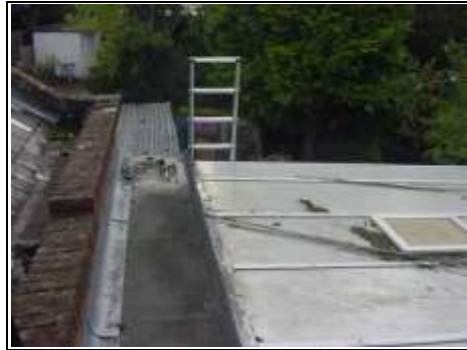
There is a plastic polycarbonate roof over the conservatory and to the rear over the smokers area there is also another plastic corrugated roof. We would add that we believe the polycarbonate roof over the conservatory is leaking due to the displacement of some of the panels and we would comment that a corrugated plastic roof is not an ideal roof for a smoker's area.

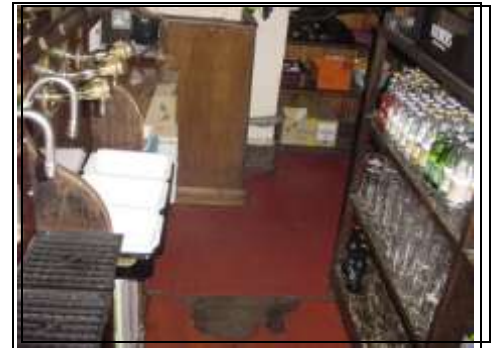
Worn altro style floor in bar

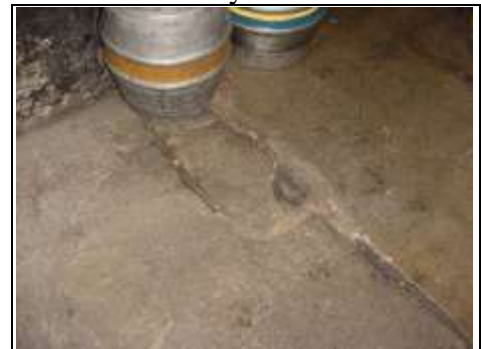
Cracked and uneven floor to cellar

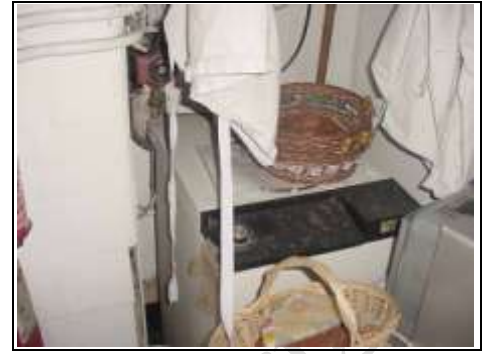
There is a very dated Potterton floor mounted boiler. We would say it is past its sell by date and you should budget to replace. We also noted that the radiator system throughout the property was on micro bore pipes which we tend to find that these are not particularly efficient and tend to block which is particularly important where you have a damp property such as this.

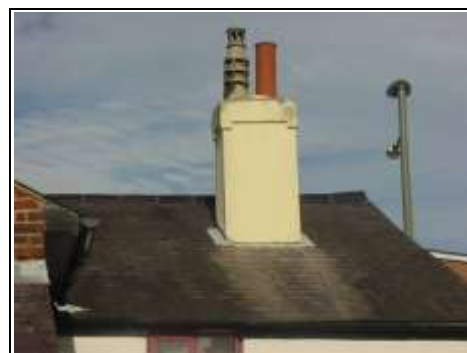
This chimney is painted white render with a cut lead flashing with one flue and one chimney pot. From what we could see from ground level it looked in average condition considering its age, type and style. We were unable to see the flashing fully, we therefore cannot comment upon them. Within the roof, unfortunately we were unable to see this chimney properly so we are unable to advise whether dampness is getting in.

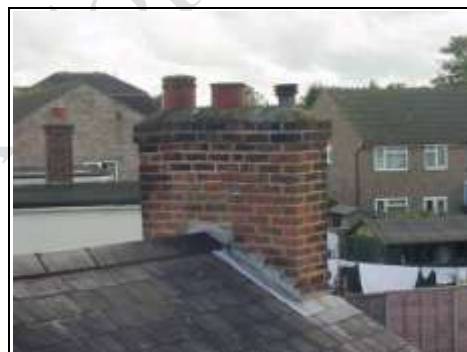
Chimney three located to rear

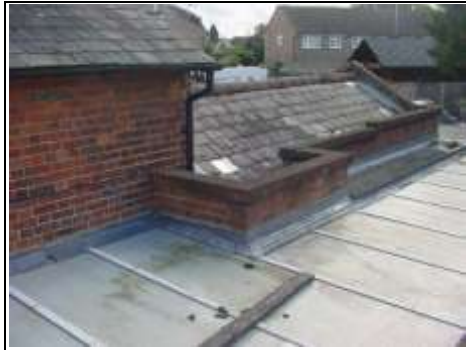
Rear roof parapet wall

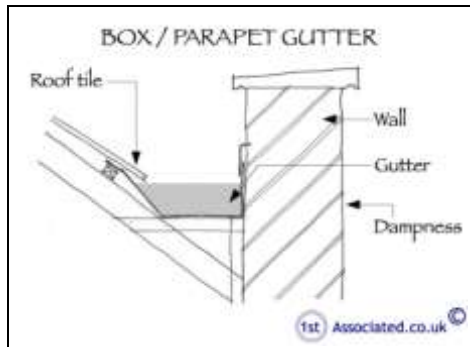
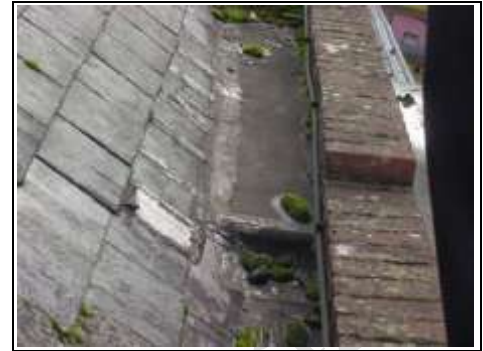
Moss on box gutter indicates it hasn't got a fall on it. Also note flashband repairs to the slate roof at the junction of the slate and asphalt

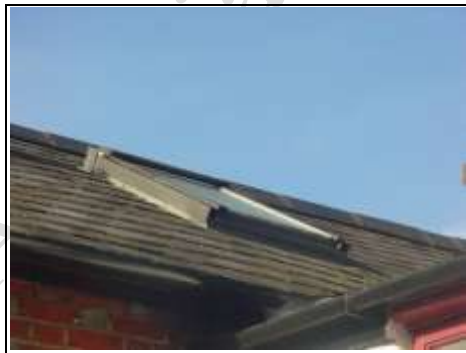
The property has a purpose made roof light, which looked in reasonable condition. We would recommend that you check its condition when carrying out work to the main roof.

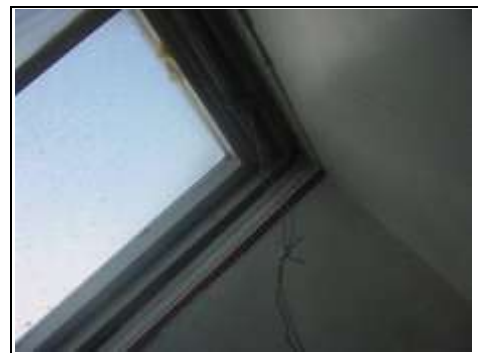
Internal view of roof window

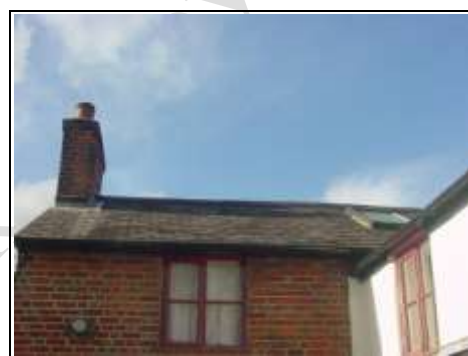
ACTION REQUIRED: Please see our comments in the Executive Summary. We recommend the roof is replaced.

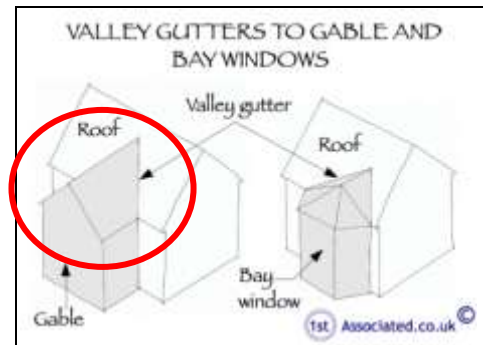
Low level slate roofs

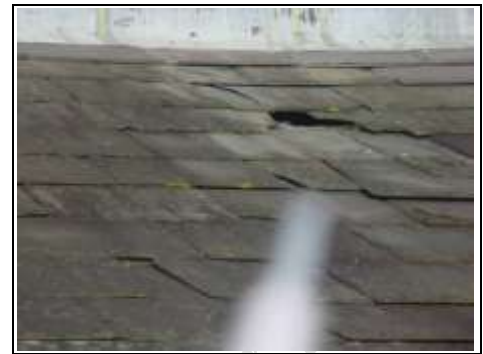
Slates completely displaced.

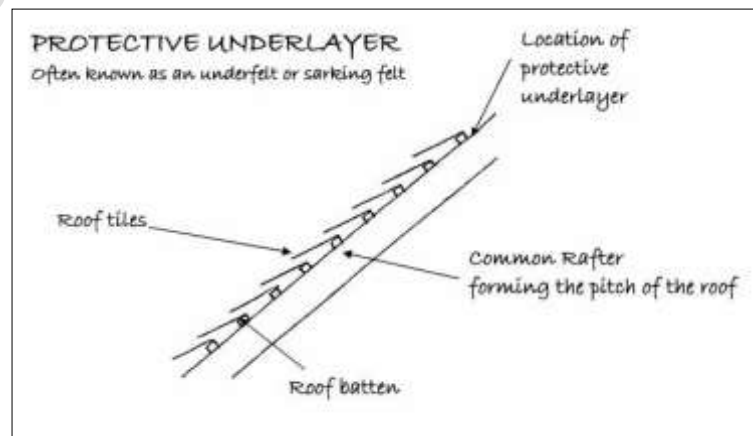
When we inspected the main loft space we found a Hessian base Bitumen membrane. This type of membrane has been used since the 1960s. We generally found it to be in average condition, it is damaged in a few more places than we normally find.

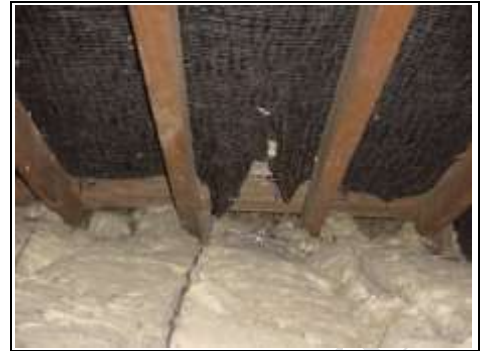
Damage to sarking felt

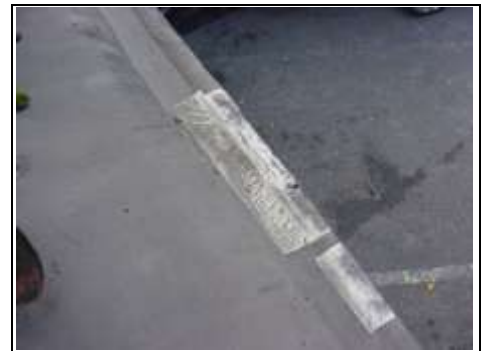
Flashband repair to asphalt roof

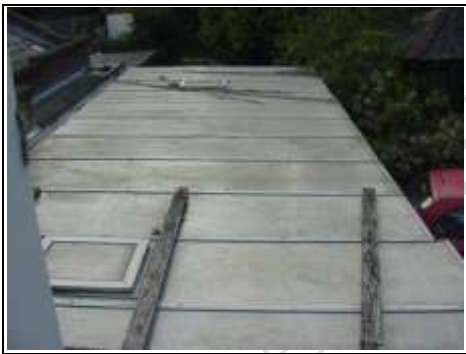
This is a very shallow pitched conservatory roof of polycarbonate. One of the panels is displaced. We normally find that these leak at the joints. We were pleased to see that there were two roof windows in them which can be opened when these areas get too warm. Conservatories generally have heat gain during the summer and heat loss in the winter.

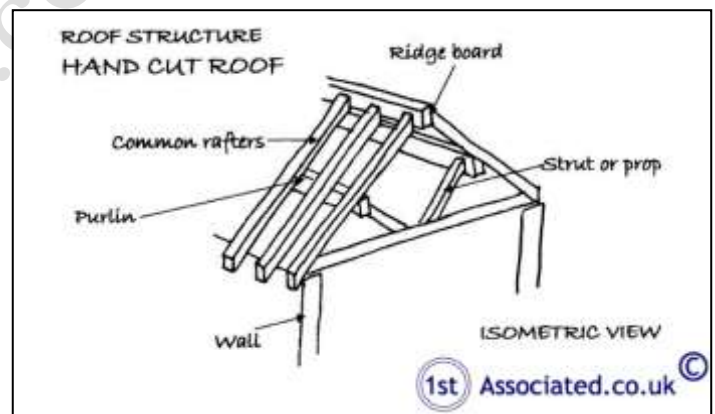
This type of roof structure has what is known as a cut timber roof. This is a roof that is purpose made and hand built on site. Without the original design details we cannot categorically confirm that there are no defects; however it is in line with what we typically see.

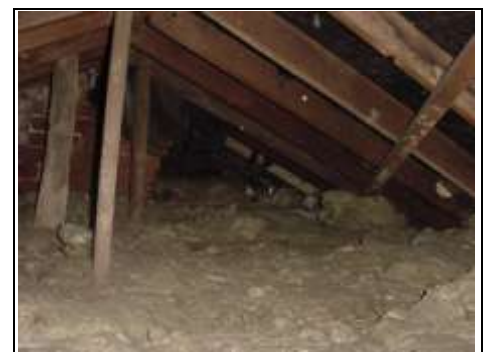
General view of inside of roof

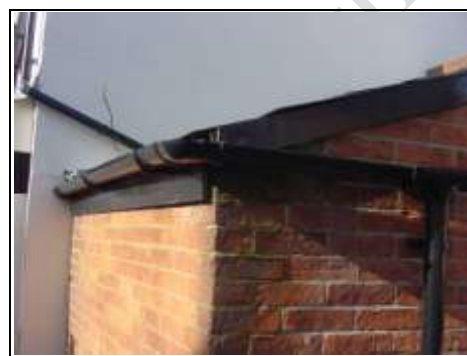
Plastic gutters and downpipes

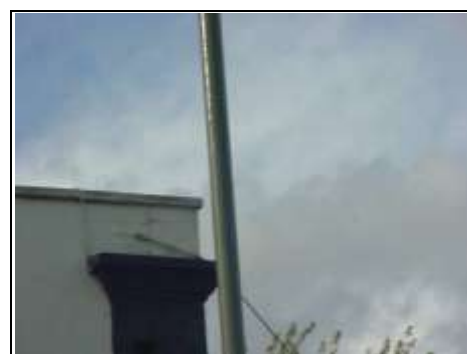
Hopper head to left hand side of property leaking and paint flaking

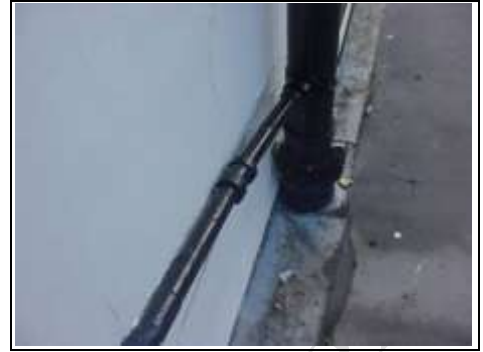
Plastic soil and vent pipe

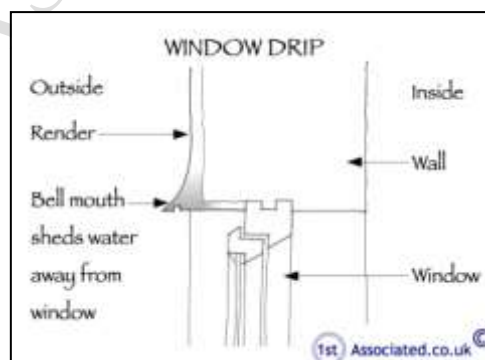
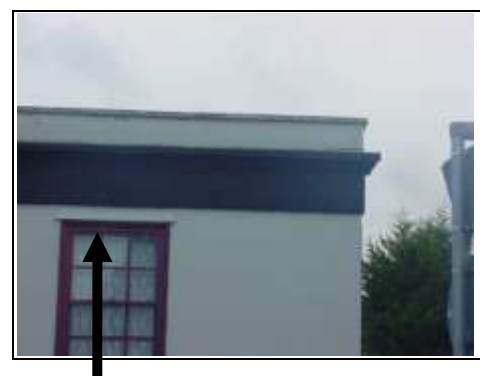
In this case we found drip details to the windows.

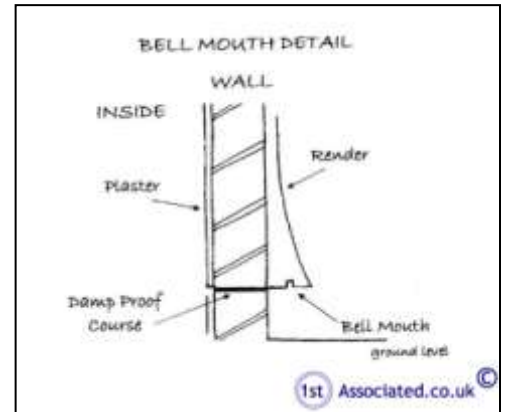
Painted render/painted walls

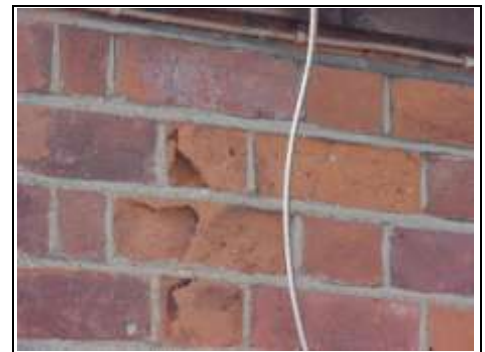
Wrongly repointed in cement mortar

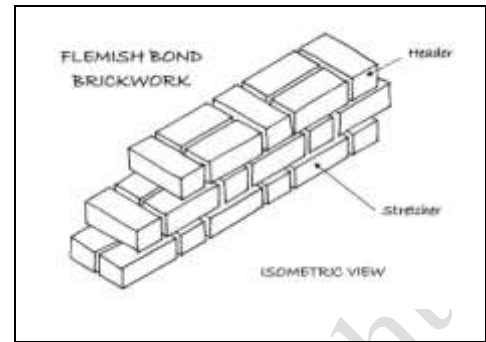
The solid external walls may be liable to penetrating dampness internally, dependent upon their condition and their exposure to the weather. External faces should be kept in good condition.

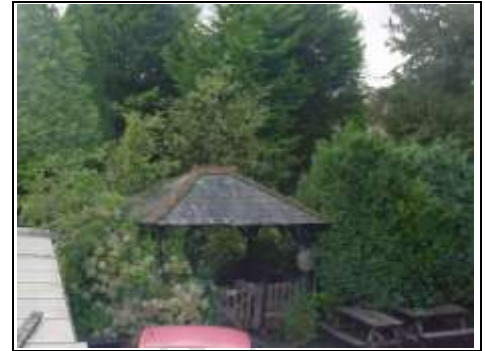
There are trees within what insurance companies would term as influencing distance of the property. You need to check whether there are any tree preservation orders (TPO) on these.

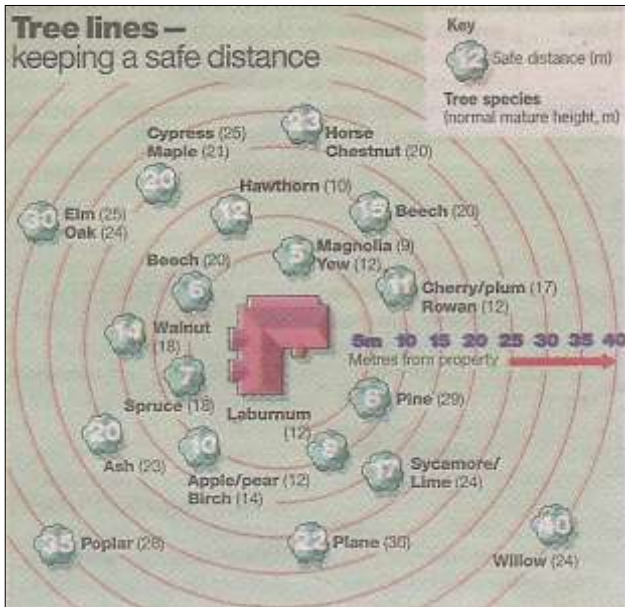
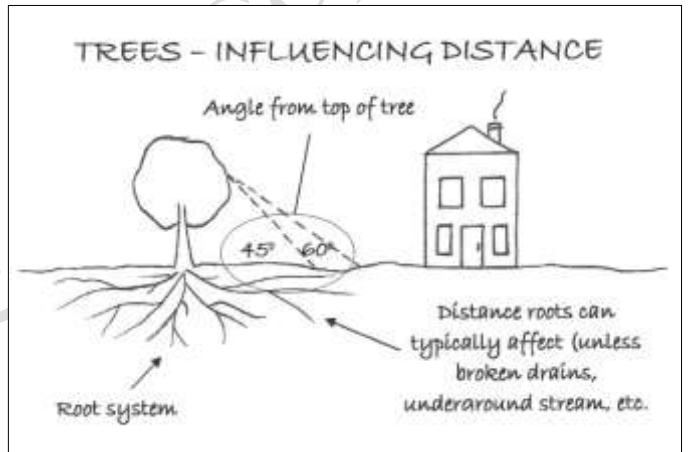
Influencing Distance Defined

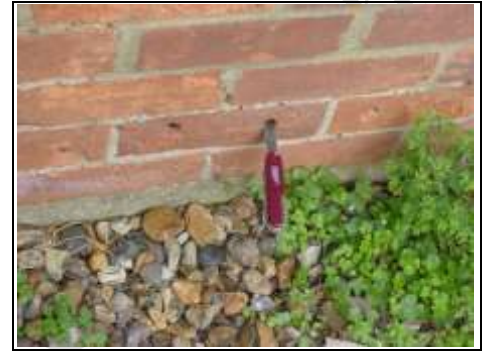
Wrong type of damp proof course inserted for this type of property

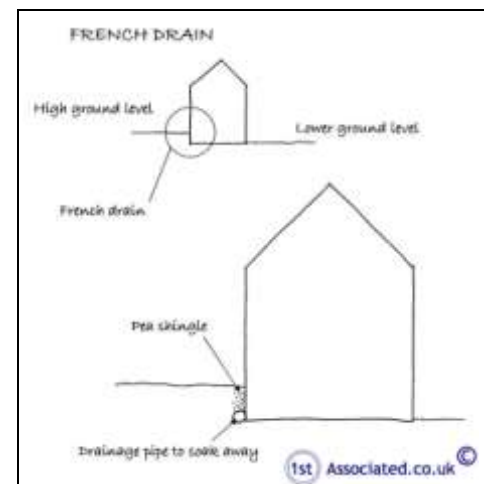
Finally, sometimes it is difficult for us to identify if there is a damp proof course in a property. We have made our best assumptions based upon our general knowledge of the age, type and style of this property.

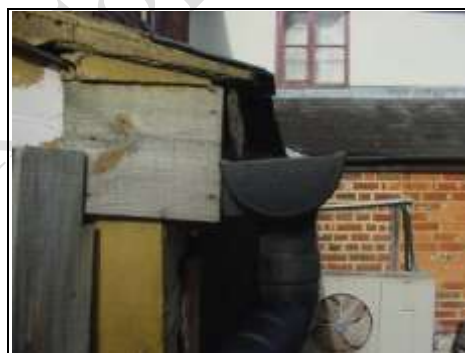
Fascias and soffits not painted at all

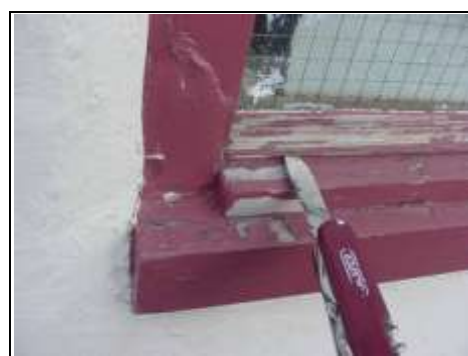
The property has a mixture of sliding sash windows, casement windows, metal windows and double glazed windows. We would specifically comment that there is rot to some of the timber windows and some metal windows are rusting.

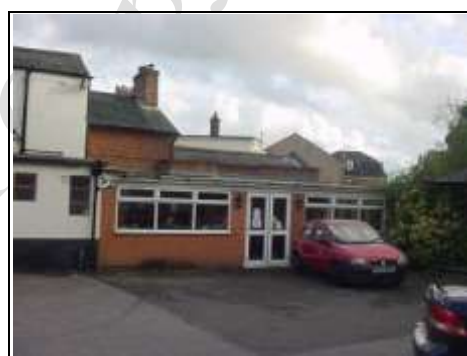
Plastic double glazed windows to conservatory

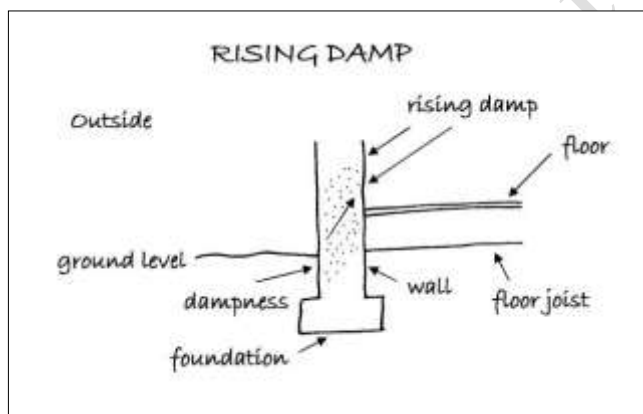
A random visual inspection and tests with a moisture meter have been taken to the perimeter walls. In this particular case we have found rising damp throughout the property.

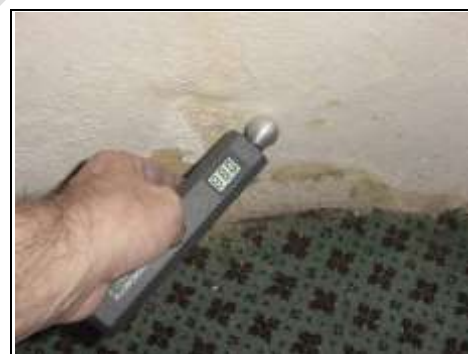
Testing for rising damp in bay window of bar

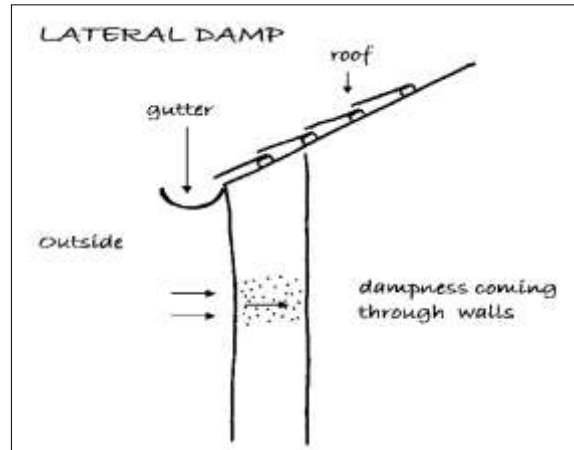
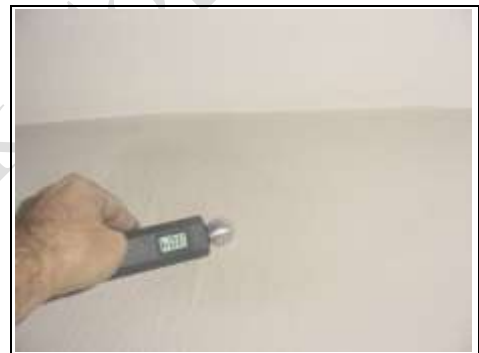
Testing for lateral dampness within rear right hand bedroom

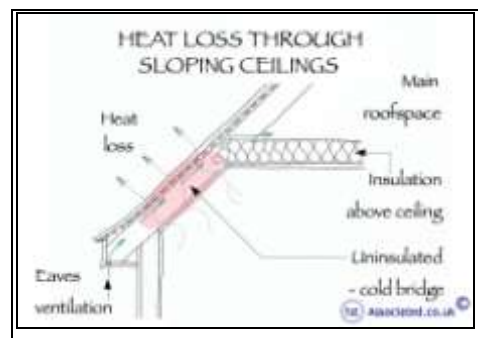
ACTION REQUIRED: We would recommend that large extract fans with humidity controls are added to the bathroom and kitchen areas.

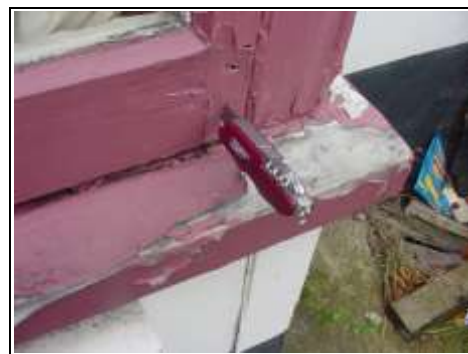
We would advise that we have not opened up the floors and we had a limited view of the roof.
