# PROPERTY REPORT

**XXXX**  
**City of London,**  
**EC3V XXX**

We have been instructed to inspect and prepare a Report and Schedule of Condition for XXXX, City of London, EC3V XXX. We inspected the property on XXXX

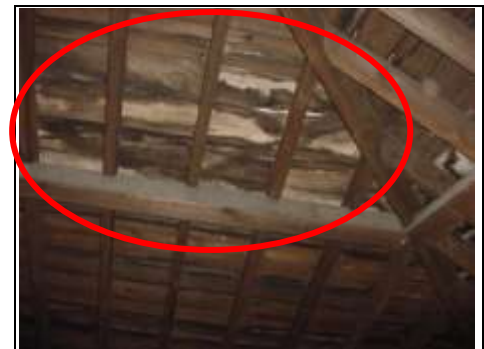
We have had no access to view the roof coverings; however we have had a view of the underside of the roof from within the roof space. From within the roof space we can see the underside of the roof is close boarded and has many areas of dampness coming in which looks to have been a long term problem.

Dampness coming through close boarding

**ACTION REQUIRED:** We would recommend a joint inspection of the roofs externally or the roofs are completely excluded from the Lease.

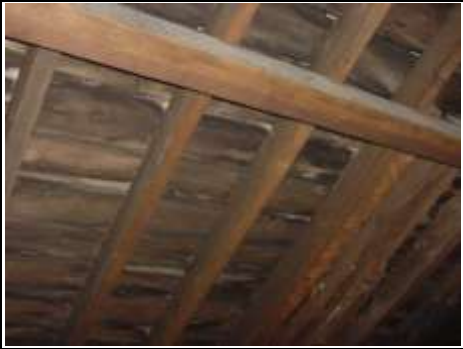
We can also see one area to the centre of the roof where a polythene sheet has been laid down, presumably to stop dampness getting through to the store room below.

Dampness coming through the roof

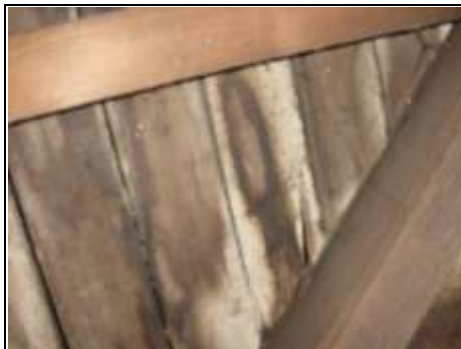
Signs of dampness to boarding

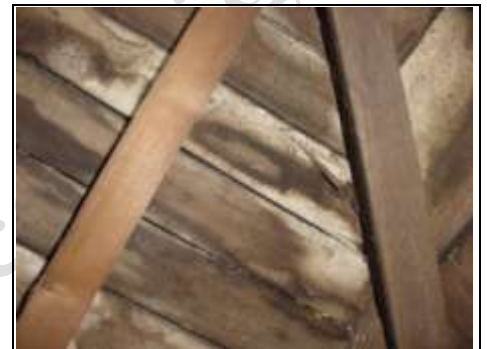
Dampness to boarding

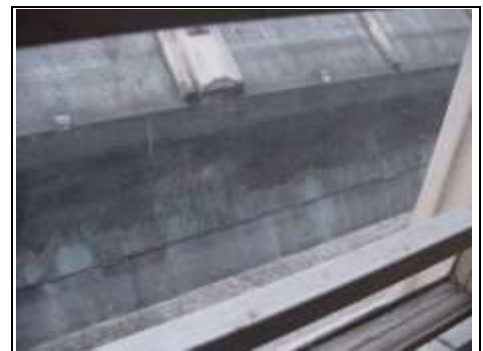
We can see through the windows at second floor level that there are lead lined box gutters. Unfortunately box gutters are renowned for leaking. We were unable to closely inspect the box gutters as the windows had been screwed shut which we assume is for security purposes.

Lead gutter

**ACTION REQUIRED:** A joint inspection to be carried out of the lead guttering. We suspect the guttering is leaking.

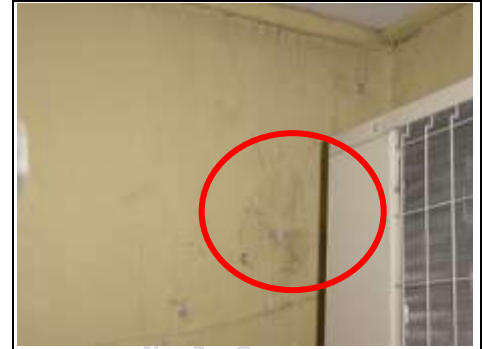
Dampness is visible to the plant room to the front elevation of the top floor, particularly to the right hand side which may relate to the roof. We do not have a view of this section of the building (the windows have been screwed shut therefore there is no access onto the roof as far as we could see).

Dampness in plant room

In our experience this damp area will only become worse in time.

**ACTION REQUIRED:** A joint inspection with the landlord's surveyor to confirm condition and remedial action.

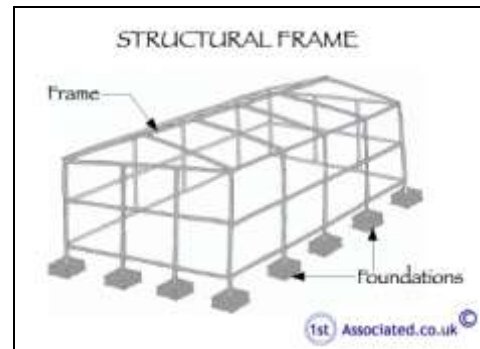
Dampness is causing the structural frame on the ground floor to rust. We can see there have been additional steels added in the basement.

Structural frame

**ACTION REQUIRED:** We believe that this structure may require additional support over the term of the lease. You need to exclude the structural frame from the lease and/or receive information from the landlord with regard to the additional steelwork that has been added to the property.

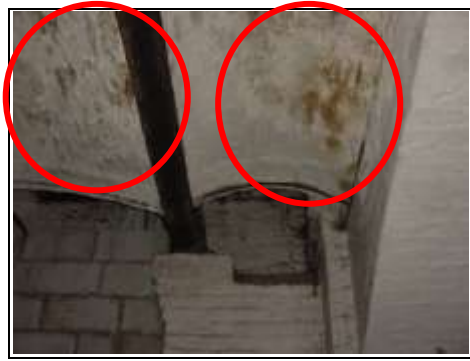
Dampness to  
Vaulted brickwork coming  
through from ground floor

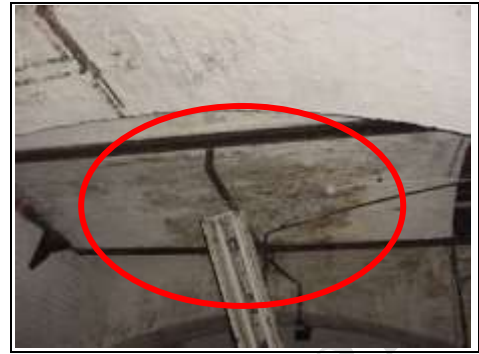
Dampness within basement  
causing rust to cast iron

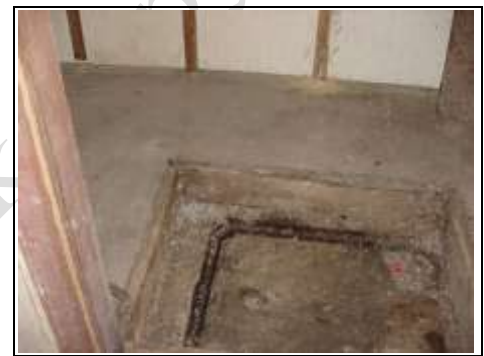
The basement looks to have been partially flooded, possibly by sewerage.

Drain within basement

The drains did look to have overflowed but this could be years old.

**ACTION REQUIRED:**  
Responsibility needs to be established with regard to the drains and access requirements. We recommend you speak to the existing occupiers to check and confirm the frequency of access required with regard to the drains.

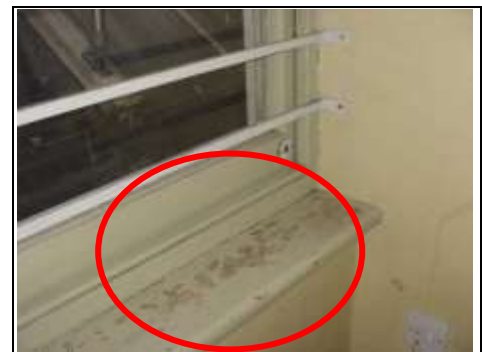
There is a considerable amount of joinery work internally that requires redecoration to the windows. Most leases require a redecoration at the end of the Lease/Yield up clause which has clearly not been carried out.

Window in need of redecoration

**ACTION REQUIRED:** Repair, prepare and redecoration to be carried out by existing lessee's or a sum agreed.

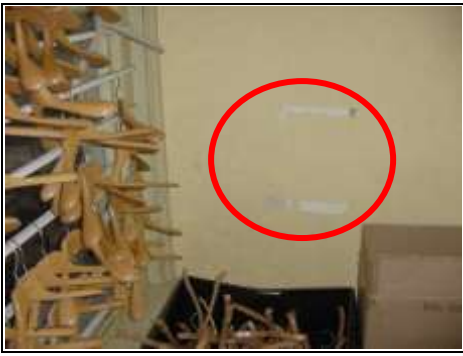
Heavily marked wall in store room

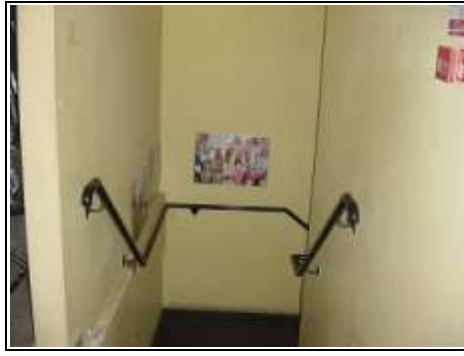
Staff room staircase marked walls and old pictures

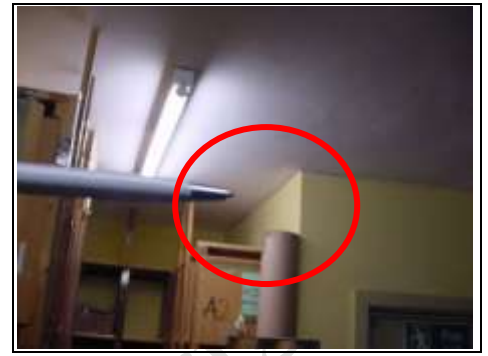
Cracks between studwork partitions and ceilings

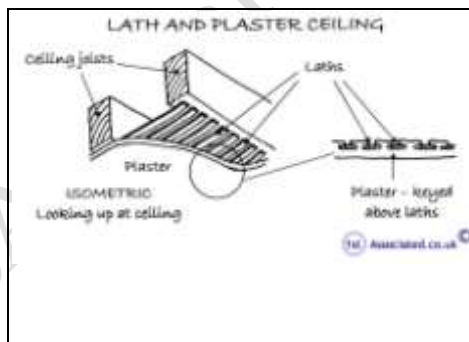
The laths have broken on the lath and plaster ceiling.

Lath and plaster ceiling

**ACTION REQUIRED:** You may need to replace the ceiling during the term of the lease.

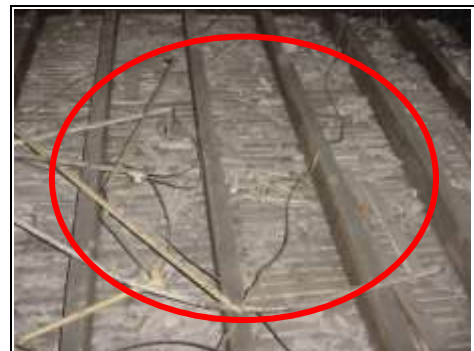
Laths broken
