PROPERTY REPORT

Hockcliffe, Leighton Buzzard,
Bedfordshire. LU7 XXX

We have been asked to inspect and prepare a Report and Schedule of Condition for XXX Hockcliffe, Leighton Buzzard, Bedfordshire. LU7 XXX

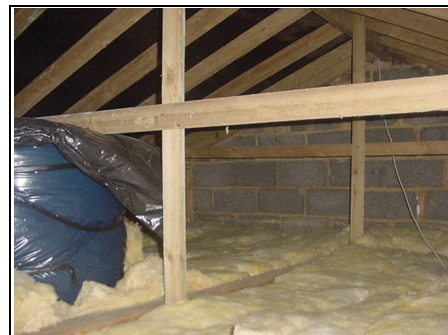
1.0) Main Roof requires venting

There is a mass of insulation in the main roof space with very little ventilation from what we could see and feel. This means that condensation is likely when this property is rented out.

General view of the roof requires ventilation

ACTION REQUIRED: Add ventilation

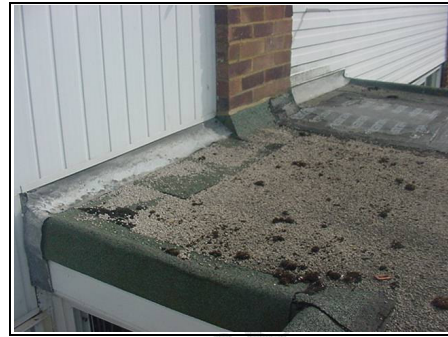
There is a rear felt roof. The felt looks relatively new.

Rear flat roof

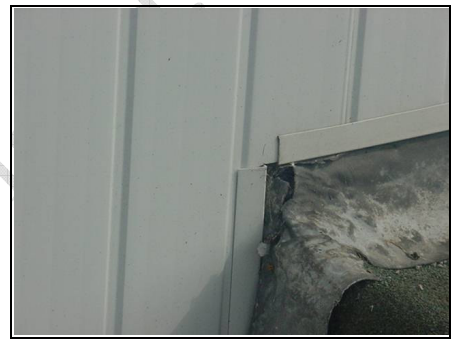
Hole in flashing

ACTION REQUIRED: We would recommend checking the flashing as there looks to be a hole in it.

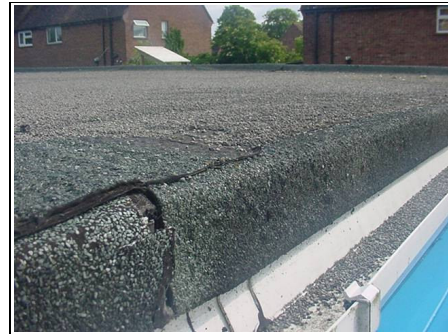
The garage roof looks to be relatively new and were advised this was carried out a few years ago.

Garage roof

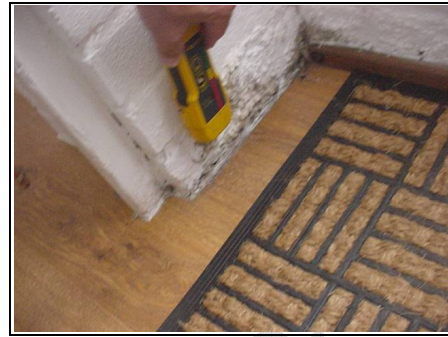
There is rising damp to the rear of the property, originally this was not built as a habitable area. In addition to this we also believe that it attracts condensation from the nearby cooking area.

Dampness to rear of the property

ACTION REQUIRED: Add extract vent to the kitchen to remove any moist air as quickly as possible and possibly an extract fan to the toilet. Modern extract fans can be controlled with a humidity thermostat and thereby switching themselves on when the air gets to a certain humidity which is best when the property is occupied by tenants.

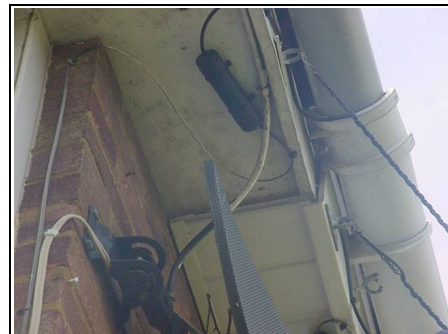
Over cladding has been carried out to the fascias and soffits.

Plastic over cladding to fascias and soffits

ACTION REQUIRED: We would recommend that this is removed and replaced. It is likely that timber beneath is in poor condition.

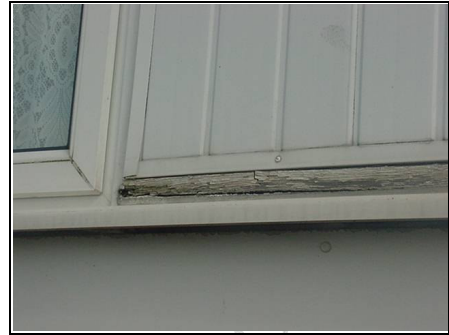
The front and rear walls have plastic cladding, there are some timber elements remaining which need removal and repair.

Plastic over cladding

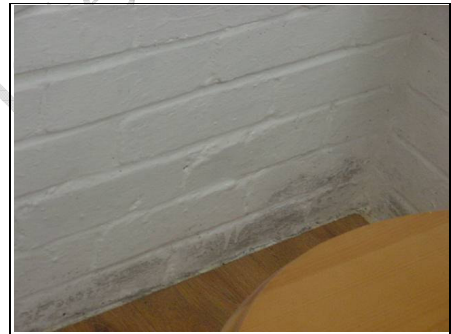
Properties from this era we find are often more prone to condensation than an older property or one with a more modern construction particularly as there are no extract fans available in some of the rooms and there are no trickle vents present to the windows. In addition to this there are cold areas in the building such as the rear WC which will attract dampness.

Mould/condensation to base of wall in WC

ACTION REQUIRED: Add extract fans to the bathroom, kitchen and cloakroom; use a mould resistant paint.

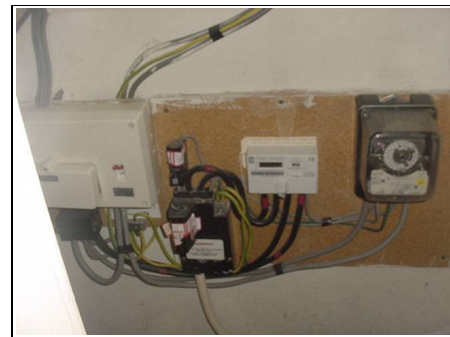
The electrics are dated and in need of renewal.

Dated electrics

ACTION REQUIRED: New fuse board.

ANTICIPATED COST: A few hundred pounds to be installed by NICEIC registered and approved electrical contractor recommended by The Institute of Electrical Engineers (IEE) and to also carry out an inspection, test and report.

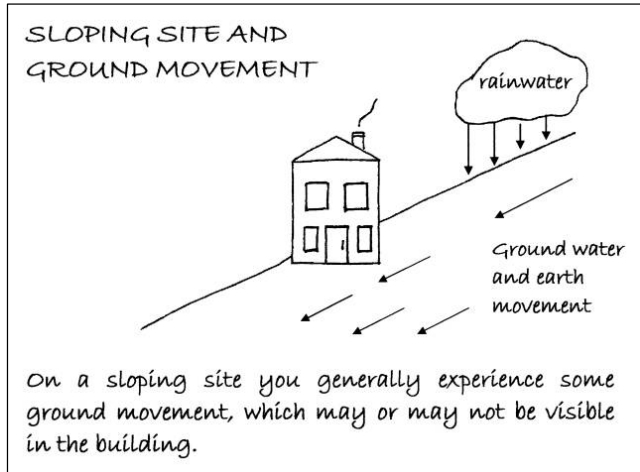
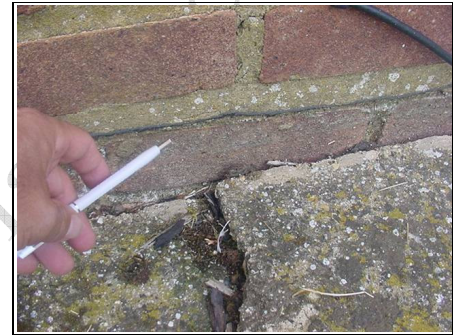
There is a sloping front garden and the damp proof course is a single brick above ground level rather than two bricks. This is more a characteristic of the building than anything else.

Damp proof course too low

ACTION REQUIRED: Wait and see what happens in the winter!
