# PROPERTY REPORT

## Public House in Wandsworth, London SW15

We have been asked to inspect and prepare a Report and Schedule of Condition for a Public House in, Wandsworth, London SW15.

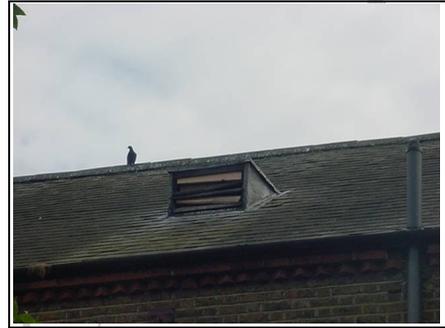
We do not believe that the main slate roof will be watertight for the standard length of lease. In fact, you are currently getting water into the property from, we believe, the box gutters and guttering. There is also infestation of pigeons in the roof which limited our viewing.

Main pitched slate roof

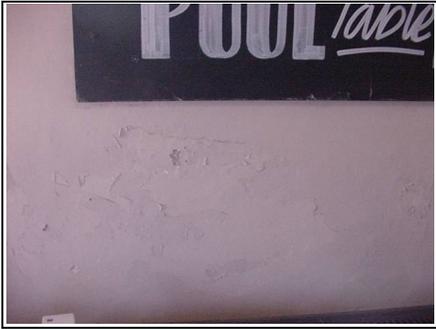
Lateral dampness coming in left hand side wall left side of main bar

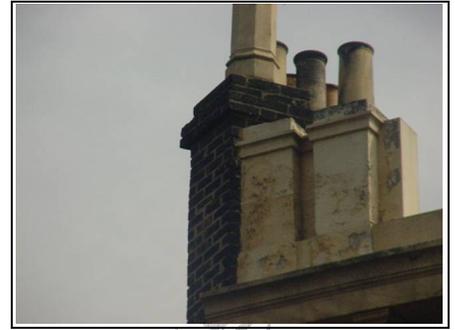
Dampness getting in at high level

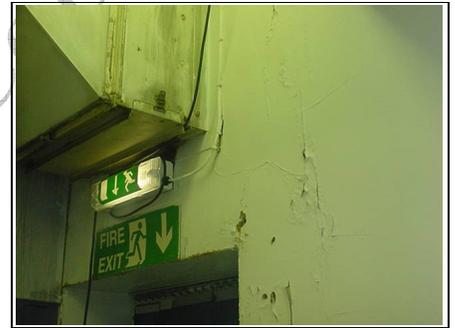
Lateral dampness coming in to kitchen area

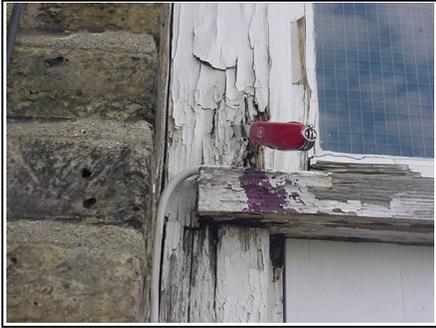
Rotten windows

**ACTION REQUIRED:** We recommend repairing the existing windows if at all possible; we would not recommend replacing them as looks to be good quality original timber. We recommend the addition of draught seals for the existing sash units or good quality secondary glazing (assuming that this does not block an option on a fire exit).

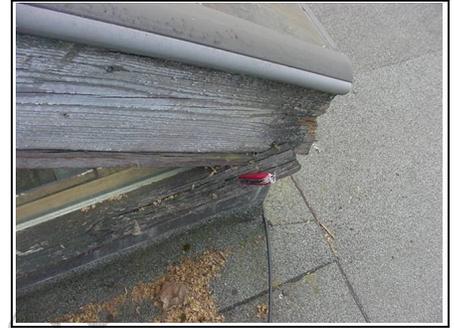
Deteriorating timber to roof window

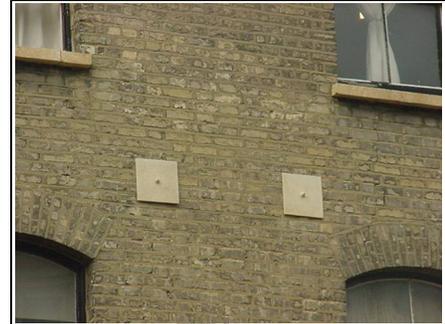
There are areas to the front and rear where tie bars are visible. We can see internally that the joists run from the front to the rear. We assume the joist ends were originally embedded and have got wet rot.

Wall ties

**ACTION REQUIRED:** The floor needs to be opened up in these areas to check the condition of the timber and to see if the tie bars are still working.

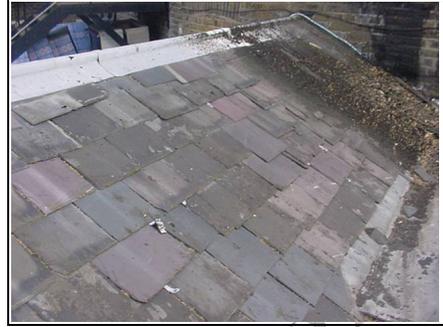
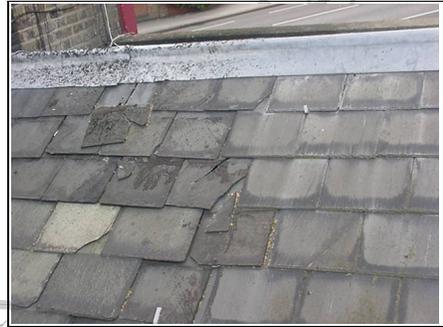
There are missing cracked and broken slates and also some have been repaired with lead tingles, indicating to us that the nail fixings are rusting.

Rear pitched roof

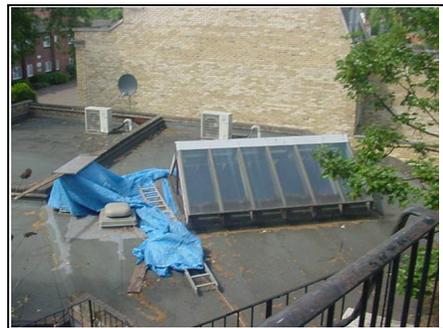
This flat roof has temporary roof repairs in the form of tarpaulin over part of it. There are also other patch repairs and blistering. As far as we can see the flat roof is flat, meaning that water sits on the roof as opposed to going to the outlet.

Rear flat roof

**ACTION REQUIRED:** We recommend an insulation cut to falls to minimise future heating bills (and to be green) and a high performance felt to all flat roof areas, ensuring there are good falls to the downpipes.

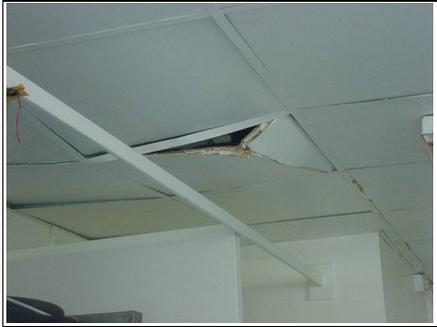
These are generally poor. A deep clean is required throughout (including the dead pigeon that was present at the time of the survey!). There are areas where the ceiling is leaking and it has displaced the suspended ceiling.

Leaking ceiling in kitchen

**ACTION REQUIRED:** Repair ceiling, repair flooring and carry out a deep clean, particularly to the cooking area where there are excessive grease stains.

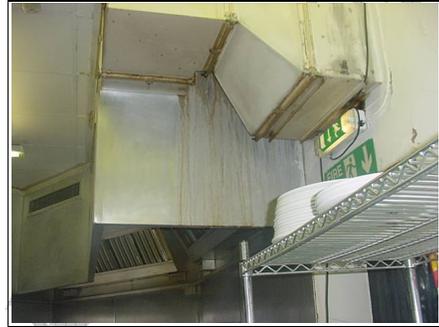
Excessive grease stains

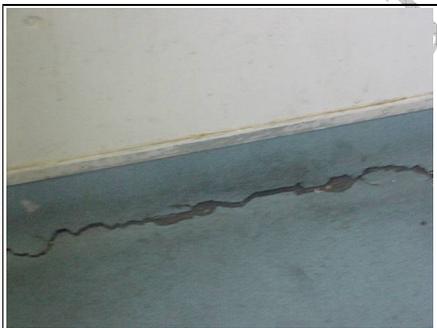
Damaged altro style flooring

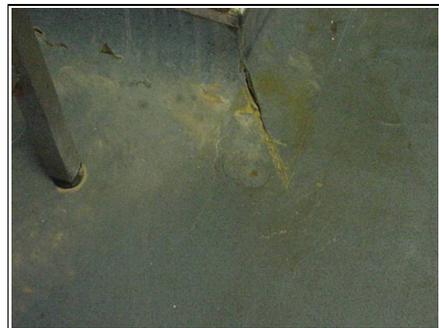
Altro style flooring is worn, marked and breaking up

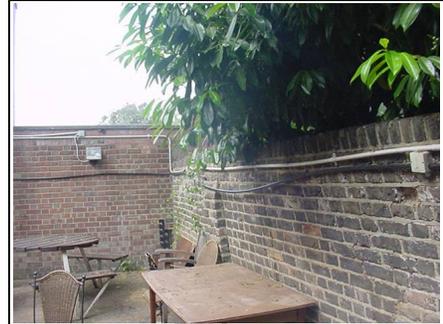
The boundary wall has been pushed over by next door's tree on the far right hand side (all directions given as you face the property).

**ACTION REQUIRED:** We recommend a meeting with the neighbour to come to an agreement with how the trees should be pruned on that side of the property.

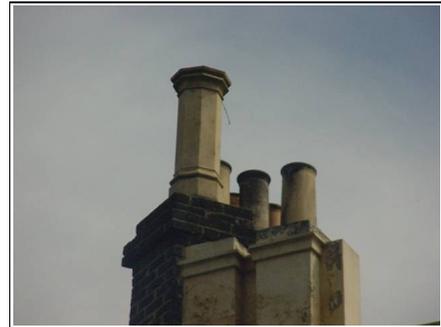
This chimney is brick finished with numerous chimney pots; we were unable to see the flashings. From what we could see the chimney looks in average condition, although we would not at all be surprised if a closer inspection found problems. Unfortunately we were unable to see the top of the chimney known as the flaunchings we therefore cannot comment upon them.

Front left hand chimney

**ACTION REQUIRED:** Given this is next to the parapet wall that is leaking allowing water into the structure and repair work is going to have to be carried out, we would at the same time check the condition of the chimney.

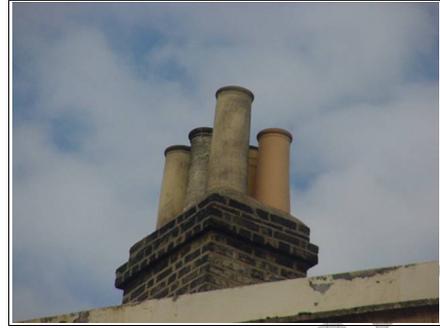
Front middle chimney

**ACTION REQUIRED:** We think it is better to recommend that whilst the roof work is being carried out this chimney has a close up inspection.

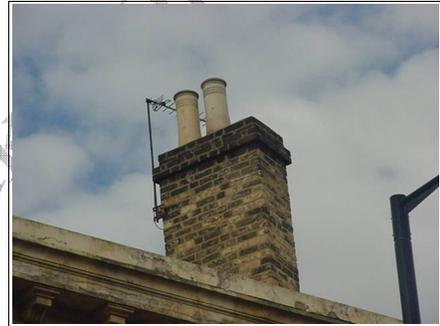
Right hand chimney

This again from the ground looks in average condition, however we would again take the opportunity of a close up inspection when you are carrying out work to the roof

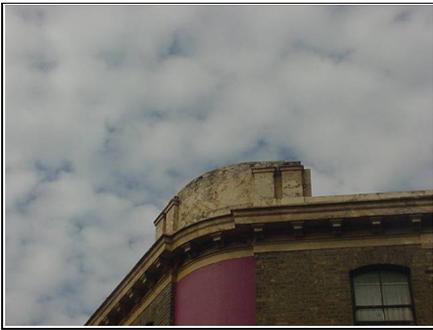
These were difficult to view but we can see that the render to them is deteriorating and internally we can see dampness getting into the structure, all of which indicates that there is perhaps a leaking box gutter behind them or an awkward detail.

Left hand view leaking parapet wall

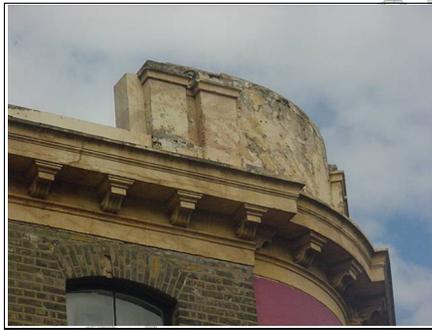
High level parapet wall  
With leaking box gutter

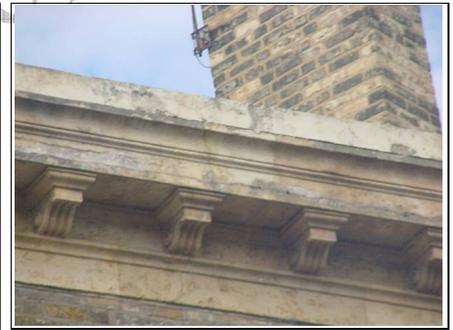
Leaking parapet wall to front

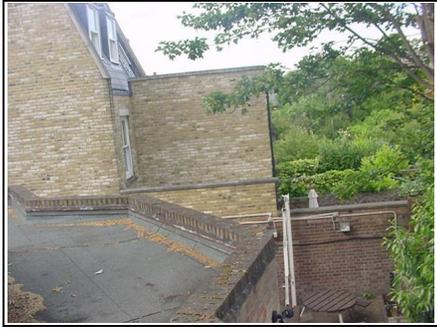
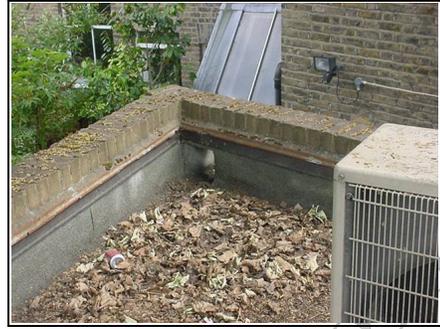
There is a low level parapet wall around the perimeter of the flat roof made up of various different designs, from a felt flashing to a metal flashing and several of these areas are defective and need repair. We can see, for example, to the left hand side parapet wall where there is some metal flashing it has come away and the parapet wall is deteriorating and another area where plants were literally growing out of the parapet wall which is never a good sign. There is also, what we can best describe as a lead up stand which is creating a very awkward detail that needs to be looked at.

Low level parapet wall

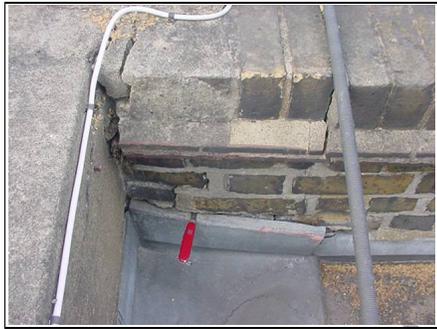
Metal flashing has come away and metal flashing deteriorating

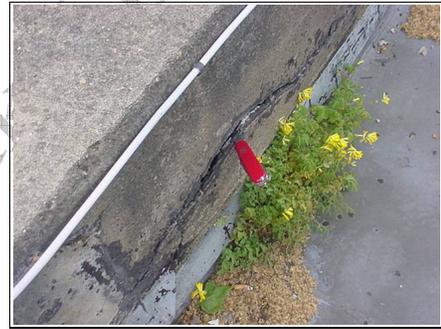
Plants growing from parapet wall

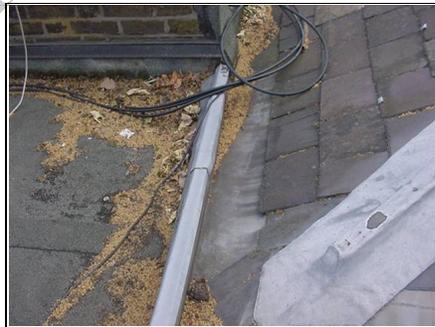
Awkward upstand

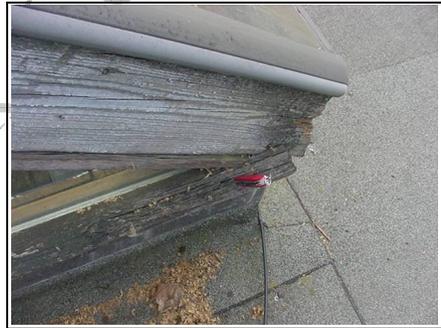
The property has one large purpose made roof window, located to the centre of the flat roof area. This is predominantly timber with a glass top. Here we can see rot is occurring to some sections of the timber.

**ACTION REQUIRED:** Repair of roof window.

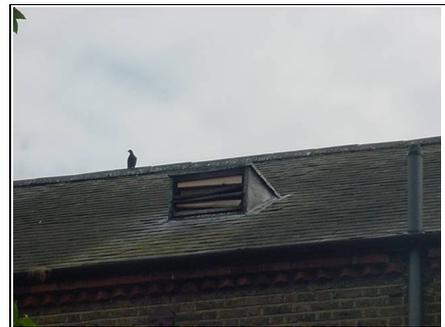
The roof is pitched and clad with quarried slate. The slates sit fairly true and are generally in average condition considering the property's age, type and style.

However, internally within the rooms we can see there is lateral dampness. This we believe indicates that there are problems with either the box gutter or the roof and needs a closer inspection. We certainly do not believe that the roof will last the life of the lease and expect major works to be carried out in the next ten years.

Main slate roof

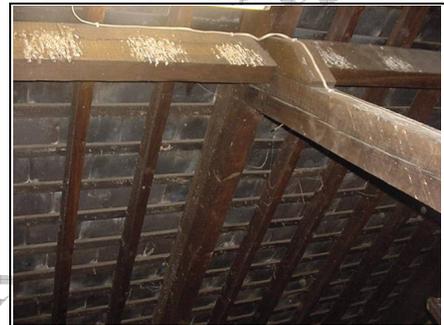
There is no protective underlayer. Our view inside the roof was limited due to an infestation of pigeons.

No underfelt to roof

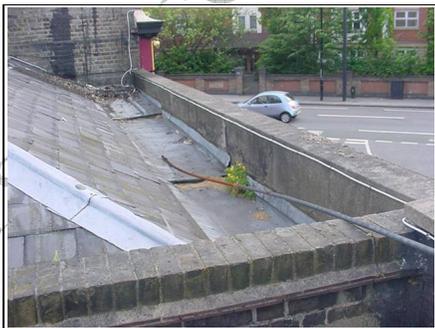
There is a rear pitched slate roof that is looking the worse for wear.

Internally we can see that dampness is coming into the perimeter and there looks to be wet rot in this area.

Box gutter to rear pitched roof

**ACTION REQUIRED:** Re-roof this area, replacing timbers as necessary and repairing parapet walls as previously mentioned.

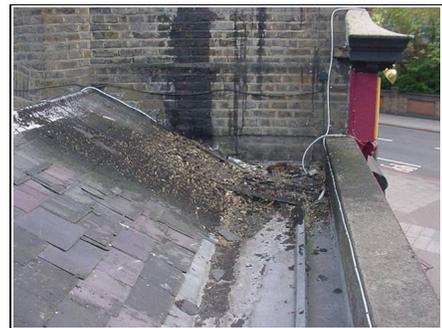
Debris and broken slates

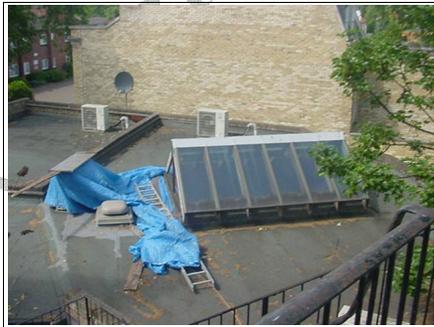
The flat roof is located to the rear and is covered predominantly with felt. This is of various levels and has been developed over the years, as is often the case with this type of property where it has been extended and then re-extended. Some of the felt work is very poor quality, such as where the felt is taken into the guttering, but the main problem is where the felt flat roof is flat and we feel that water will sit on the roof. Unfortunately, we do not believe this will survive the life of the lease.

Rear felt covered flat roof  
With roof window

**ACTION REQUIRED** We recommend that the roof is replaced with an insulation cut to falls roof with a high performance felt. Please see our comments in the executive summary.

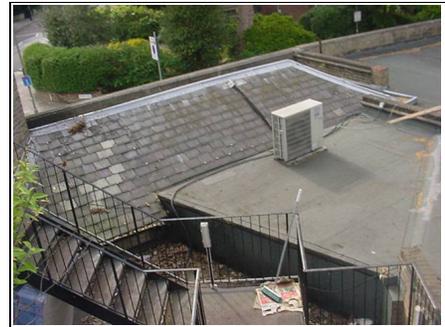
Rear felt covered flat roof on right

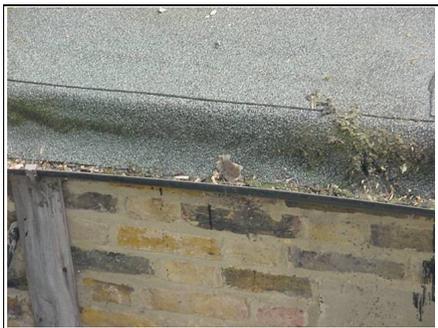
Poor quality felt work taken directly into gutter

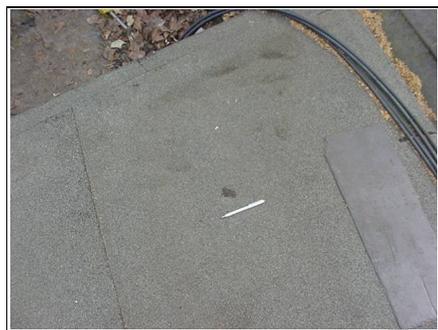
Blistering to felt

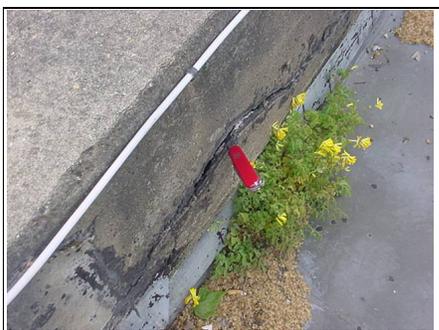
Flashing deteriorating

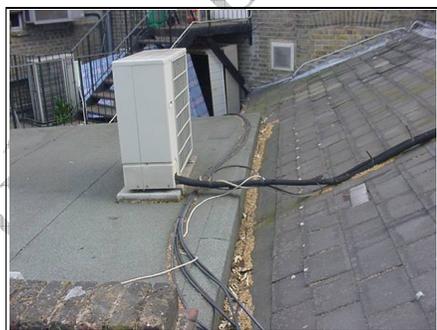
Poor detail between pitched roof and flat roof

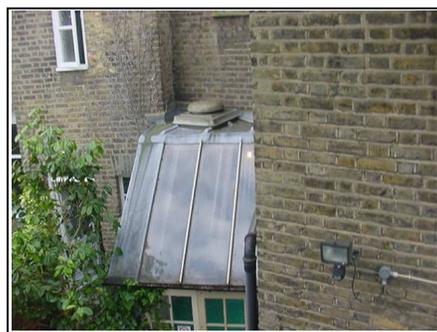
There is a glazed roof to the rear which we were unable to view properly. We would set aside the sum of £1,000 as a contingency on this roof.

Rear glazed area rear right hand extension

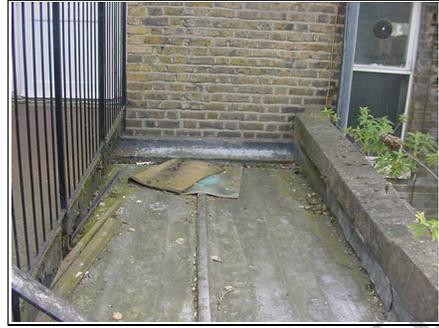
This is next to the fire escape and is in poor condition. It is one of the older roofs. We would set aside the sum of £2,000 to £3,000 for repair works.

Old lead roof to rear of property

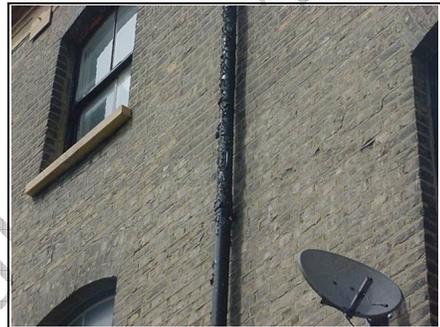
Cast iron downpipe in poor condition

**ACTION REQUIRED:** We would always recommend that the gutters and downpipes are cleaned out, the joints are checked and the alignment checked to ensure that the gutters fall towards the downpipes. In this instance there may be some repair/replacement of cast iron.

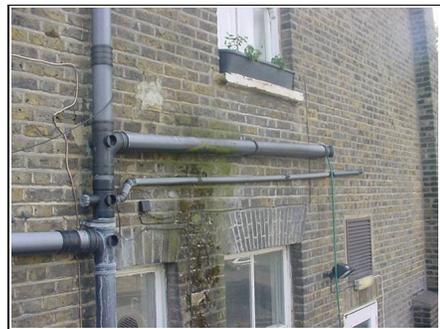
To the rear there is a plastic soil and vent pipe. This has been added to over the years. We can see a leak close by it, we are not certain whether this is coming from the soil pipe or from a rainwater pipe above, but either way it can literally be seen inside in the kitchen.

Leak near to soil and vent pipe

**ACTION REQUIRED:** Make watertight and carry out repairs in kitchen.

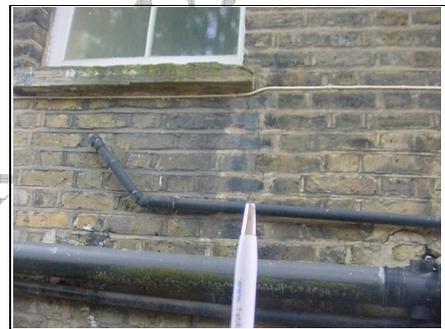
Pen indicates cracking to Flemish Bond brickwork

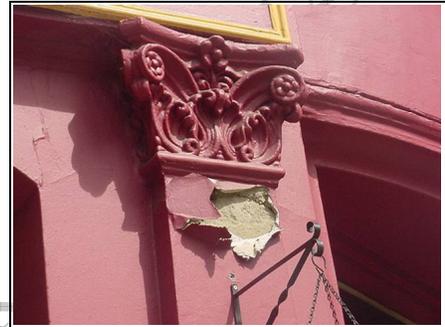
The walls to this property are finished in a "smoothish" faced painted render. We have carried out a tap test to the render at low level (literally hitting the render with the back of a hammer) to try to establish if there are any hollow areas. We have found some areas that need repair and all requires redecoration

**ACTION REQUIRED:** We have used the term smoothish as some areas have seen better days, it has cracking and will need repair when, probably when next redecorated.

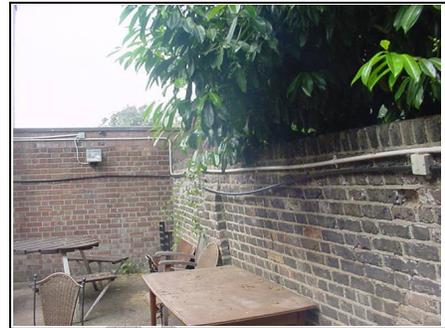
You have some trees to the left hand side boundary wall. They are all within what is termed as influencing distance of the property and may be affecting the foundations and underground services. The rear trees in the neighbour's garden is starting to push over the wall.

Next door's tree pushing over your wall

**ACTION REQUIRED:** You need to meet with the neighbour and decide on a way forward. You may need an arboriculturist (not a tree surgeon).

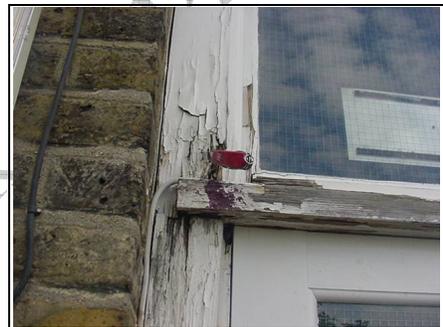
To the rear we noticed there are areas of wet rot occurring where we could push a knife into them, as you can see in the adjacent photo. In the past they look to have been filled. There are some particularly poor rear windows where we can literally see bare timber where the painted has flaked off.

Wet rot to windows

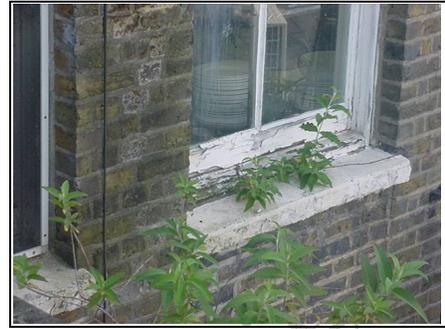
We would also draw your attention to the window cills. Some of these have not been maintained for a long time and literally have plants growing out of them. This needs to be resolved at the same time as the window work is taking place.

Plants growing out of window cill

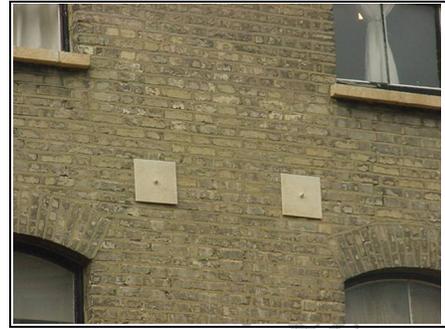
We could see to the front of the property and to the rear tie bars. These are normally included where the embedded timbers in the walls have rotted over the years and the walls have started to move causing structural damage.

Tie bars
