PROPERTY REPORT

A Public House In Somerset

We have been asked to inspect and prepare a Report and Schedule of Condition for a public house in Somerset.

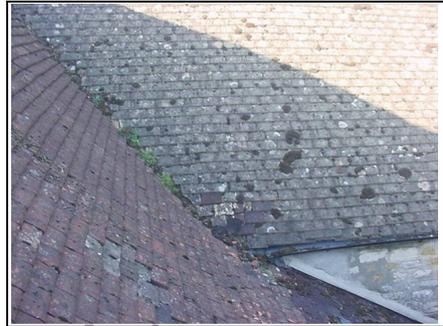
Deteriorating tiles and a valley gutter that is full of vegetation

ACTION REQUIRED: You need to budget for repair work, both in the form of tile and slate repairs and ultimately we feel there will be a lot of tile repairs and there will be some strengthening of the timber frame required, from the limited view we had.

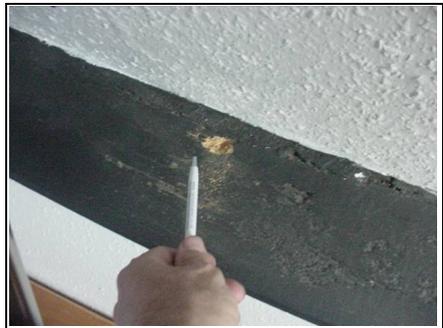
Woodworm in rear roof

Whilst we would be the first to admit that it takes a lot of woodworm to affect a property, and in this case you have also had additional timbers added to support the roof (although we have only had a very limited view of it), we do feel that some work will be needed to be carried out within the term of your lease.

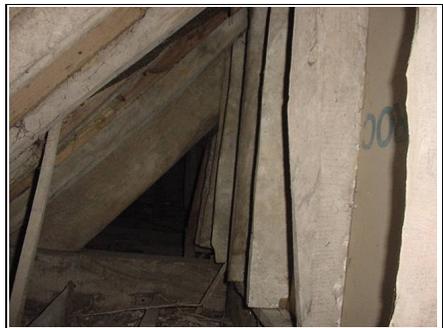
Side of the rear roof where there is a mixture of old and new timbers

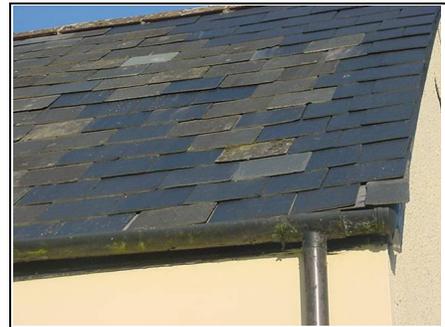
As you can see from the photo, there is a mix of slates, old and manmade and they look unsettled on the roof. In our experience, where we have seen this type of roof previously, the wind can get underneath it and lift the slates.

Rear slate roof

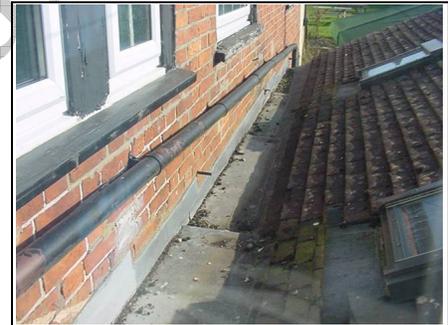
We noted that the valley gutter that runs adjacent to the ladies toilets is leaking into the ladies toilets. We also noted (as is pictured previously) that other valley gutters were full of vegetation, etc.

Valley gutter over ladies toilets

ACTION REQUIRED: You will need a roofer for approximately one day to clear the valley gutters and to carry out some specific work on the valley gutter over the ladies toilets, where it needs to be stripped back and the lead checked and check the adjacent tiles for leaks.

ANTICIPATED COST: To have a roofer for the day plus whatever work is ultimately found in the valley gutters, plus materials, we would expect costs in the region of £500 to £1,500, assuming scaffold access is not required. Please obtain quotations.

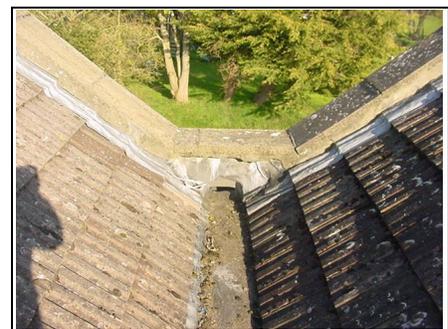
Valley gutter to front of property

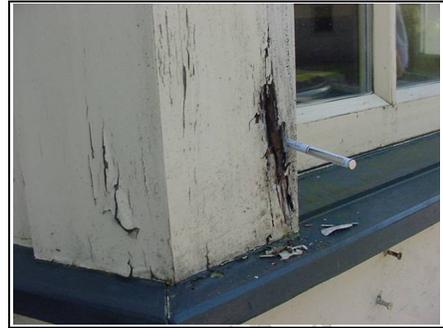
We were able to check and test the windows, particularly to the ground floor area, and we noted approximately 30% had some form of deterioration and/or wet rot. This is especially evident in the front right windows and also in the windows to the toilets and in the door entrance canopy area to the front of the property, all of which we could literally push a penknife into, or a pen in some instances as shown in the photo.

Pen going into the front window

ACTION REQUIRED: Whilst we feel all windows are saveable it may not be the most economical decision to repair this quality of window. Some of the windows are relatively modern softwood windows that have rotted, which we often find to be the case and we would recommend that a good joiner is asked to look at each window in turn to quote for cutting out the rotten timber and splicing in new timber.

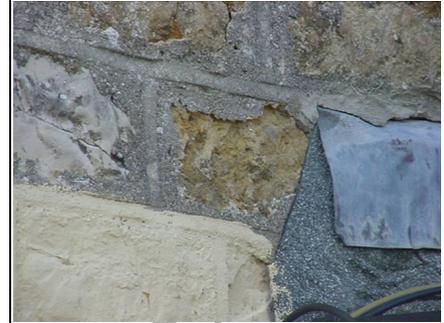
This type of older property would originally have been built using lime mortar and that is what we think should be used on it today as it allows the property to breathe. Unfortunately, the property has been repointed in the majority of places with a hard cement mortar (this is something we often come across), just as the render that has been used is a hard cement based render in other parts of the property. Whilst you find this in the majority of properties we look at, we feel that over the course of the lease this will cause a lot of deterioration. It is, however, hard to appreciate the effects of spalling stonework.

Close up of front of stone spalling

ACTION REQUIRED: We recommend that you find a builder experienced in lime mortar and ask them to return on sunny days with a soft brush to gradually remove the cement mortar and the repoint in a lime mortar; this is a major task.

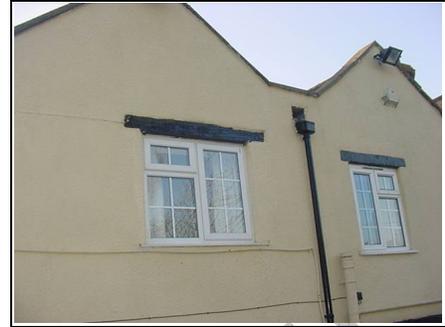
Render

There is a lot of cement render on this property, which is not ideal. Unfortunately it will cause deterioration to the timber lintels, as effectively you have sealed the building and the structure cannot breathe.

ACTION REQUIRED: We recommend that you fill in any hairline cracks to the render immediately with a flexible mastic and also check around the timber lintel where deterioration can occur.

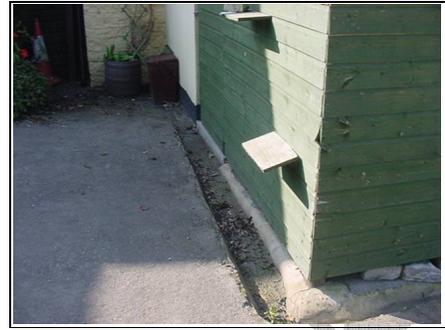
Drainage run to left hand side of property could be improved

ACTION REQUIRED: Ideally we would recommend a French gully is placed around the property to give the rainwater a path to follow and to minimise the rainwater getting onto the road, which you have a liability for if there are any accidents.

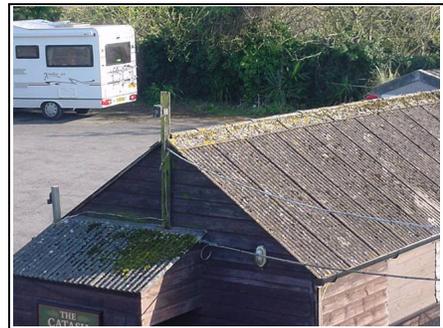
We noted asbestos to the skittle alley roof. We are advised you have an Asbestos Register and you need to consult this before you commit to purchase the property to see if there is any work that will be required immediately or within the term of your lease.

As a general comment we feel that asbestos is becoming less and less acceptable and should be removed if at all possible. We were surprised that the skittle alley has been updated yet the asbestos roof has not been removed.

Asbestos to skittle alley roof

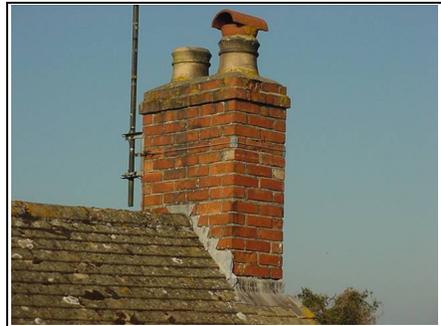
Left hand chimney

This chimney is brick finished with two chimney pots and a lead flashing. We can see some cement repairs of old on the chimney which is not ideal. We cannot see the top of the chimney known as the flaunchings therefore we are unable to comment.

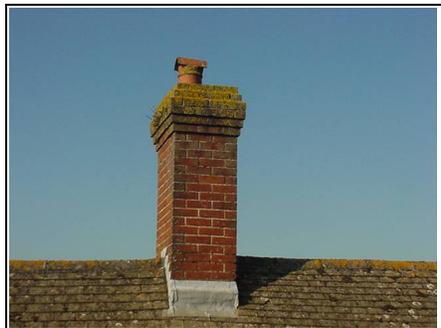
Middle chimney

We would comment in a similar manner to the previous chimney, although this has more moss at the top and more weathered joints.

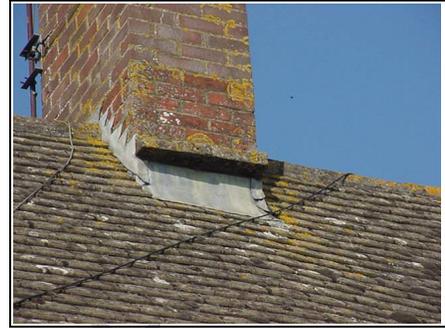
Step at base of chimney

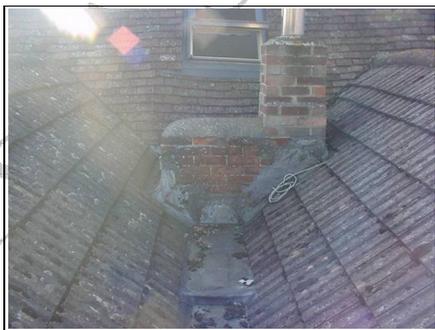
Rear left hand side chimney

This chimney sits in the valley gutter to the left hand side of the property and is the most accessible chimney, via the top floor window. It looks to be in average condition, although there is damp getting in, which we believe to be at the base of the chimney where it sits in the valley gutter.

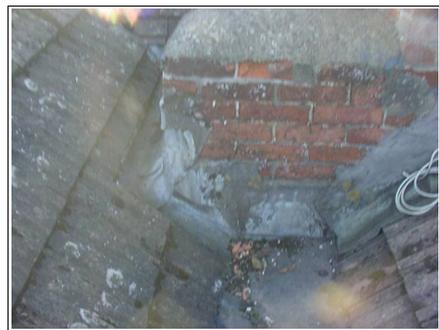
The very base of the chimney to the valley gutter

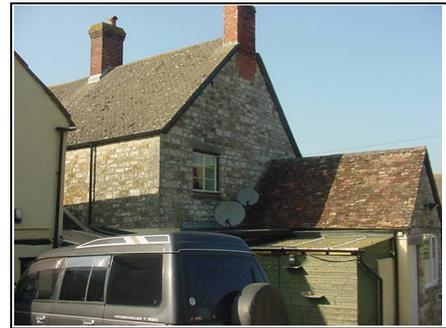
Main roof

The main roof is finished in a small tile, we believe it to be concrete that has been added after the war years. The front looks very different to the rear, with the rear having a smooth finish and the front having an undulating finish, indicating there may be deterioration to the roof structure beneath.

ACTION REQUIRED: Open up the roof access to the timbers in the summer of 2011. There may well be wet rot and woodworm in the roof structure to the front of the property. Before taking on the lease your legal adviser needs to ask the landlord specifically what repair work they have carried out to the roof coverings and roof structure.

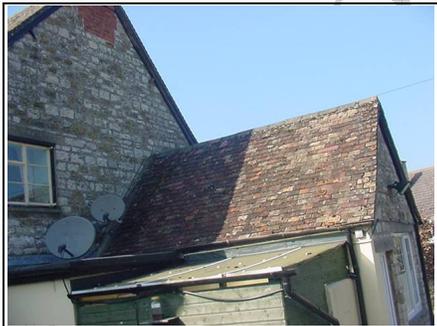
Polycarbonate roofs

Polycarbonate is sheet plastic that has been used on the store but also to the entrance to the upstairs guest room accommodation. As this is the exit as well we would recommend it is replaced as we believe it to be a fire hazard if people tried to escape through this exit.

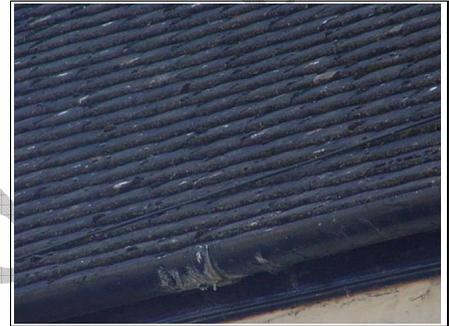
The property has a mixture of the original cast iron gutters and downpipes and the more modern plastic gutters and down pipes to the main roof in average condition. The cast iron we found was in below average condition, all things considered, and we can see areas where the gutters/downpipes are rusting and damaged.

Leaking plastic guttering

ACTION REQUIRED: Next time it rains hard you need to watch the gutters and down pipes for leaks make a note and repair them this process will need to be repeated many times.

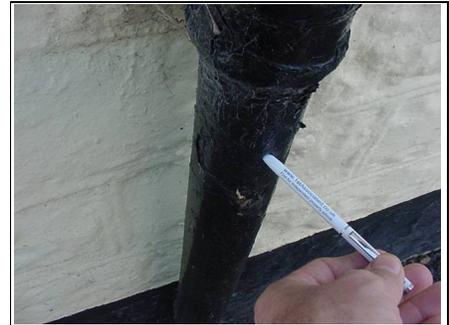
Rusting cast iron guttering

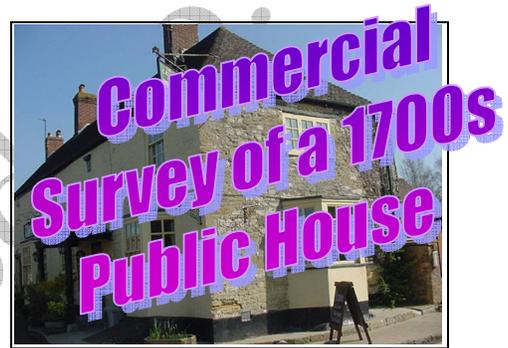
The front of the property is formed in a coursed stonework with what originally would have been a lime mortar bedding which has now been repointed in cement mortar.

ACTION REQUIRED: Please see our comments in the Executive Summary about the quality of the cement mortar pointing.

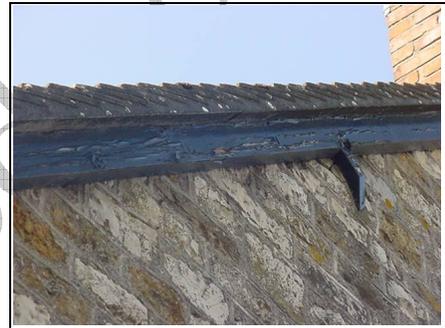
The end of the roof is finished in a variety of ways There are bargeboards at the gable end and we can see that some of these have flaking paint on them and need redecoration. The same could be true of the fascias and soffit boards.

Bargeboard

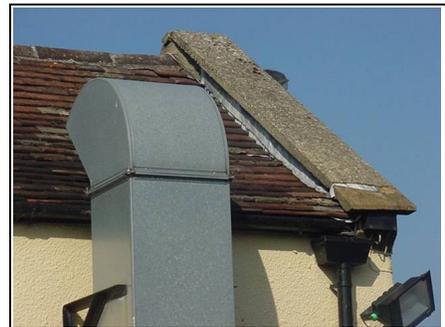
Parapet wall

There is a small parapet wall to the left hand side of the property near the hidden valley gutter area. We suggest the lead is checked around this area to make sure the parapet wall is watertight.

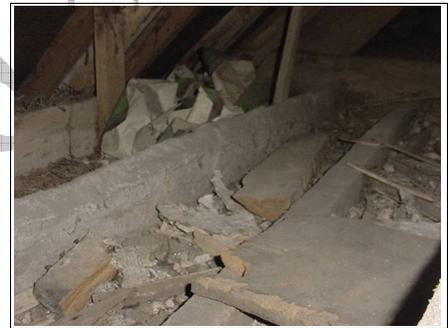
No insulation in the main roof
