PROPERTY REPORT

**Public House,
Worcestershire**

We have been asked to inspect and prepare a Report and Schedule of Condition for XXXXX Public House, Worcestershire. We visited the property on XXXXXXXX.

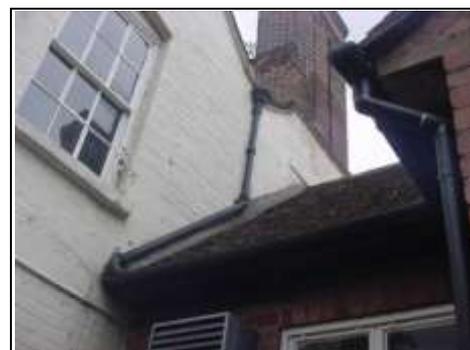
Poor detailing around the chimneys (and inappropriate for older properties) such as tile and edge flashing. Poor detailing (cheap) to the parapet walls such as bricks on edge, for example this needs a coping stone or damp proof course added. Valley gutter repaired in felt (cheap alternative to lead) allowing water to get into the property. This is emphasised by the amount of plant life/vegetation growing from the chimneys, parapet walls, etc.

Poor detailing – cement fillet flashing should be replaced with a lead flashing

ACTION REQUIRED: General repairs are needed throughout the property by skilled tradesmen who understand older properties to include lead flashing details to the chimneys and rebedding of the flashing in appropriate mixes, lead to the valley gutter, etc

ANTICIPATED COST: As some of this work is at high level scaffolding may be required. We would expect costs to be in the region of £15,000 - £25,000 depending upon what is found particularly at high level. Once this work has been carried out and the building has been allowed to dry then you can move on to the other work recommended within this report. Quotations required.

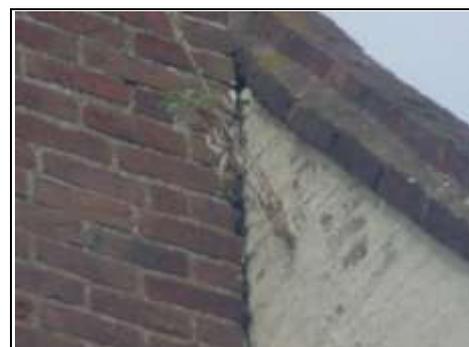
Parapet wall with plant growing out of it

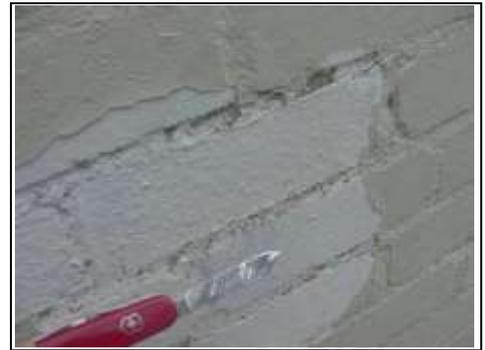
The external paintwork is a non-breathable, believed to be plastic based paint. The paintwork beneath is a breathable lime wash. As older buildings need to breathe and dissipate dampness the present type of painting is inappropriate. This explains why there are areas where the paint has blistered away.

ACTION REQUIRED: All modern paints need to be removed completely, appropriate paint needs to be applied bearing in mind the existing brickwork we recommend a micro porous or lime based paint.

ANTICIPATED COST: In the region of £15,000 - £20,000. It is very difficult to remove paint successfully. We do believe this needs to be carried out by the landlord and/or specifically excluded from the lease. Quotations required.

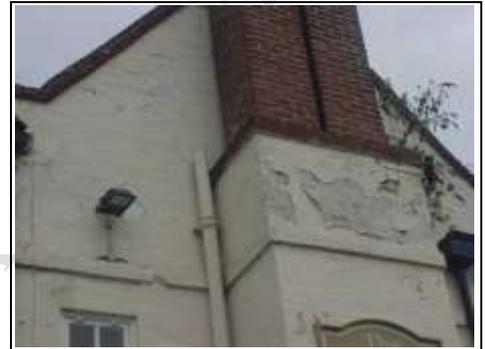
Paint flaking to walls

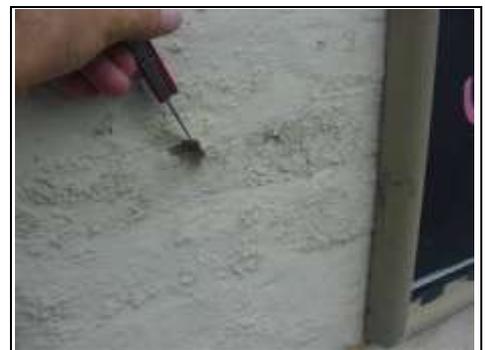
Spalling to brickwork indicating damp within in behind modern paint

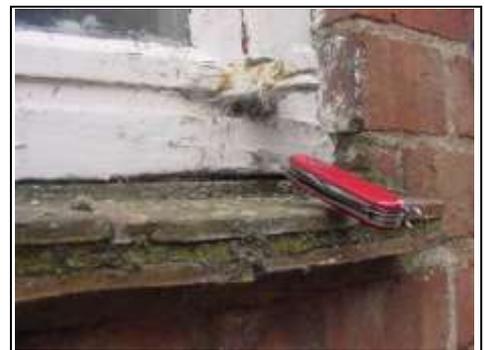
We have knife tested the external joinery at ground level where we can gain access and found approximately ten to twenty per cent is rotten and needs replacement.

Wet rot to timber windows

ACTION REQUIRED: General

overhaul of all the windows to ensure they open and shut efficiently. We would term the windows in a poor but saveable condition.

ANTICIPATED COST: It really is a very difficult thing to estimate. We would expect costs to be in the region of £5,000 - £10,000, in some cases it may be more economical to replace with an appropriate window; quotations required.

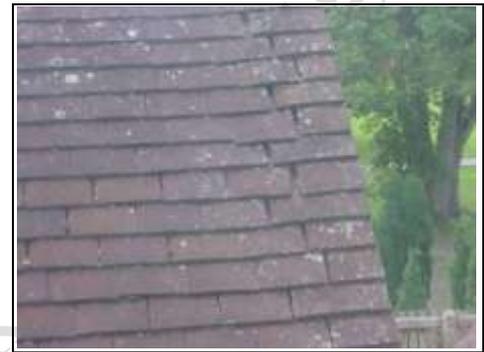
1. The cracks to the front and the rear of the property (please see our comments below.
2. The opening up of tiles at both high and low level roofs (see adjacent photo)
3. There have been measures in years gone by to try and stabilise the property using tie bars which were common in the 1950's/1960's. Tie bars were typically added for lateral restraint from the floors where the embedded timbers have rotted away from within the wall added to give strength. From our discussions with the present pub manager and our general investigations we believe that there may be rot to joist ends at present and/or active woodworm within the floor.

Roof tile with opening up of tiles showing movement

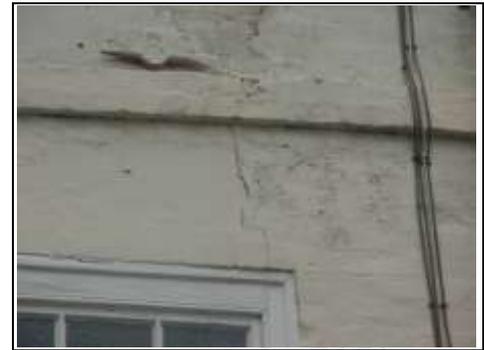
There is cracking to the front elevation underneath the valley gutter and to the rear adjacent to the chimney. Both these need to be excluded from the lease as we believe that there are inherent design defects.

Crack to front of property possible deterioration to timber lintels

ACTION REQUIRED: Record, monitor and exclude from the lease.

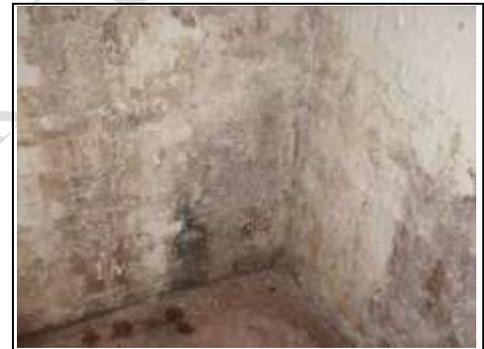
Currently there is mould which can be seen growing within the cellar. We do not believe would be to Environmental health standards. It can ultimately if not repaired lead to the closing down of the business.

Dampness in cellar

ACTION REQUIRED: We recommend that you have an Environmental Health Officer visit before you take over the lease of the property to carry out both informal and formal discussions.

ANTICIPATED COST: Between £2,000 - £4,000; quotations required.

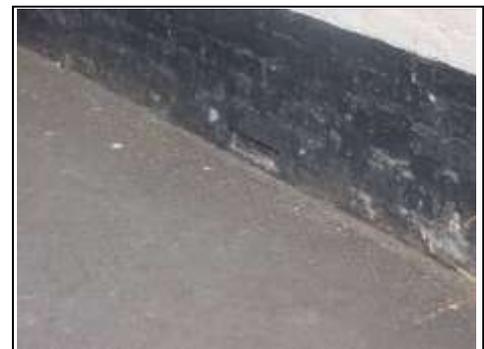
You should have an airflow underneath this property to reduce the risks of damp timbers and deterioration. We noted an air brick externally acting as a gully so that whenever it rains it will discharge water into the property.

Airbrick acting as a gully

ACTION REQUIRED: You need to create a barrier to these.

ANTICIPATED COST: A few hundred pounds a brick, bedded down normally suffices; quotations required.

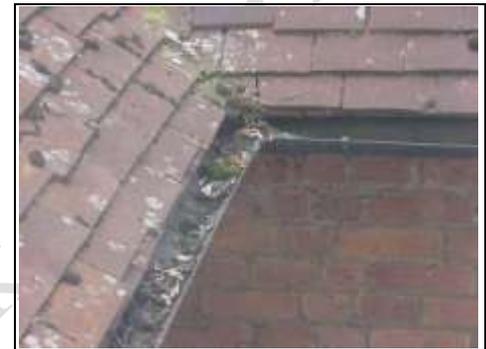
There has been a lack of general maintenance and temporary patch repairs over the years such as clearing gutters and patch repairs to roofs dealing with the effect of the problem rather than the cause.

Gutters need clearing

ACTION REQUIRED: We would suggest a week of general maintenance on the property.

ANTICIPATED COST: Very difficult to give accurate figures. We would expect costs to be in the region of £2,000 - £5,000 depending on the amount of labour and materials needed; quotations recommended on a day work rate.

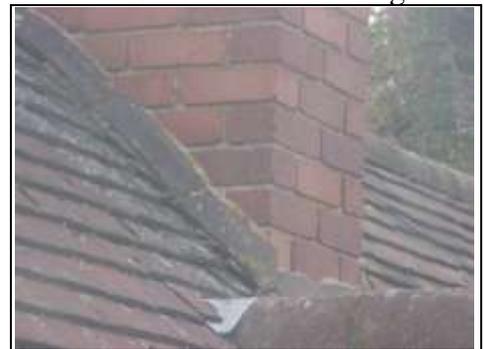
Tile on edge flashing rather than a lead flashing

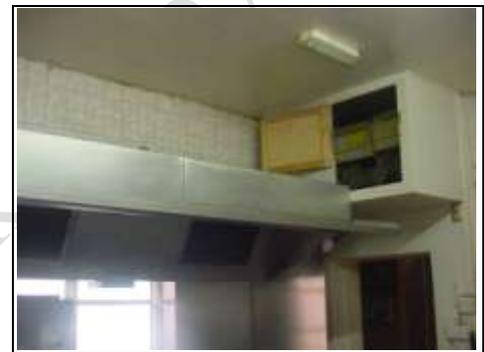
We do not believe the electrics are to NICEIC standard and would like to see a test and inspection report. The electric fuse board is located within the kitchen which is considered a high risk area. Either relocate this or ensure it is enclosed in a one or two hour fire resisting structure. You need to take further specific advice from the fire brigade with regards to this due to the unusual nature of its location. We feel this is a very high risk item.

Electrics dangerous in kitchen

ACTION REQUIRED: NICEIC test and inspection.

ANTICIPATED COST: £300 - £500 plus costs for any work; quotations required.

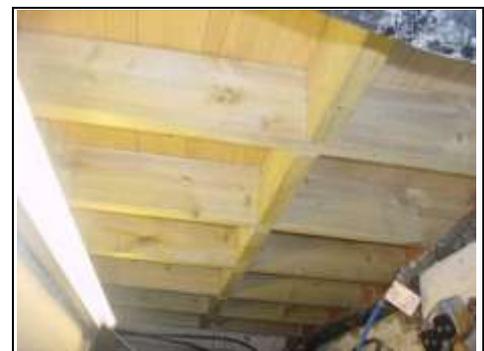
It was noted in the cellar that there was no insulation or boarding out of the cellar which means that the cooling had been affected by the warm environment above. There is literally a full thickness of timber between the two and equally upstairs in the trading area you are affecting the temperature in this area by cooling it which may be OK in the summer months

Uninsulated ceiling in cellar

but won't be very pleasant in the winter.

ACTION REQUIRED: Add insulation and boarding to the ceiling.

ANTICIPATED COST: In the region of £1,500 – £3,000; quotations required.

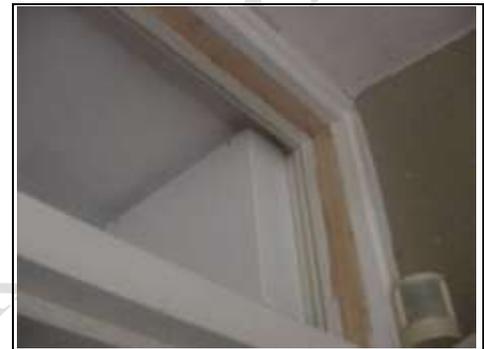
We don't believe the property currently meets good or best practice with regards to fire regulations. We mentioned the electric units within the kitchen. We would also add a lack of fire and smoke detectors throughout, no fire extinguishers or fire blankets noted or fire doors. Whilst compromises often have to be made in an older property we do feel that a radio activated fire alarm system for example should be part of your lease negotiations.

Lack of fire doors and missing glazing from stairway on first floor

ACTION REQUIRED: Fire alarm system to be installed by the owners.

ANTICIPATED COST: £3,000 - £4,000; quotations required.

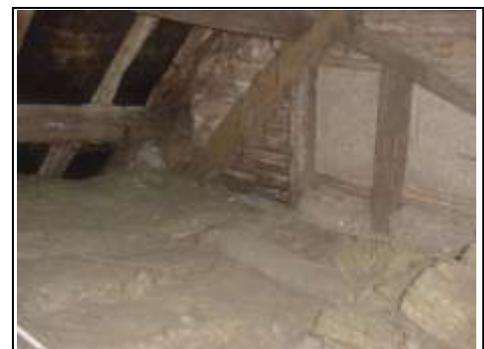
The roof has been insulated to modern levels without ventilation being added to the roof space. This will promote condensation and we can see staining within the main roof already. It will also promote woodworm as it is in an ideal climate for it.

Mass of insulation

ACTION REQUIRED: Add

ventilation to the roof space. This may be possible with airbricks to the gable end. We would suggest you check with the Local Authority to make sure this is appropriate. Generally with the access to the roof we would suggest this is improved and lights added.

ANTICIPATED COST: A few hundred pounds; quotations required.

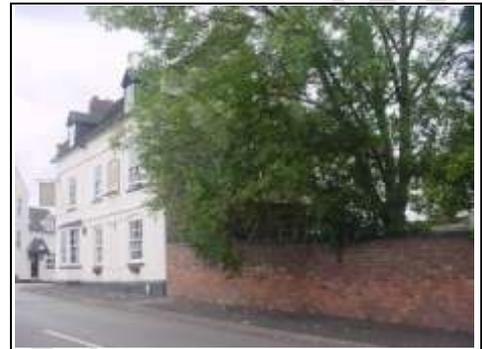
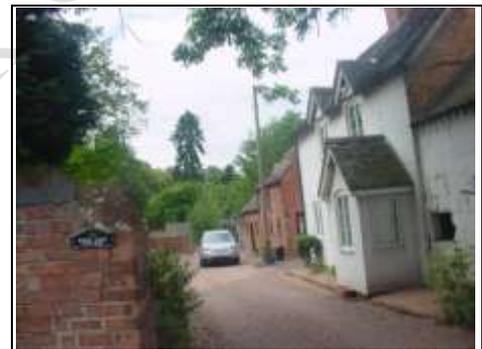
The trees have had a lack of maintenance for a considerable time. Many of them are now at the height of the property or above. It is not clear where the boundaries are at the rear of the property in particular.

ACTION REQUIRED: We recommend that an arboriculturalist is appointed and a twenty year action plan drawn up.

ANTICIPATED COST: A few hundred pounds for the actual tree report and then annual costs; quotations required.
