# PROPERTY REPORT

East Sheen,  
SW14

We have been instructed to inspect and prepare a Report and Schedule of Condition on xxxxxxxxxxxx for xxxxxxxxxxxx.

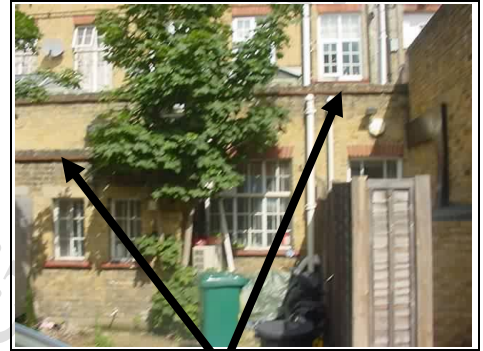
From the condition of the asphalt flat roof and the staining to some of the suspended ceiling tiles below we believe these flat roofs are leaking into the property. These roofs are situated to the rear partly over the treatment rooms but mainly over the kitchenette and W.C. areas.

We can see this has been a long term problem as there have been felt repairs in the past.

Flat asphalt roofs

**ACTION REQUIRED:** You need to establish whose liability/responsibility it is to repair the asphalt and the associated roof window which looks to have had repairs in the form of Bitumen paint over a period of many years.

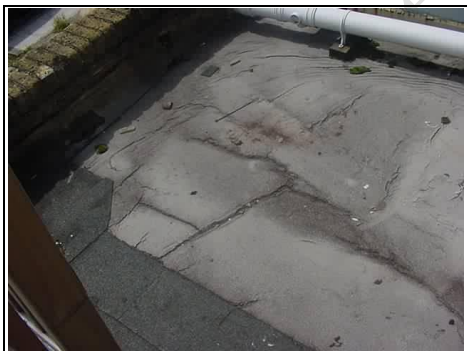
Asphalt felt roof has been repaired

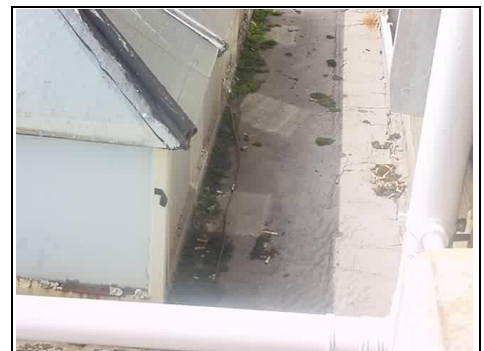
Moss sitting on the roof

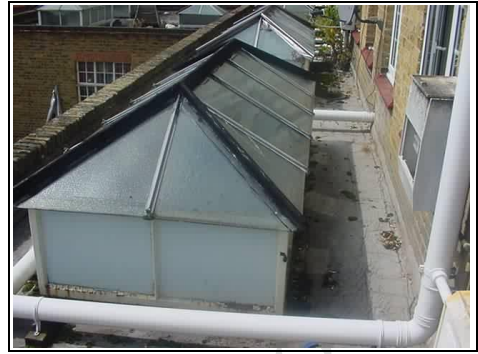
**1.1.1** Where the glass joins. There have been leaks over the years and Bitumen has been added. We can also see around the base of this that the Asphalt is starting to deteriorate.

Old style roof window on flat asphalt roof

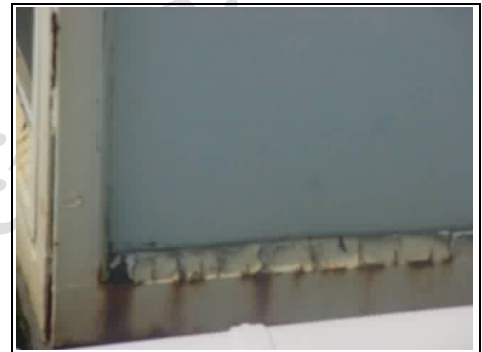
**1.1.2** The metal frame itself is starting to rust.

The window frame is starting to rust

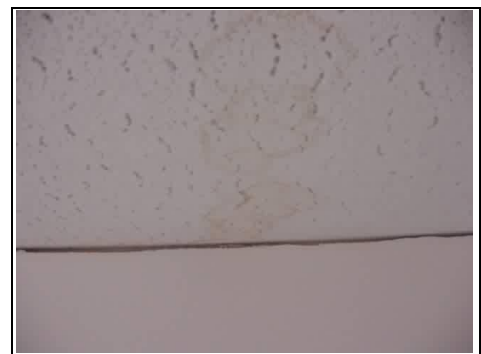
Internally we can see damp stains to the ceiling tiles. Whilst these are located in the back of house areas and not seen by the public it is not ideal.

Dampness coming through to ceiling tiles

Alternatively we would recommend that you alert the landlord of this issue and have this excluded from your lease or the landlord should carry out the work.

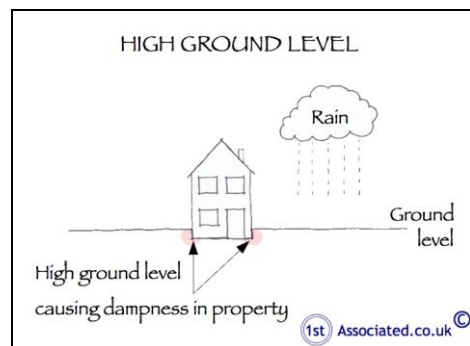
Rising damp is visible to the rear of the property within the W.C. area. We believe this is caused by high ground levels and plant growth around the outside of the property. There is also a pile of materials stacked against the property.

High ground level

**ACTION REQUIRED:** We would recommend a reduction in the ground level and possibly the adding of a running gulley or a French Drain (please see our French Drain sketch and the article at the end of the report.

**ANTICIPATED COST:** £1,000 - £3,000 (one thousand to three thousand pounds). Ideally this should drain into the drain; please obtain quotations.

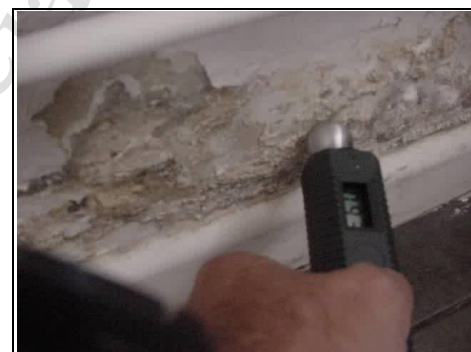
Testing for dampness

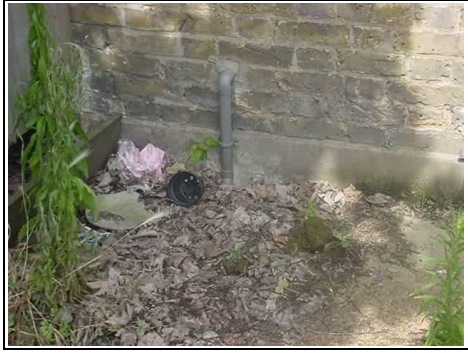
Rendered plinth where water is getting in

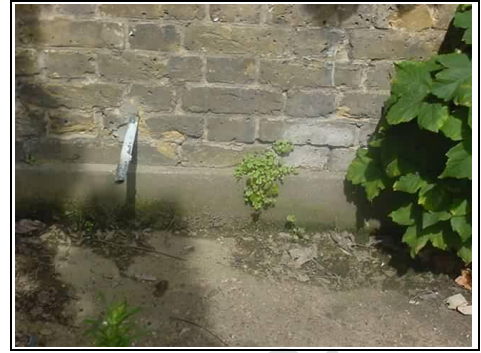
Plants growing within the wall indicate dampness

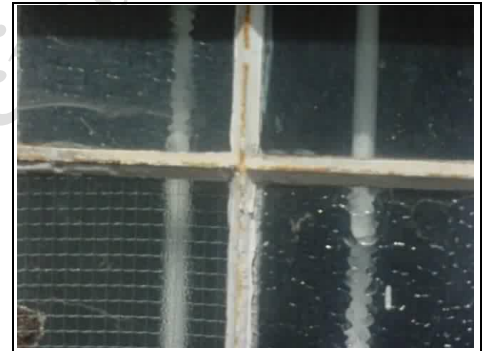
The single glazed metal windows to the rear of the property in the W.C. area are rusting. These metal windows are commonly known as crittal windows and are not ideal as they tend to warp and rust over time. In this case we can see they are rusting.

Rear windows in W.C. area are rusting

**ACTION REQUIRED:** We would recommend major re-decoration in the summer of 2012. This will involve preparation and the use of a rust-stop proprietary paint.

**ANTICIPATED COST:** Most Full Repairing and Insuring Leases (FRI) require that the outgoing tenants carry out such redecoration and repair but which clearly have not been carried out in this instance. We would recommend that you negotiate either rent free periods in lieu of you carrying out the work or for the landlord to carry out this work. Alternatively you can exclude it from the lease.

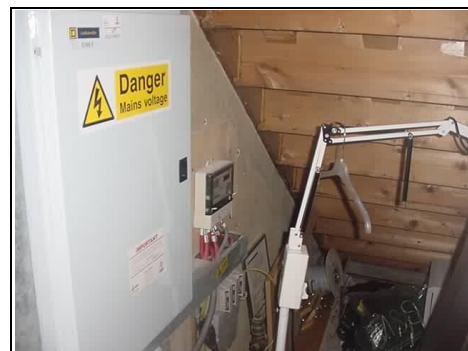
We noted that in the first treatment room on the left hand side that there is access to a cupboard under the stairs. Within this cupboard are various services including the electrics. These stairs give access to the units above and is therefore a fire escape. It should have a fire barrier in the form of a lining. This can be a double layer of plasterboard or a fireboard of some type. The idea behind lining a stair case is to stop fire from spreading from floor to floor and the stairway acting as a chimney.

Stairs not lined, asbestos has been removed

**ACTION REQUIRED:** We would recommend that the stairs are lined.

**ANTICIPATED COST:** In the region of £150 - £300 (one hundred and fifty to three hundred pounds).

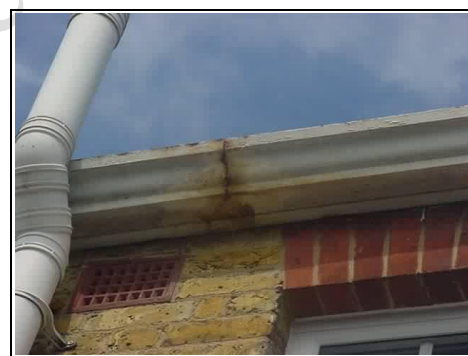
Ogee cast iron gutter is rusting

- 6.1) The original Ogee cast iron guttering is still in place and we could see that the joints are rusting and no doubt leaking and need repairing/replacement. As mentioned this is likely to have a shared cost with everyone in the building. You may have a larger proportion of the cost than the other occupiers being a commercial property.

**ACTION REQUIRED:** Repair or replacement of gutters. We would also recommend that the gutters and downpipes are cleaned out, the joints are checked and the alignment checked to ensure that the gutters fall towards the downpipes and that they are watertight. Also add sealant/mastic around the soil and vent pipes.

**ANTICIPATED COST:** If this is carried out by the landlord it is likely to be a higher cost particularly as scaffolding will be needed. We would expect costs in the region of £2,500 - £5,000(two thousand five hundred to five thousand pounds); please obtain quotations.

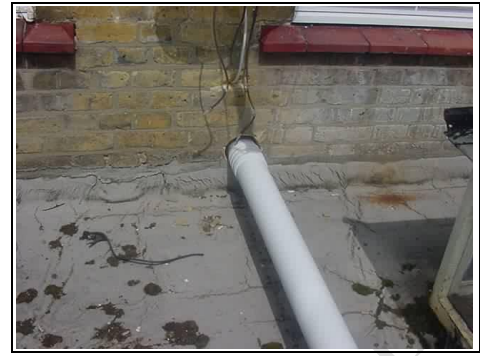
- 6.2) We also noted where the plastic soil and vent pipes have been added that they have not been sealed properly with a flashing of any sort. They simply have holes cut into the building with no sealant /mastic at all.

No flashing around soil and vent pipes
