**SUMMARY PROPERTY REPORT
AND MARKET APPRAISAL**
(for non-mortgage purposes)

**Watford,
Hertfordshire
WD18**

Trial Hole Record

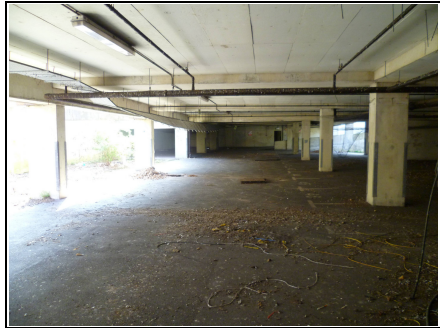
General view of underground car park

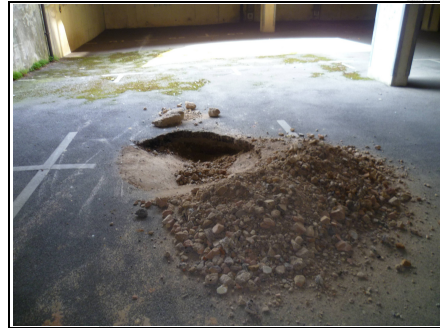
Starting to dig one of the holes

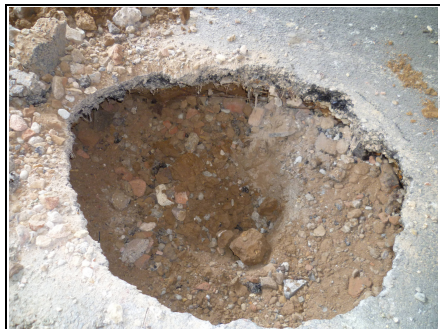
Trial holes have been dug during the course of our investigation in April 2012. All of these indicate that the ground is in poor condition. This when in conjunction with the bore hole information from the British Geological Survey of a nearby site indicate there is a clay gravel sub-soil and chalk before it meets the bed rock for this road which is approximately 25 metres deep. See article in Appendices with regard to the properties of clay. There is further detail available on these, please see the other reports.

Shows how hole opens up without any hard digging

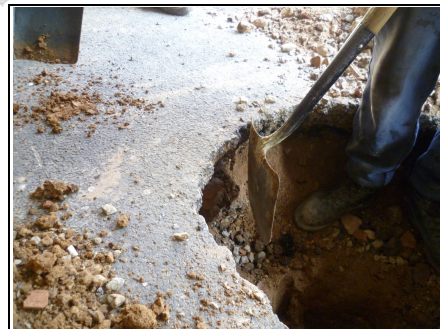
The trial holes that we have carried out within the basement car park have identified that the car park is sitting on clay. We noted areas of either subsidence or trial holes for further investigation with regard to problems. Please see our brief photographic record of the trial holes we have included within this report.

Breaking pattern indicates subsidence

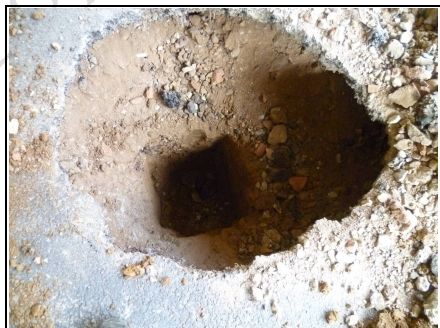
Approx two metre deep trial hole
of clay

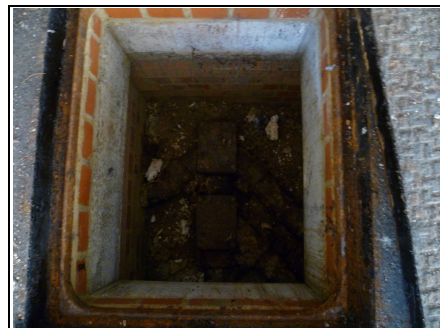
Drains were in cast iron
indicating clay
