# PROPERTY REPORT

**West Hampstead  
London NW6**

We have been asked to inspect and prepare a Report and Schedule of Condition for a commercial property West Hampstead, London NW6.

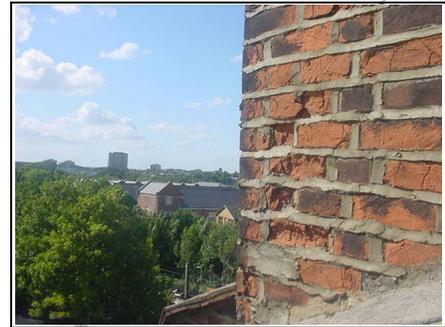
There is spalling (deteriorating) brickwork due to the use of cement mortar. The bricks are built of a relatively soft red brick which is affected by the use of the cement mortar.

Close up of chimney with red spalled brickwork wrongly repointed in cement mortar

**ACTION REQUIRED:** We believe that proper repointing in an appropriate lime based mortar will be required in the next few years. Whilst the work itself is not very expensive scaffolding or access to it will be.

**ANTICIPATED COST:** We would expect costs to be in the region of £5,000 to £10,000 to gain access and carry out the work. Please obtain quotations. Also, please see our other high level work which should be carried out at the same time. This is likely to be a shared cost.

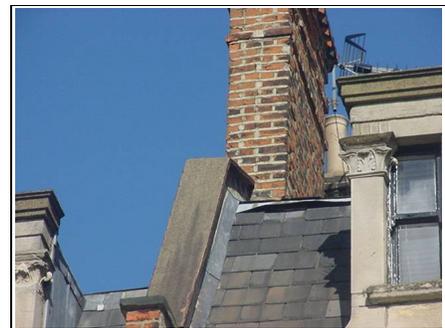
Along with the chimneys there is other high level work that needs doing, which we have put under the term roof. This includes the re-securing of flashings and replacement of slates, together with repairs to the parapet walls and flat roof. The parapets are weathered and they need repointing as well.

Slates need replacing/re-securing

**ACTION REQUIRED:** Specifically we would recommend that the flat roof is re-covered in a high performance felt and for the long term durability of the parapet walls they need to be repointed in an appropriate mortar, not a strong cement mortar as they have been at present.

**ANTICIPATED COST:** Costs in the region of £5,000 to £10,000. Please obtain quotations. This is likely to be a shared cost.

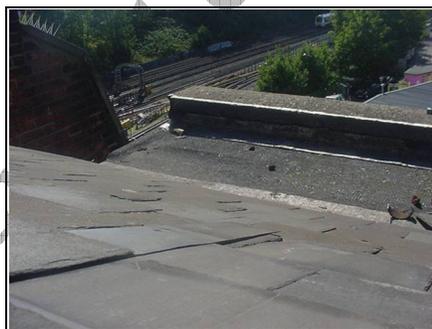
There is a low level flat roof to the front of the property. We can see there has been what we would class as temporary repairs using a product called Flashband, which is a sticky backed lead/tar.

Flat roof

**ACTION REQUIRED:** The roof needs inspecting and we would be happy to comment if photos are taken. We were unable to access it with our ladders as it was too high.

**ANTICIPATED COST:** We can only assume the entire roof will need re-roofing. We would expect costs to be in the region of £3,000 to £5,000, assuming that there are no major repairs and the decking does not need replacing. Please obtain quotations.

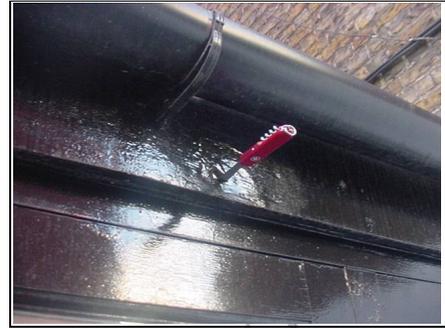
We were able to find at lower ground level some wet rot, particularly to the rear of the property. We would anticipate similar wet rot is present higher up which has simply been painted over, as in this instance. This needs repairing properly.

Wet rot above entrance door

**ACTION REQUIRED:** You need to cut out the areas of wet rot, repair, prepare and redecorate.

**ANTICIPATED COST:** We would expect costs for basic repairs to be in the region of £2,000 to £4,000. Please obtain quotes. Again, unfortunately the problem will be access.

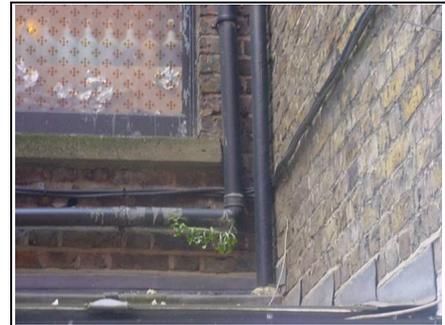
The gutters and downpipes have suffered from DIY repairs or no repairs at all and we can literally see plants growing out of some of the downpipes. We can also see staining at high level.

Plant in one of downpipes in rear

**ACTION REQUIRED:** A general overhaul of the gutters and downpipes.

**ANTICIPATED COST:** In the region of £500 to £1,000, assuming this can be carried out off ladders. This is likely to be a shared cost. Please obtain quotations.
