PROPERTY REPORT

A Warehouse in
West Molesey,
Surrey KT8

We have been instructed to inspect and prepare a Report and Schedule of Condition for a warehouse in West Molesey, Surrey KT8

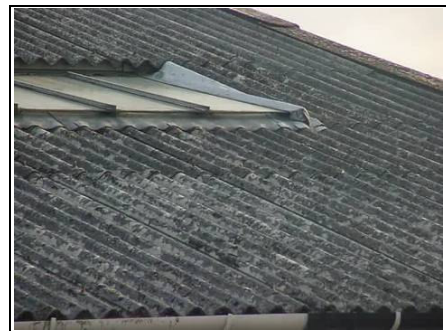
A test and report is recommended for the asbestos. The present owners should have an asbestos report, however you should note that fairly recently asbestos regulation requirements have changed so it does need to be an up to date report that includes testing.

Asbestos roof on Unit X and Y

ACTION REQUIRED: Obtain an up to date asbestos report and include this as part of the lease/schedule of condition.

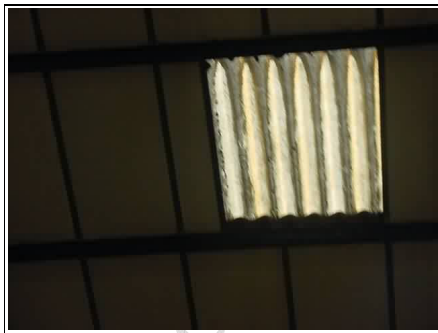
At the time of the survey there was water staining in the vicinity of some of these roof lights (on the floor and at roof level) indicating that rain is getting in. We would also comment that they need a clean.

Corrugated roof light

ACTION REQUIRED: Make roof lights watertight and clean. We would add that some of the roof lights had cracks in them and need replacing.

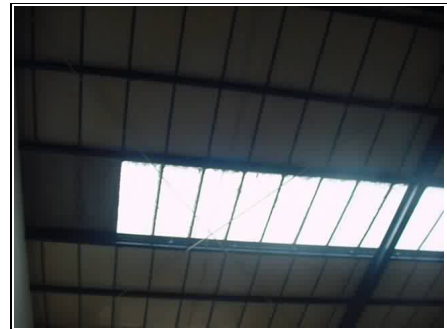
Georgian wire polished plated glass roof light

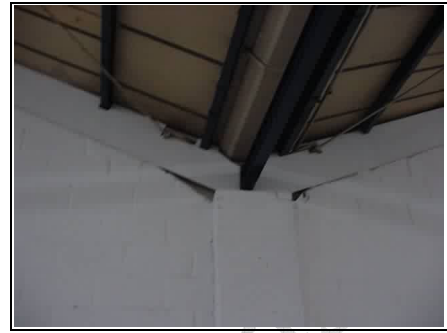
There are visible signs that the roof is leaking. We noted in some areas the under cladding has been replaced and in other areas the other cladding has literally come away and was hanging in position. We also noticed rusting to the metal roof structure, all indicating that the roof is leaking.

Rusting, indicating dampness getting in

ACTION REQUIRED: We recommend that the roofs are excluded from the lease.

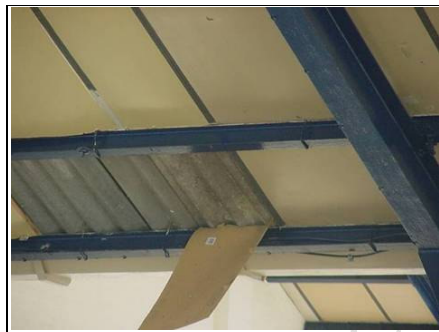
Under cladding coming down

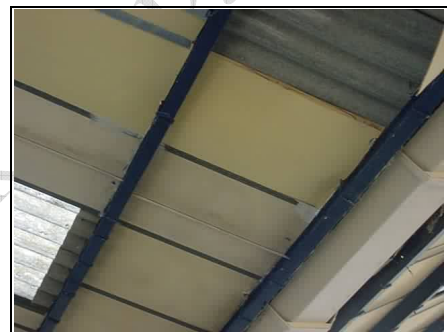
Different colour under cladding where it has been changed

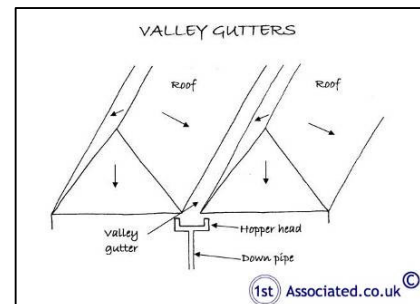
We have not had access to the roof at roof level, but we are aware from this type of design that there may also design defects with regard to the valley gutters as this is a relatively common issue. Please note these roofs are often considered dangerous to access.

ACTION REQUIRED: We will be more than happy to jointly view the roofs from a tower scaffold or equivalent for the landlord to agree its condition, otherwise we believe you will have to exclude all cracks from the lease.

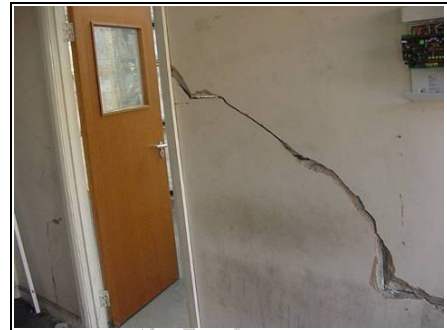
We noted a vertical crack to the front right hand corner which is in line with what we typically find where there has been movement to the front wall. We also entered Unit Z and noted there was extensive cracking in this property as well.

We also briefly entered Unit Z and noted there was extensive diagonal cracking within the plasterwork.

Cracking in Unit Z

ACTION REQUIRED: Exclude any cracks to the walls from the Lease. The Landlord to make an insurance claim with regard to the cracking.

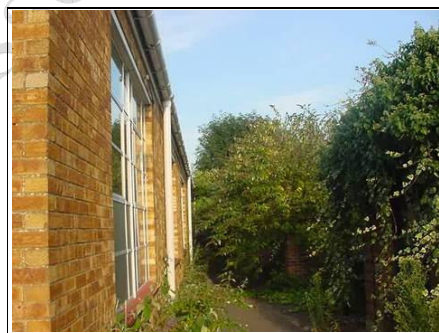
To the back of the property the trees are overgrown and would benefit from being cut back so they do not cause accelerated deterioration to the roof.

Tree to rear

ACTION REQUIRED: Cut back trees to the rear. Note, from what we can see some of them are in neighbouring properties.

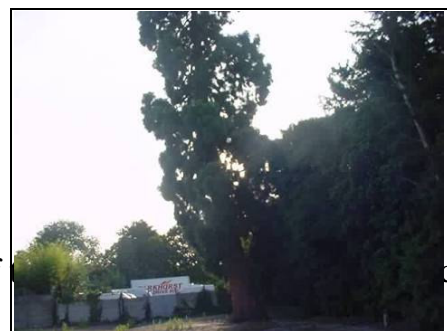
Tree to side – check whether it has a Tree Preservation Order on it

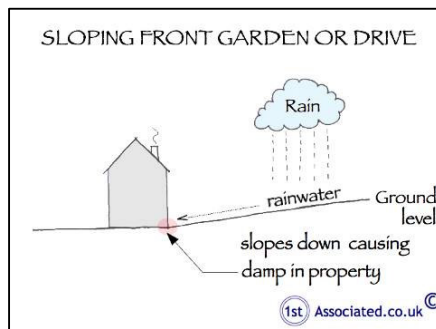
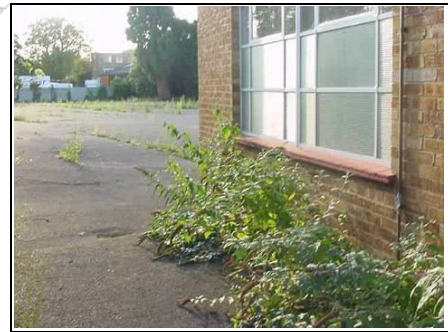
Due to the way the tarmacking is externally it discharges the rainwater against the property. We carried out damp meter readings and found dampness around the perimeter. The ground level is also slightly high when compared to the damp proof courses in many areas.

Vegetation around building

ACTION REQUIRED: Add a running gully or a French drain around the property or angle the tarmac away from the property.

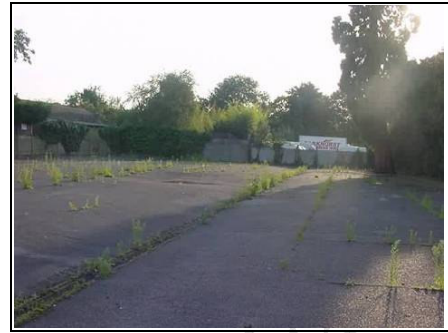
The car park on the right hand side looks like it is starting to deteriorate and also has an electric sub-station in it, which some concern has been expressed, although we believe the jury is still out as to the effects of sub-stations.

Car park deteriorating

ACTION REQUIRED: General weed killer and repairs to the car park. We would also recommend adding drainage.

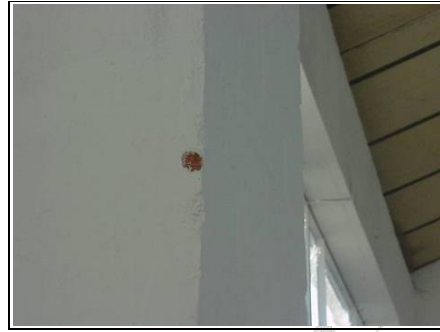
Damaged walls

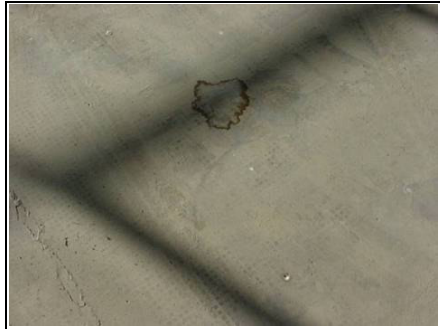
Staining on concrete floor
