PROPERTY REPORT

A Shop Unit In Woking Surrey

We have been instructed to inspect and prepare a Report and Schedule of Condition of XXX Woking, Surrey

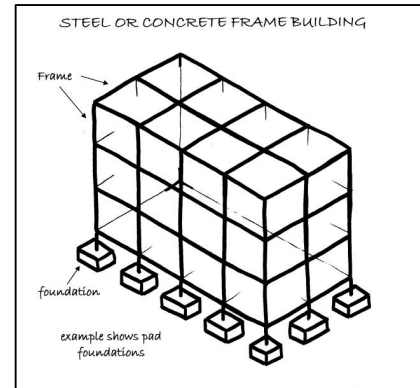
1. Cold bridging
2. Roof leaks, and
3. Multi-occupied properties/resident property problems above.

This has resulted in dampness/ condensation being visible behind the suspended ceiling tiles.

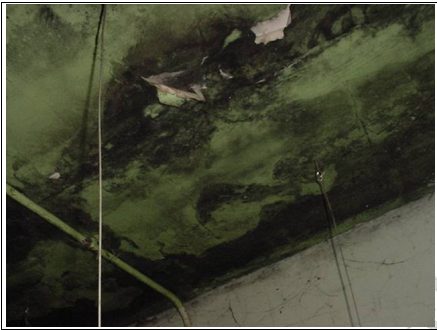
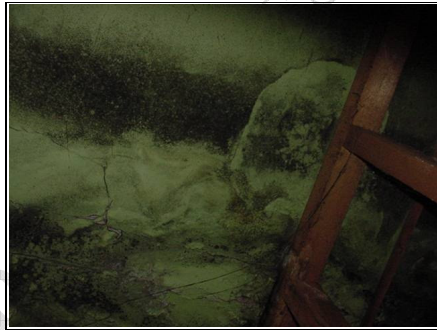
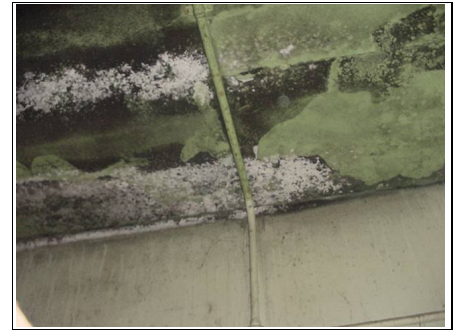
Dampness behind ceiling tiles

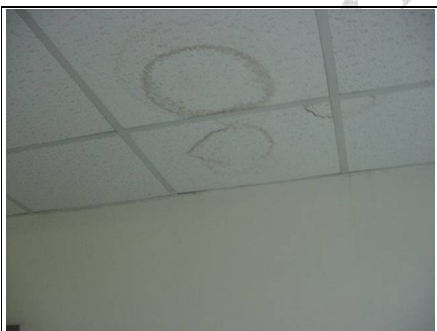
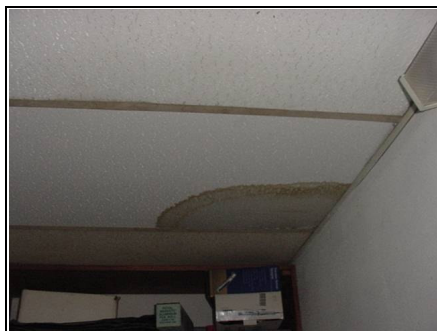
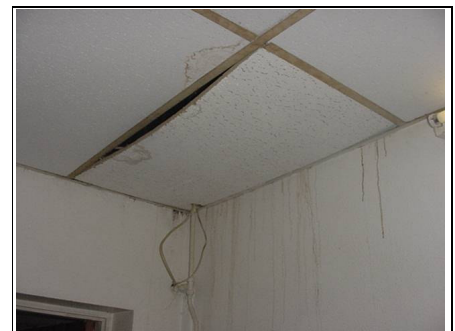
Dampness coming through ceiling tiles

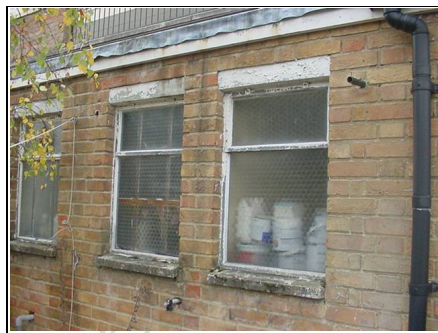
Concrete lintel

Cold bridging specifically relates to condensation occurring on cold elements of the structure, such as the concrete frame, concrete lintels and concrete roofs. This is particularly problematic in businesses that create humidity, such as a hairdresser's. This is shown in the dampness throughout the property.

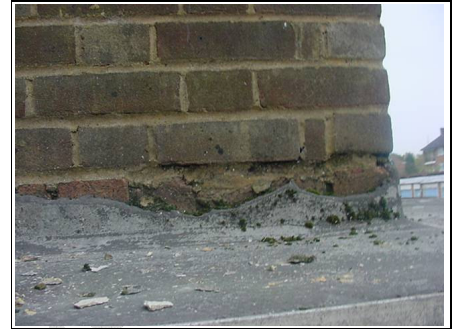
3.1 The roof is formed in asphalt. Some of the flashings are damaged and some of the asphalt is starting to deteriorate.

Damaged flashing

ACTION REQUIRED: You need to discuss with the Landlord what the long term maintenance schedule is for repairs to the roof. You need to add gutters the Landlord needs to improve the detailing to the property. Although we would add that you need to consider these again as characteristics of this property and be happy to accept they are present if you wish to take on the lease of this property, as in our experience landlords generally do not resolve this type of problem.

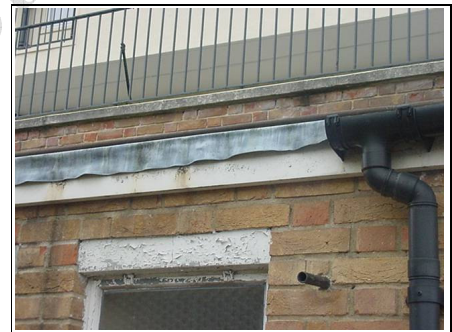
3.2 The gutters are missing to the majority of the rear wall. These need to be added as they are causing some dampness to get into the rear of the property.

Missing gutter

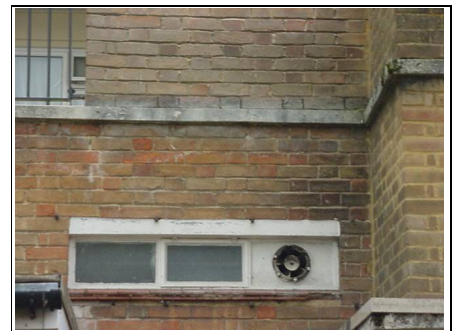
3.3 The concrete detailing is allowing water to discharge on to the roof. If you look at the adjacent photo you can see the concrete detailing, unfortunately there does not look to be sufficient grip so when it rains the water comes over the concrete detailing and then drips onto the wall itself. If anything this concentrates the water on the wall. If you look closely you can see salt to the wall caused by it being constantly damp.

Concrete detailing

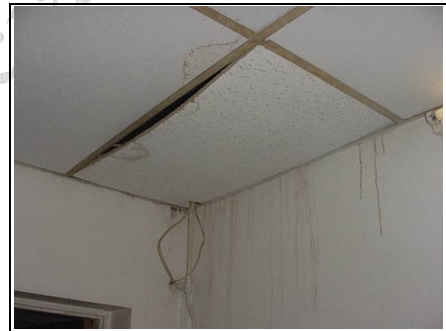
During the course of our question and answer session with the owner we were advised that the resident above had suffered a leak which caused some damage and deterioration in the property.

Ceiling coming down due to dampness / a leak

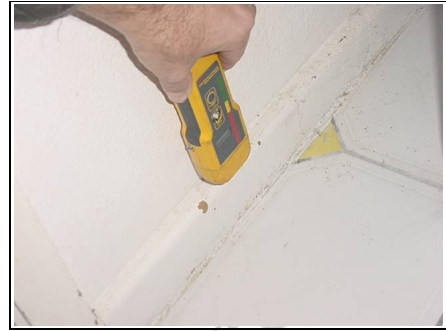
There is some rising damp to the rear of the property caused by a slightly high ground level.

It may also be being contributed to by the gutters leaking and condensation occurring in the property. We feel in this type of construction there will always be an element of dampness.

Testing for rising damp

ACTION REQUIRED: Reduce ground level.

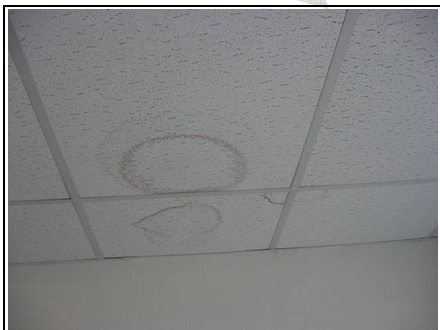
Unfortunately we can see that dampness and mould is present in the ceilings and it looks to have been a characteristic for a long term. We have already mentioned the elements that can cause dampness at the start of this Executive Summary, however often it is a combination of these. You therefore need to consider ways of running your business while these problems are present.

Leak staining visible in ceiling tiles

ACTION REQUIRED: We would recommend that you visit adjoining properties to see how they have resolved the dampness and what sort of ceiling systems they have used.

We would also recommend extract fans are added in the windows that are humidity controlled.

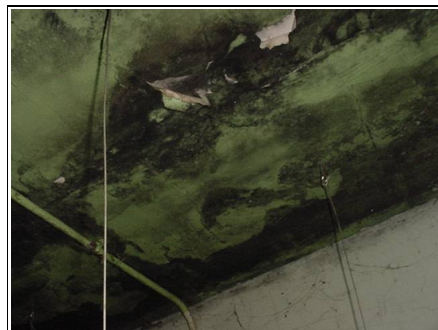
Dampness to ceiling

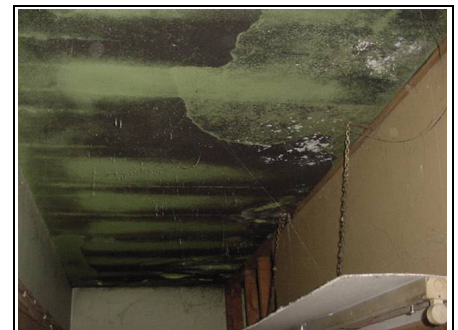
Salt coming through ceiling

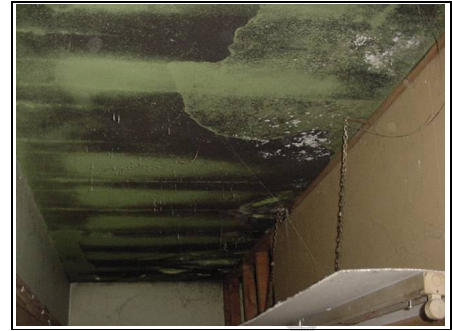
Salt coming through ceiling

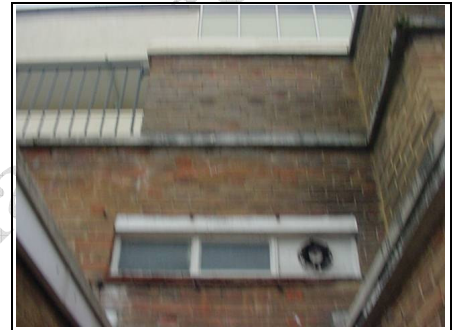
Broken extract fan

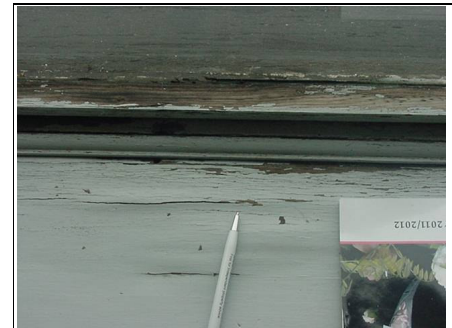
Condensation is occurring to the windows to the front and rear. To the front it is causing deterioration to the timber windows and to the rear it is causing rusting to the metal windows.

Pen indicates deterioration to timber window to front

ANTICIPATED COST: In the region of £250 to £500; quotations required.

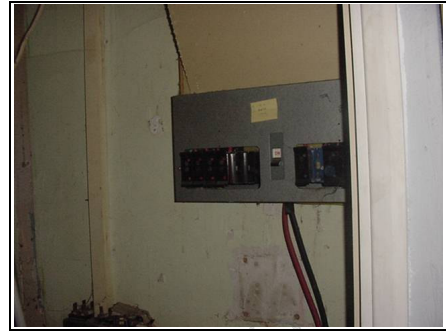
The fuse board is dated and we would recommend it be replaced and the wiring is updated. We noticed surface mounted wires and Bakelite fixings, all of which have long since been superseded.

Dated fuse board

ACTION REQUIRED: New fuseboard required. For the electrics we would recommend an Institute of Electrical Engineers (IEE) standards test and report carried out by an NICEIC registered and approved electrical contractor or equivalent.

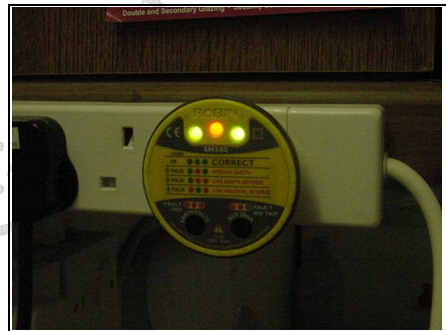
The electric test that we carried out showed there to be no earth on the system. The present owner advised that they would look at resolving the problem, however we would still have the electrical work carried out that we advise.

Earth test railing

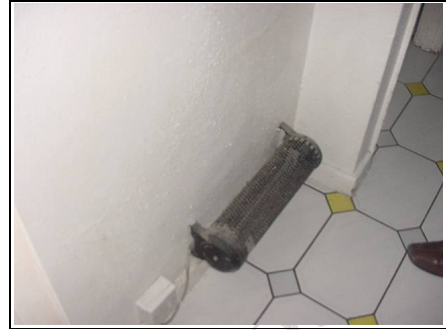
Whilst this business will give off a certain amount of its own heat there was no heating as such to the property other than the background heaters, which the owner's silent partner who showed us round was not sure if they were working.

Background heater

ACTION REQUIRED: We would recommend that you install new heaters to the rear of the property to ensure there is an element of warmth in these areas.

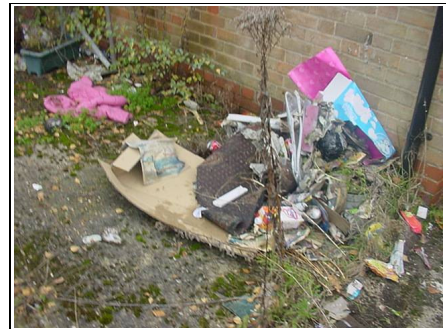
As discussed, the rubbish in the garden is best being removed. As you are aware, we discussed about clearing up and that it could potentially be from the residents above or be fly tipping.

Rubbish from flats above

ACTION REQUIRED: Clear area (if you recall you took John's phone number).

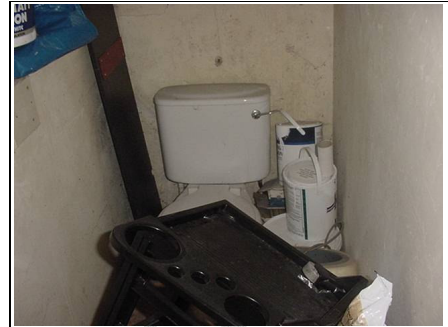
Mass of stored items in outside toilet

ACTION REQUIRED: Existing owners to clear.

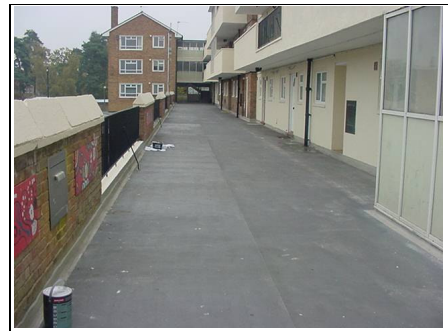
We do believe that water is getting in via the flat roof areas to the detailing that we have mentioned in the Executive Summary.

Walkway/balcony to rear of property

ACTION REQUIRED: Your solicitor should specifically write to the Landlords about these problems and ask for their comments on them and future proposals.

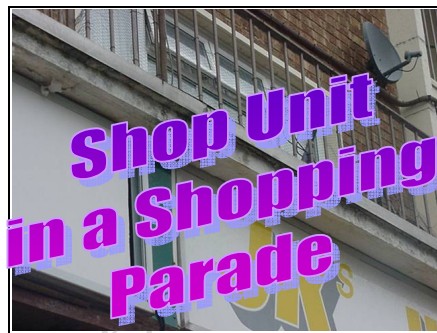
Dampness coming through the front balcony above shop

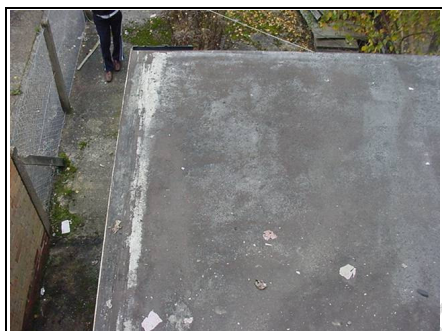
The rear flat roof over the toilet area is covered with asphalt and looks relatively flat and looks in average condition with the exception of the damage to some of the areas of flashing. We would also question the way it is detailed at the perimeter. We feel this discharges some rainwater down the face of the brickwork.

Rear flat roof over toilet area

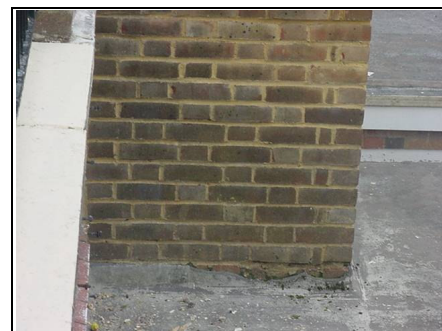
Damaged flashing

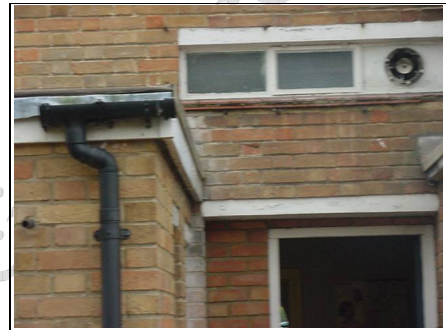
Missing gutter

ACTION REQUIRED: Please see our comments in the Executive Summary.

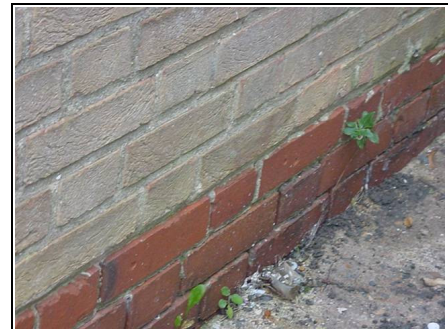
Weathering to brickwork

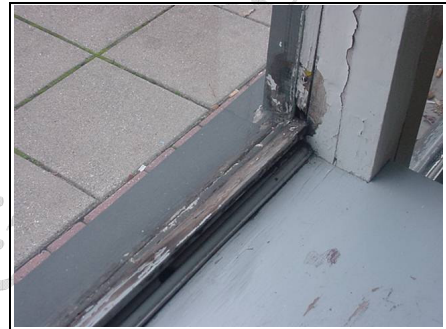
Flaking paint to window cill

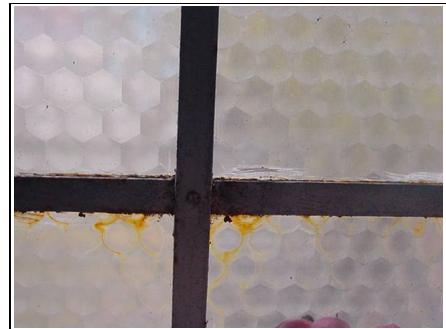
Rusting rear metal windows

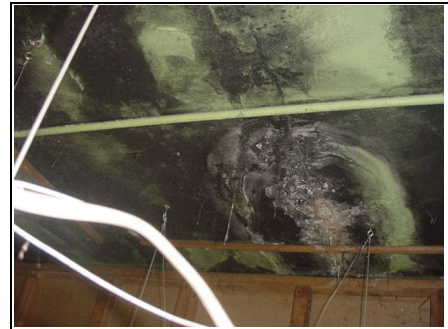
Damp ceiling

ACTION REQUIRED: Please see our comments in the Executive summary. You will have to consider this as a characteristic of this property.

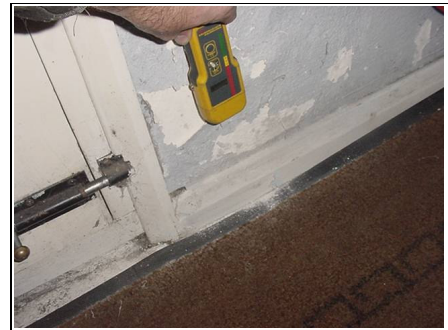
In this particular case we have found some areas of rising damp.

Testing for rising damp

ACTION REQUIRED: Please see our comments in the Executive Summary.
