RESIDENTIAL BUILDING SURVEY

A Modern Detached Property, Abbots Langley, Hertfordshire

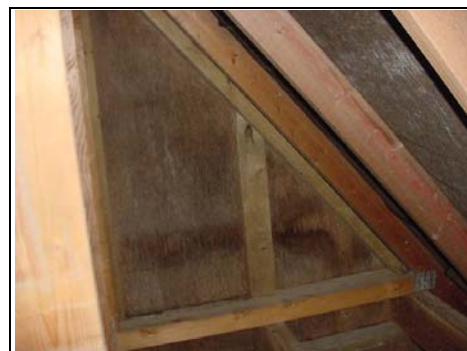
Dampness coming into the roof space.

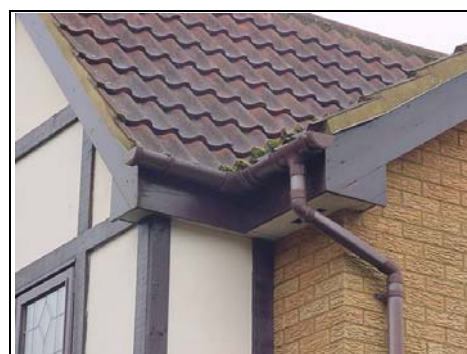
The top of the box bay window where the dampness / condensation is occurring.

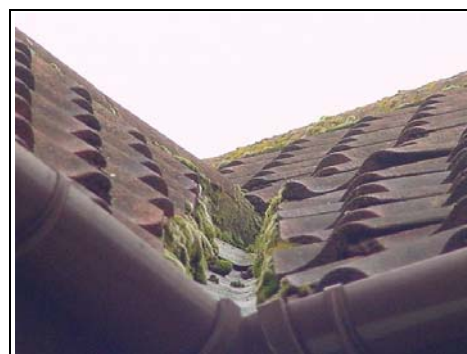
This is more something you need to keep an eye on rather than immediate concern. We could see some moss to the sides of the valley gutter. The sides are formed with a concrete edge; we much prefer a lead detail. These do tend to start to deteriorate after 10 – 20 years when the concrete comes away; this in turn leads to blocks in the valley gutters and leaks into the roof.

ACTION REQUIRED: No immediate work required. You need to keep an eye on this area and watch out for the cement coming away and sitting in the valley gutter.

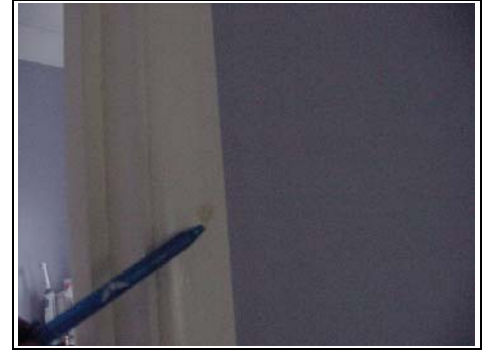
This is due to the internal timber not being knotted, primed and stopped properly. This is a problem we are coming across more frequently and probably means that the doors have not been painted since the original paintwork.

ACTION REQUIRED: Redecoration should hide the majority of knots; however some still will grin through unless you take it back to bare timber and then knot, prime and stop it.

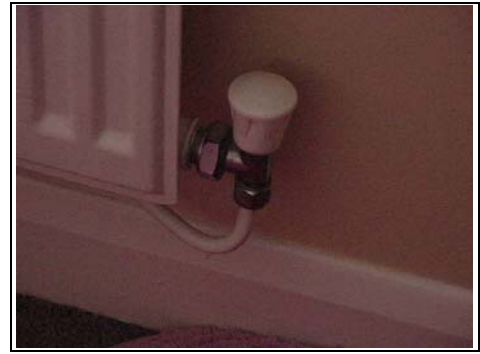
The property has micro-bore pipes to the radiators (a thing which we have experienced very bad problems with ourselves this weekend); due to the small bore of the pipe they can block up, particularly after a while when sludge builds up within the radiators. However, during our question and answer session, the owner advised that he had had no problems.

ACTION REQUIRED: We would recommend that the system is drained down, cleared of any sludge and then refilled with a chemical inhibitor within the water. You may wish to leave this until you replace the boiler or you get a blockage!

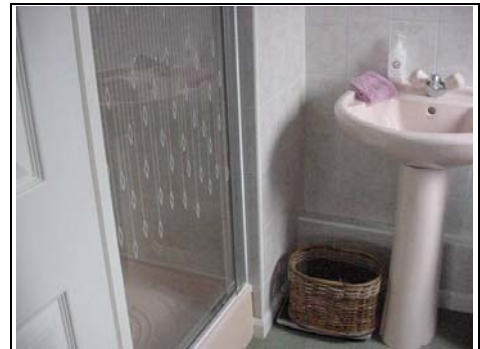
Coloured bathroom suites tend to look dated. We would also comment that you have a plastic shower tray in the en suite room, which can tend to leak as they 'give' slightly when you get into them. We would suggest that the mastic is checked in this area.

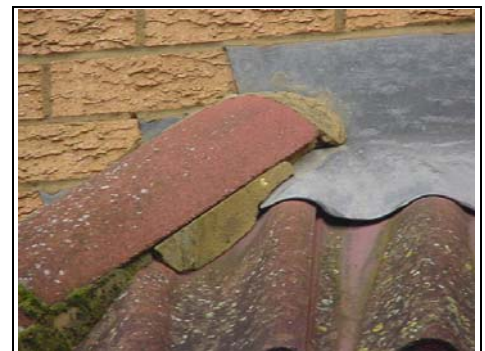
You have a small roof over the entrance door; this is pitched and clad in a similar tile to the main roof. It has a lead flashing where it meets the main building, which is a good detail. In this photo you can see how the concrete is starting to come away; this is the problem that we have mentioned will happen with the valley gutters at roof level, where the concrete then comes away and falls into the valley gutter and can block it, as well as allowing dampness into the roof, which doesn't get noticed until quite a bit of damage has been done. This is why we recommend you inspect it occasionally.

Close up of the flashing

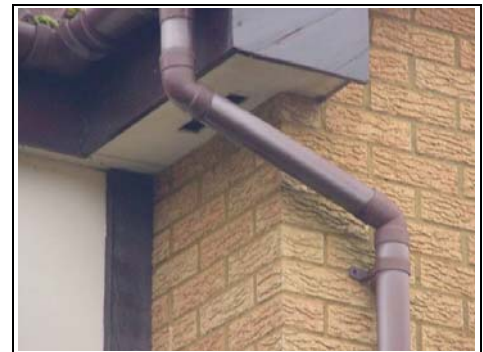
From ground level the gutters and downpipes looked to be older style plastic, which does get brittle with age and sunlight; at present they are starting to fade, as you can see in this photo, which does mean they are moving towards their brittlest stage. There may be some minor leaks, but we feel that most people could live with these.

ACTION REQUIRED: We would always recommend that the gutters and downpipes are cleaned out, the joints are checked and the alignment checked to ensure that the gutters fall towards the downpipes.
