RESIDENTIAL BUILDING SURVEY

OF
Acton, W3

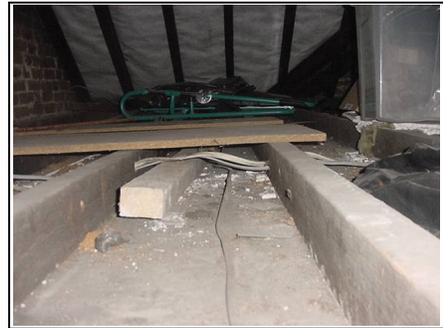
We noted in the roof space that there was next to no insulation. If you add insulation you will increase thermal efficiency. As the roof has a breathable felt you will not in theory have to add ventilation. However, we would suggest that you check the roof space on a warm day.

No insulation in roof space

ACTION REQUIRED: Please see the Roof Section of this report.

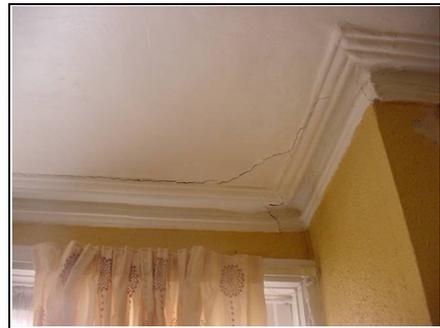
2) Cracking to the front of the property indicating that there has been movement (possibly the reason for the rendering)

Cracking to the front bay window

ACTION REQUIRED: The present owner needs to make an insurance claim for the movement and then you need to continue with the same insurance company. This will then limit your liability to the excess. You need to get a discount off the property of whatever the excess is. The insurance company will normally monitor for one year as recommended by the research establishment.

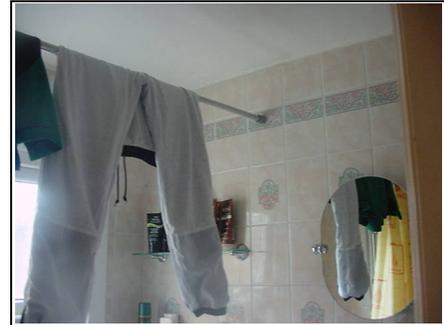
When properties such as these are converted into flats, they are prone to condensation because when you are washing and cooking and also perhaps drying your clothes within the flat then the humidity levels rise.

Clothes hanging in the bathroom

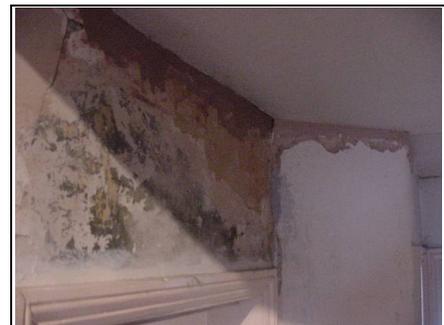
Paper off the walls

ACTION REQUIRED: We would recommend lining paper is added to the walls rather than the plaster taken off.

ANTICIPATED COST: It really does depend on how and what standard you want the decoration to be whether you are going to do the work yourself or use a VAT registered company. We expect a £1000 - £2000; quotations required.

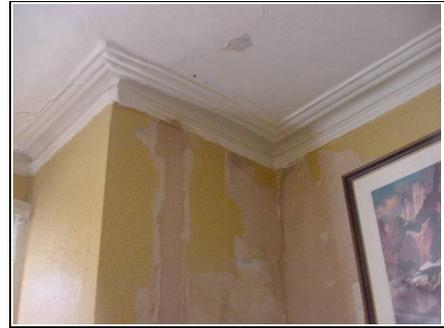
Paper off the wall due to re-wiring work

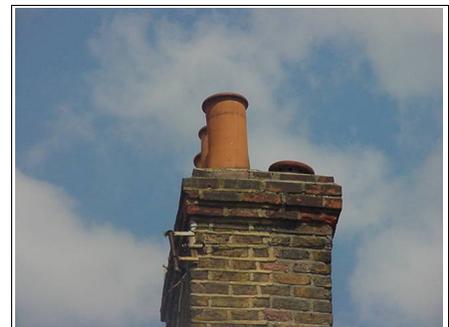
Close-up of front chimney from the rear (you can see that re-pointing has been carried out on your side but not on your neighbours side which can still mean dampness gets in)

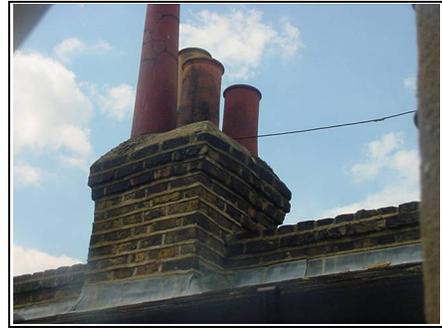
This chimney was viewed via the bedroom window. It is brick built and looked in reasonable condition and looks to have been re-pointed. We noted a lead flashing. It has chimney pots and there looks to have been repairs to the flaunchings.

Rear chimney

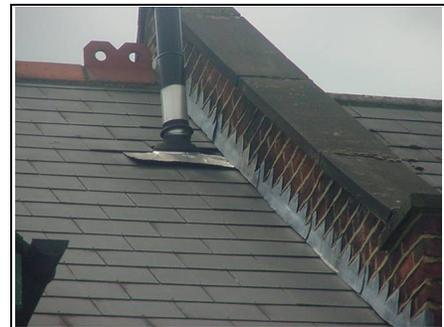
Parapet wall

which we are pleased to see is cut to follow the joint and there is also a coping stone on the top. There may be a bit of water getting in via the flashing but it is generally in average condition. We did not see anything unusual for this age of property.

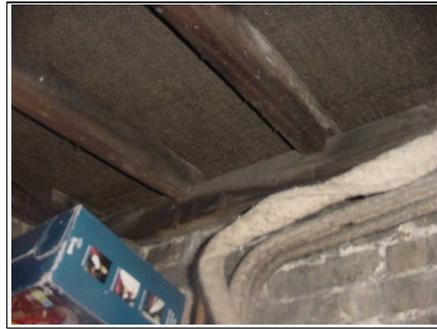
To the rear of the property is hessian based bitumen. This type of membrane has been used since the 1960s. We generally found it to be in average condition, although it is damaged in a few places but this is not unusual considering its age.

Original hessian based felt in rear roof

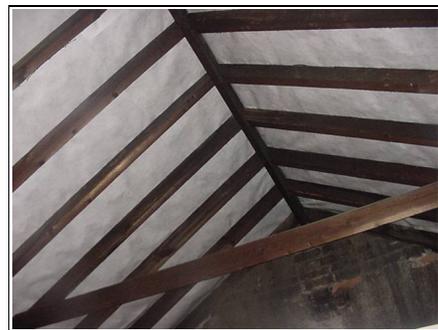
To the front of the property in the main roof we found a modern breathable underlay indicating this part of the roof is relatively new as breathable underlays have only been used since 2002.

Although we would add it seems strange that as both areas have a man-made slate they weren't both re-covered using a breathable underlay.

Modern breathable felt in roof

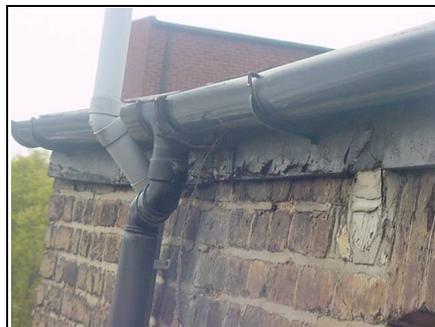
From ground level the gutters and downpipes looked to be plastic and appeared in average condition. There are a few repairs.

The plastic used is a mixture of the older and newer style. The older style is affected by sun light. It loses its colour slightly and does become brittle over the years.

Plastic gutters

ACTION REQUIRED: We would always recommend that the gutters and downpipes are cleaned out, the joints are checked and the alignment checked to ensure that the gutters fall towards the downpipes.

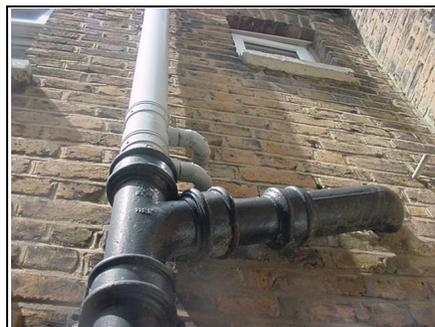
Cast iron and plastic soil and vent pipe

ACTION REQUIRED: You need to decide to either maintain the cast iron or replace with plastic.

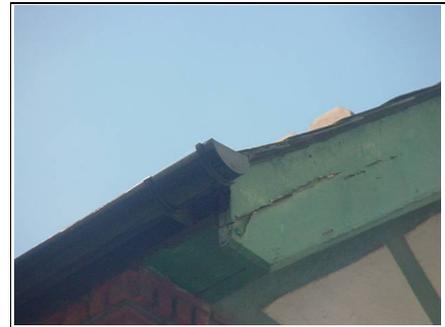
Barge board (front fascia & soffit)

ACTION REQUIRED: Re-decorate before the winter of 2012.

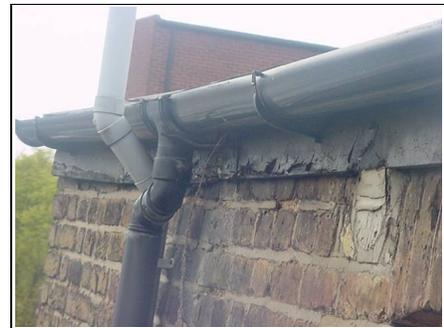
Soffit board deteriorating

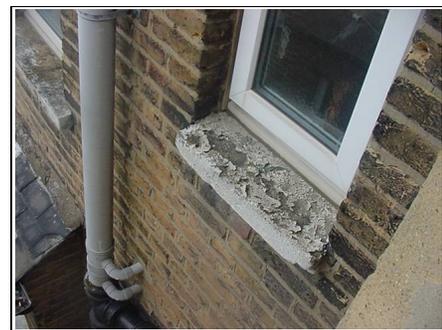
Painting needed to the window sills

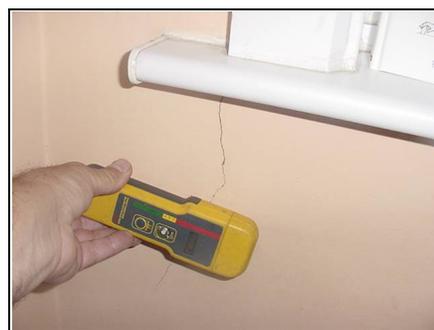
Cracking - Movement between the main property and the rear extension often caused by leaking drains

ACTION REQUIRED: Please see our comments in Executive Summary.

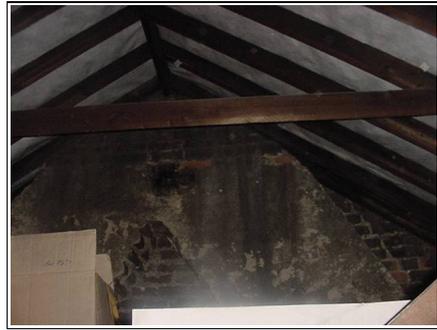
Chimney that has been rendered
(for fire reasons)

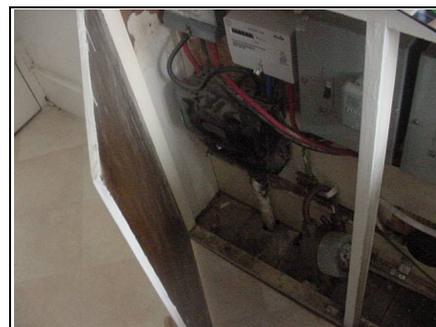
The electric fuses and consumer units were located in the ground floor shared entrance area. We would date the fuse board as being from the 1980s and, whilst not being recommended or fitted any more, it is reasonable. However, it would not meet current standards so, if you wish to be 100% safe, replace with a new fuse board.

Fuse board
