RESIDENTIAL BUILDING SURVEY

Anerley, London SE20

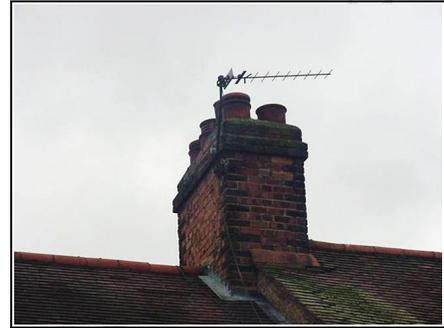
Chimney

We believe the flaunching to the top of the chimney is starting to degrade.

ACTION REQUIRED: Ideally the chimney needs a close check and probably repairing within the next few years. We would recommend the summer of 2012.

ANTICIPATED COST: Cost in the region of £500 - £1500 (five hundred pounds to one thousand five hundred pounds) as scaffolding is likely; please obtain quotations.

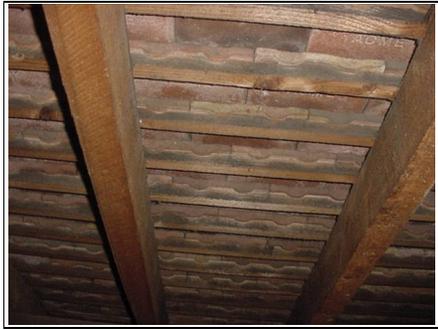
When we were in the roof space we could see that the tiles didn't have any protective underlayer. We could see from the pattern staining that wind driven rain is getting in. Today a modern roof would have a protective underlayer. The main problem with these types of roof is (in harsher weather conditions such as wind driven rain) if the nibs start to deteriorate. Generally we would say that the nibs are in reasonable condition as you can see in the photo below. We are aware that some people would be put off purchasing the property with a roof such as this.

No sarking felt

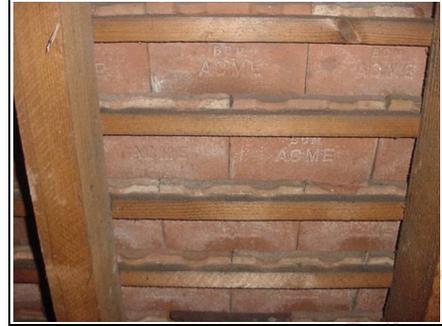
Pattern staining where rain is getting in

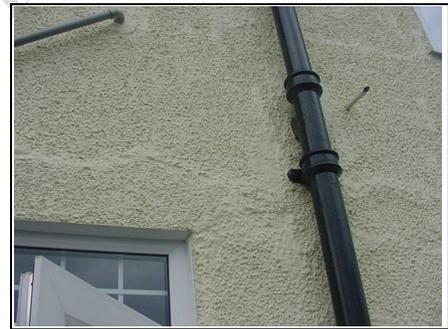
The marks that can be seen to the rear of the property (that we believe you enquired about) are from an old lean-to. There are areas that have been repaired and tend to be weaker than the original render.

Repairs to Render

ANTICIPATED COST: Likely to be in the region of £500-£1000 possibly more if render repairs are required which we feel is more than likely; please obtain quotations.

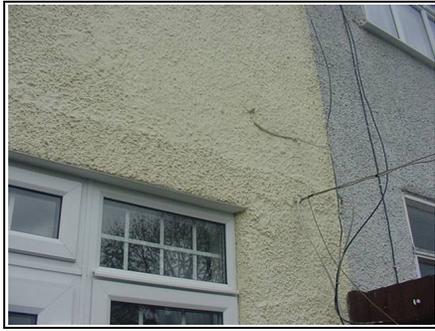
Bumpy render to the rear where the old lean-to was.

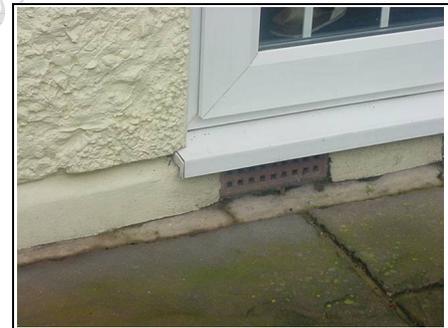
This property has what is known as a suspended timber floor. This means underneath the laminate and tiles that is throughout the ground floor there is a suspended timber floor. We were disappointed that we could not see the floor itself with the exception of under the stairs where we had a very limited view. What we did note is that there are not enough air bricks which are essential in reducing dampness and therefore deterioration. Worse still some of the airbricks are acting as gutters for any rain water that comes in. The photo shows how the air brick is at ground level allowing water to come in. The sketch shows how to remedy this.

Airbricks acting as gutters

opened up at some point to check its condition. We have found in the past that where air bricks act as gutters such as this it can lead to wet rot and woodworm. Unfortunately it is impossible to tell without opening up the floor.

ACTION REQUIRED: Additional air bricks need to be added and existing air bricks need to be amended as per our sketch. We would also comment that the floor needs to be

ANTICIPATED COST: To put extra air bricks and protect them will be a few hundred pounds. To open up the floor will be a small amount of money but it's the damage you could find under the floor that you have to guard against. In a worst case scenario with woodworm etc you may have to replace a large portion of the floor; please obtain quotations.

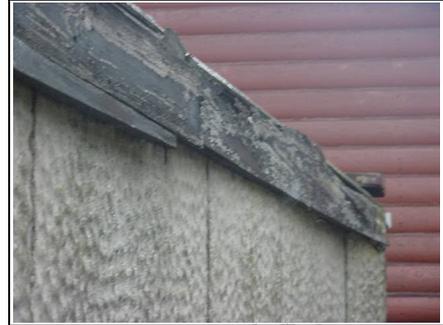
There is a single detached asbestos garage to the rear of the property. There are health hazards associated with asbestos especially where it's deteriorating. With residential properties we also find that the perception of asbestos is difficult to deal with and therefore leads to a reduction in the value of the property/or people simply don't want to buy a property with any asbestos.

Asbestos garage

ACTION REQUIRED: We would recommend that you remove the asbestos as soon as possible.

Our insurance company require us to advise we are not asbestos specialists. We recommend you have an asbestos survey carried out by a specialist asbestos company.

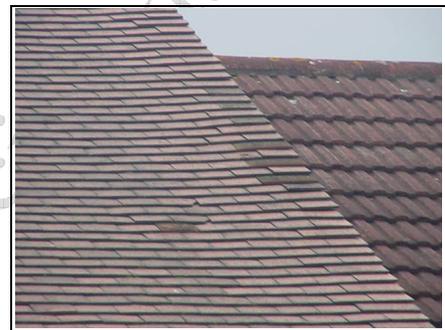
The roof is pitched and clad with a nibbed clay tile and, from ground level, this looks in slightly below average condition considering the roofs age type and style. With this age of roof there will usually be a few missing or displaced tiles, this is nothing unusual. We can see that some of the tiles have been lifted to the edge and duly replaced. This is caused by heavy winds.

Tiles on roof lifted by the wind

ACTION REQUIRED: You need to have a supply of these tiles to hand and carry out periodic visual inspections and maintenance of the roof, as required. You may need a roofer for half a day.

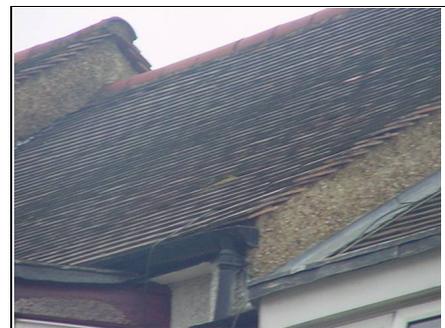
As the property sits on a sloping site there are upstands to the roofs to accommodate the slope. It also means there are exposed areas of render at high level and these areas can be susceptible to dampness getting in and deterioration.

Front left-hand side upstand

ACTION REQUIRED: You need to keep a particularly close eye on the render in these areas

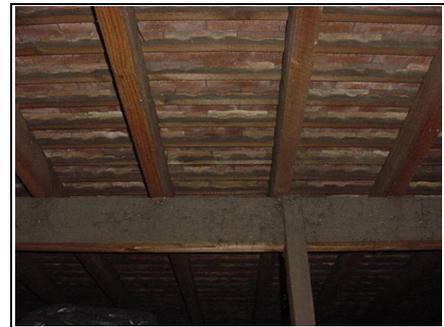
No sarking felt present.

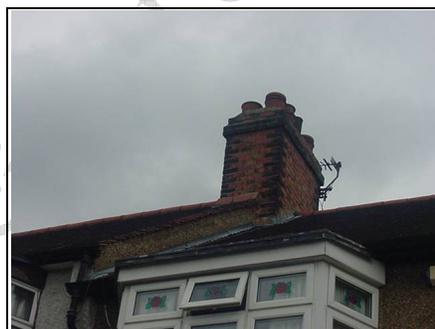
There is a flat roof to the front bay window which unfortunately we couldn't see. These are renowned for leaking. We checked in the bedroom and couldn't see any visual signs of dampness getting in so checked it with a damp meter.

Flat roof over bay window

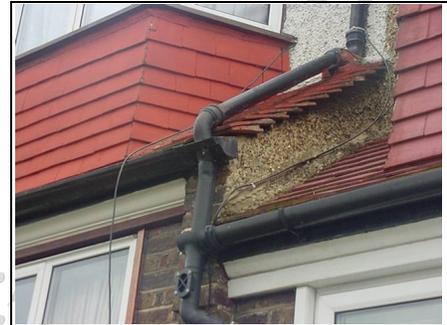
The gutters and downpipes have mainly been replaced with plastic but some cast iron remains; usually they were originally cast iron.

Gutter and downpipes

There may be some minor leaks but most people would be happy to live with these.

ACTION REQUIRED: We would always recommend that the gutters and downpipes are cleaned out, the joints are checked and the alignment checked to ensure that the gutters fall towards the downpipes.

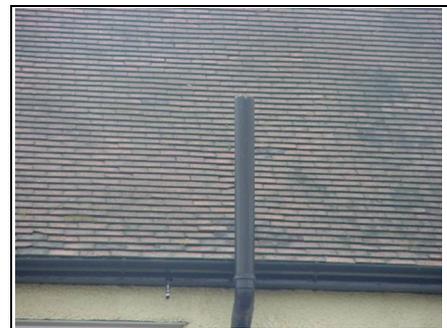
The property has cast iron soil and vent pipes. Cast iron of this age is likely to leak and corrode therefore you need to regularly maintain it and is probably the reason why the gutters and downpipes have been replaced.

Cast iron soil and vent pipe

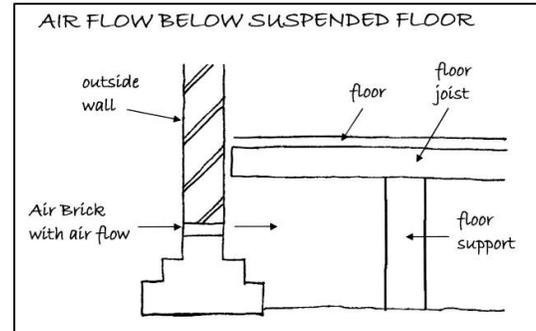
The floors of the property are suspended timber floors. This had a laminate covering and we unfortunately unable to gain access to view inside the floor. We are concerned there may be some dampness/woodworm under the floor

ACTION REQUIRED: You need to open up the floor and investigate in due course and before the summer of 2013.

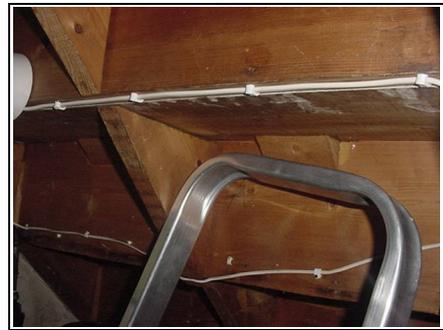
We noted that the underside of the staircase was exposed. It is more normal today to have a half hour fire barrier to stop fire spreading from the ground floor to the first floor in a worse case scenario. You may wish to take a view on whether you add this.

Staircase not lined

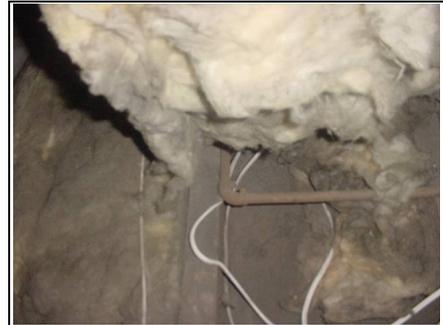
Some roof insulation was present although not to current Building Regulations requirements of 300mm. In this instance it is approximately 100mm-200mm.

Insulation in roof
