RESIDENTIAL BUILDING SURVEY

xxxxx Ludlow, Shropshire. SY8 X

INDEPENDENT CHARTERED SURVEYORS

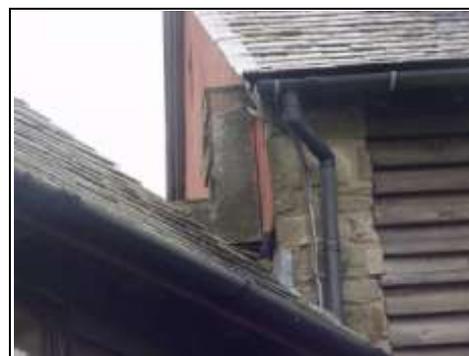
We can see there has been some damage to the perimeter of the slate roof which is just visible in the centre top of the adjoining photo. This is due to we suspect the exposed location and is a very unusual detail to have on such a new property. Also some of the lead around the chimneys have been displaced again we believe this is due to the exposed location.

Damage to perimeter of the roof

ACTION REQUIRED: Although it is common sense you will need to have a check of the high level areas such as the roof coming up to the winter months and you also need to get to know a good roofer, we always recommend that you have a supply of your own slates as well so that the roofer does not have to look around to try and find these which can all take up time which you may not have if the roof is damaged.

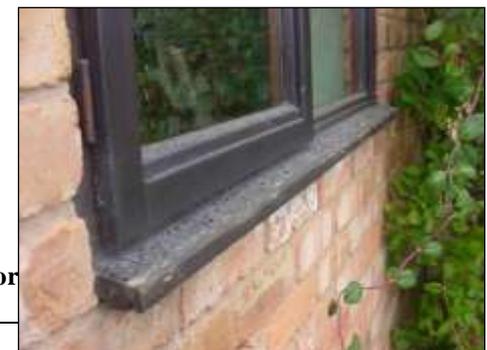
Softwood window

we noted some of the double glazed units had misted over, this is fairly common in timber windows, particularly poor quality windows where the timber moves and breaks the seal of the double glazing unit.

ACTION REQUIRED: You will need to redecorate within the next few years and also replace the misted up double glazed units if this bothers you.

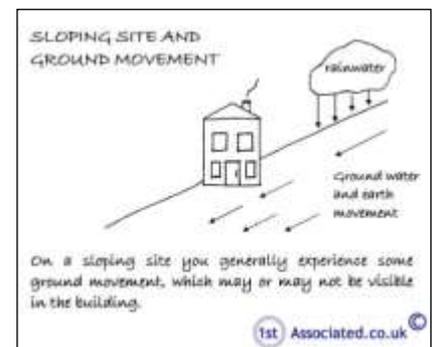
We would expect during heavy periods of rain that some rain may get into the property bringing dampness to the stonework however we would advise that we found the interior of the property to be dry lined (also known as false wall).

Sloping site

ACTION REQUIRED: You do need to stand outside next time it rains heavily and see how the water travels, if it does prove to be a problem we would suggest a French drain.

ANTICIPATED COST: In the region of £2000-£3000 dependent upon how difficult the digging is to put a French

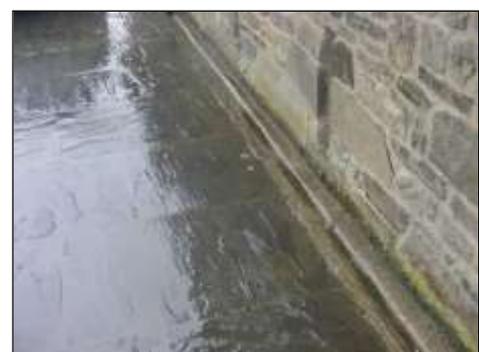
Running gully – water may get into property

gully along the front of the property; quotations required.

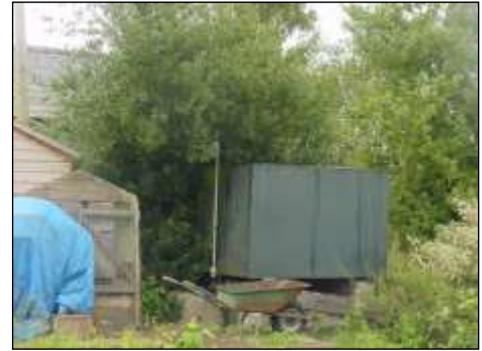
We noted the property had a metal oil tank without a bunged wall this does mean that if there is any deterioration to the oil tank then the oil can escape. The mess oil can make is an experience to be believed!

ACTION REQUIRED: We would Metal oil tank budget to replace this with a plastic tank adding a bunged wall.

ANTICIPATED COST: £3000-£4000; quotations required.

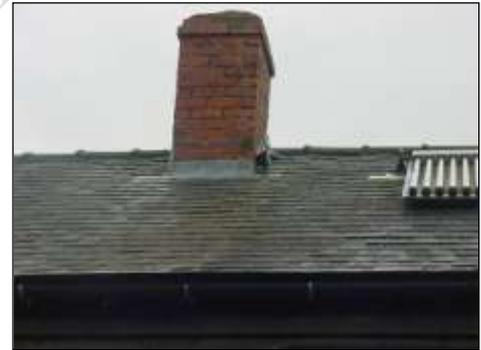
Chimney one

This chimney is brick finished with no chimney pots with lead flashings. From what we could see the chimney looks in average condition. We were unable to see the top of the chimney known as the flaunchings therefore we cannot comment on this. We did note that the lead was lifted, probably due to the exposed location and there is likely to be some pointing that is worn.

ACTION REQUIRED: Before the winter of 2010 you need to check this chimney, reposition the lead and repoint if necessary.

ANTICIPATED COST: It will be likely that scaffold access will be required therefore the cost will be in the region of £1000-£2000

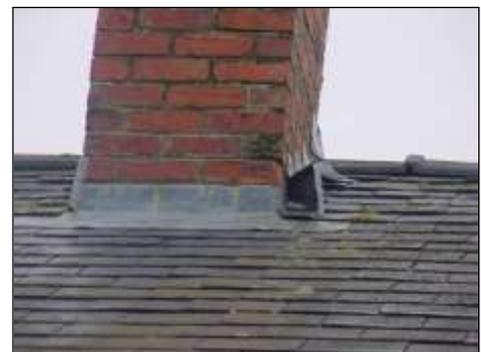
Chimney one showing lead coming loose, possibly some repointing needed

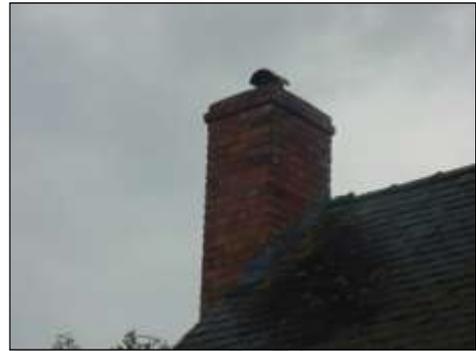
Chimney two

We would comment in a similar manner to chimney one, it is brick built with a single chimney pot we would recommend that this chimney is also inspected close up when the repair work to chimney one is being carried out in the next few years.

ACTION REQUIRED: Whilst the work is being carried out to chimney one the central chimney we would also recommend that the other chimneys are inspected.

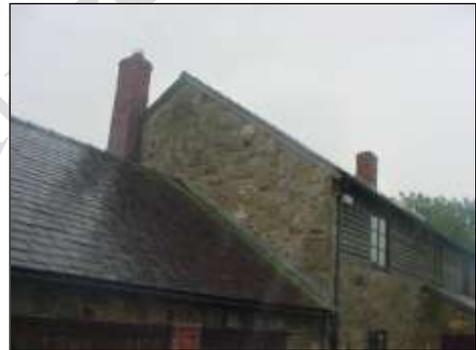
Chimney three

This chimney is again brick built and is in a similar condition to the other chimneys.

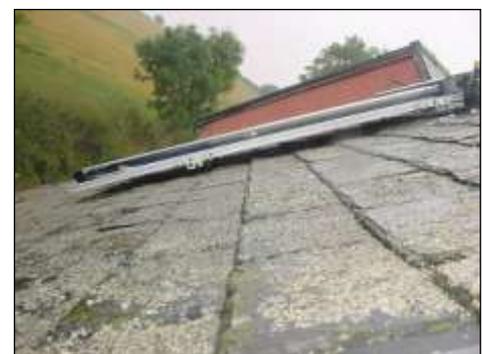
Generally we would comment there is a minor amount of moss growth present on the roof slopes, particularly those that do not get the sunlight. In this case, in extreme cases, impede the run-off of rainwater, lead to gutter blockages and cause water penetration which, in turn, may lead to rot or other defects in nearby timbers.

Moss to annex roof

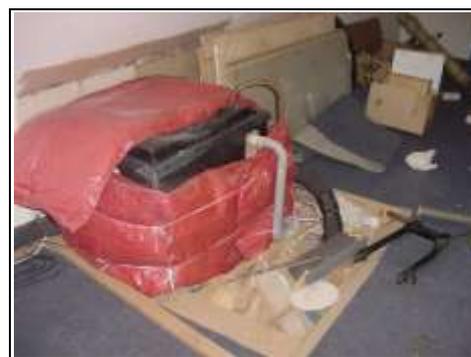
Ventilation

We did not see any vents to the roof to help prevent condensation.

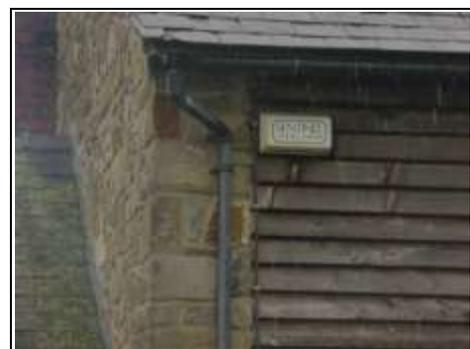
The property has plastic gutters and downpipes. What we found was in average condition all things considered; we can see areas where the gutters are leaking and some general repairs are needed but most people would be able to live with these.

Gutter and downpipe

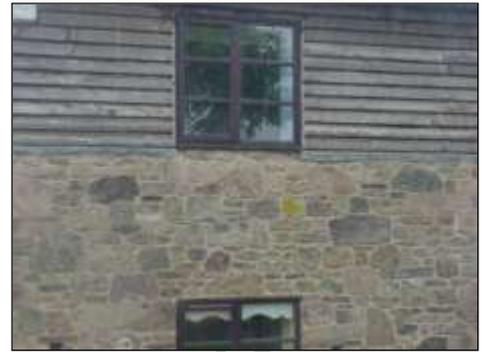
Timber cladding has been used to the upper part of the property. The outside face that we can see looks to be untreated which is how it is meant to be/or the timber may need treating. We are not 100% certain in this instance.

Timber cladding

ACTION REQUIRED: Your legal advisor needs to specifically ask the owner whether the timber is pre-treated or whether it needs regular treatment. It is high level work and is likely to be costly in the region of several thousand pounds. Please refer to our Executive Summary.

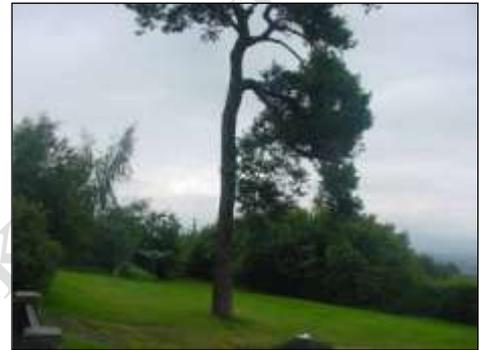
Damage to foundations and underground services can be caused by trees and shrubs. There is one fairly large tree which is quite close to the building but we do not believe it to be, what we term within influencing distance, and it needs to be maintained. We would refer you to the Executive Summary and note our comments with regard to how quickly Leylandii trees grow. Properties with trees nearby will always be susceptible to movement

Tree fairly close to the property

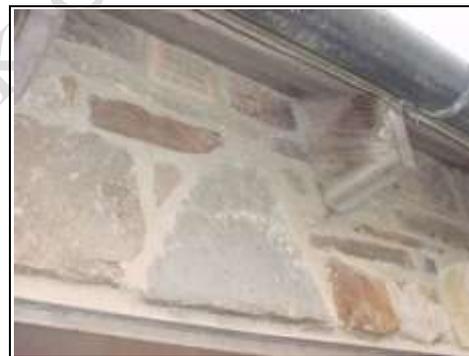
The roof perimeter detail includes exposed rafter feet. We generally find that due to the awkwardness of these they do not get painted / stained as often as they should and you may find rot if they are closely examined.

Fascias and soffits

ACTION REQUIRED: Paint/ Stain before the winter of 2010.

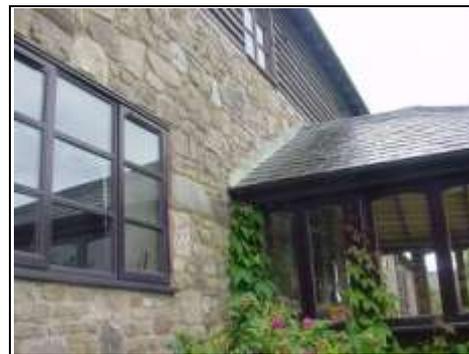
The property timber double glazed windows we noted trickle vents to some of the windows. The original property has hardwood windows which are in relatively good condition the annex has softwood windows where the paint is starting to flake and needs attention.

Double glazed timber windows

ACTION REQUIRED: Please see Executive Summary

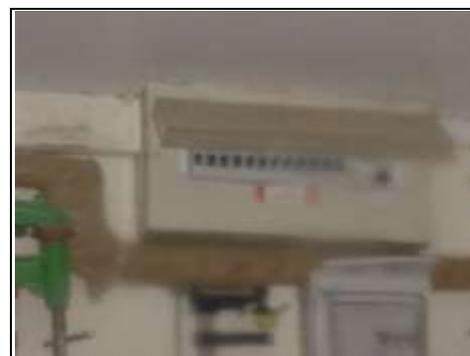
The electric fuses and consumer units were located in the annex toilet and garage. We believe the fuse board is original, whilst not the best now available, it is reasonable. If you have young children in the property or elderly people you may wish to change and update to the latest fuse boards that cut out far quicker than these ones.

Fuse board in garage
