RESIDENTIAL BUILDING SURVEY
OF
London, N11

Firstly, may we thank you for your instruction; we have now undertaken a Building Survey (formerly known as a Structural Survey) of the aforementioned property.

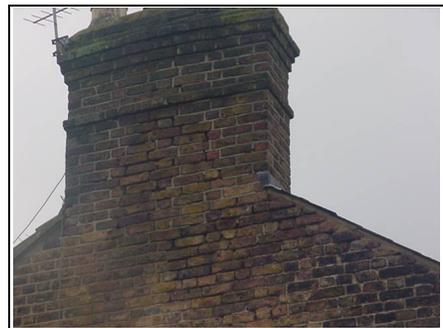
Rear chimney in need of repointing

ACTION REQUIRED: Repair and repoint.

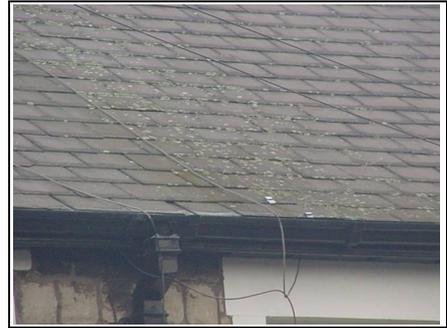
The Slate roof has a number of lead tingles which indicates that the nail fixings are rusting. Normally it is said if there are more than a dozen (which it is close to that) there are problems with the roof. As discussed we have been unable to access the upper apartment (we knocked but no-one was in at the time, they were probably at work!) and therefore have not had access to the roof.

Lead tingles to slates

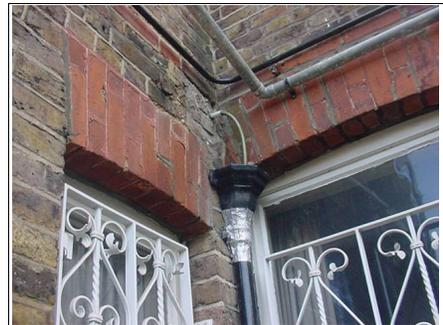
There are cast iron gutters and downpipes, a lot of which have been temporarily repaired using flashband which is a sticky backed lead. We consider this a temporary repair.

Flashband repairs to gutters and downpipes

ACTION REQUIRED: You need to ensure that the gutters and downpipes are watertight and taking the water away from the building (at the moment we believe it is discharging quite a lot of water into the building). This will then allow the building to start drying out. It has absorbed over the years a lot of water and as a rule of thumb it is generally considered that for every inch (2.5cm) of wall and you have 9 inches of wall here at least, it takes a month of good weather to dry out. The sooner the repairs to the gutters and downpipes are carried out the better.

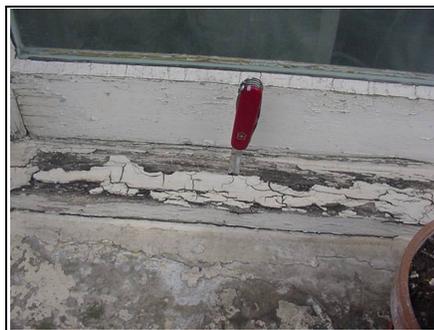
The windows are in a poor but saveable condition. We have included the windows in the general section as often these are a shared responsibility however they may be specifically your responsibility. You need to check with your solicitors/the lease. We are more than happy to carry this out for you if you wish.

Windows in need of repair

ACTION REQUIRED: We would recommend that new timber is spliced into the sliding sash windows for example which look to have been filled quite extensively over the years, then general easing and adjusting and redecoration.

ANTICIPATED COST: For basic repairs in the region of £500, major repairs would have to be priced on an individual window by window basis; quotations required.

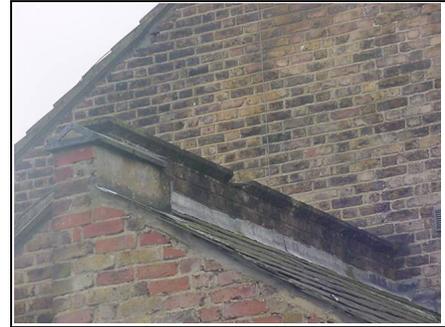
We are not certain what is happening to the rear extension but we can see some deterioration/distortion. It may be due to the parapet wall leaking over the years. This in turn has resulted in some rot to the timbers. There is also a wooden lintel on the gable end so it is likely that there are timber bearers in the wall as well and these may have rotted slightly. This together with the purlins support that we can see, normally there would be one piece of timber running all the way across rather than two pieces of timber that are propped in place.

Parapet wall

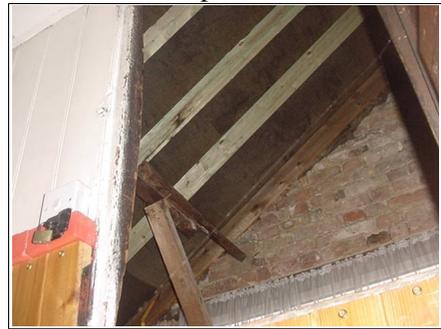
Deterioration to timbers

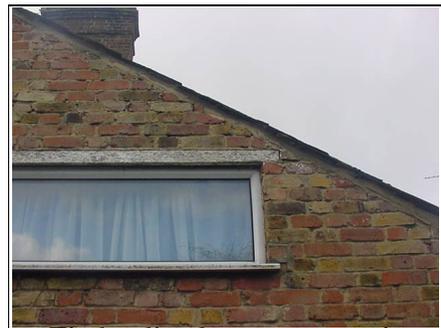
Timber lintels and bearers defined
Many years ago we used to use timber lintels to give support over any openings. We also used to use a system of timber bearers set within the wall which was thought at the time it would help reinforce it however it does in fact allow these timbers to rot and have the opposite effect.

Timber lintel on rear extension

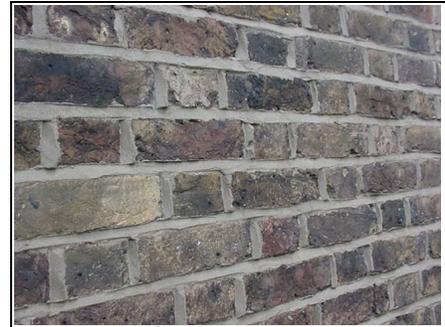
Dampness is coming through the walls in part due to the cement mortar that has been applied.

Cement mortar

ACTION REQUIRED: This property needs to be allowed to breath. We recommend the removal of the cement mortar and repointing in a lime mortar. This work needs to be carried out to the front and the rear of the property and the side of the kitchen and the bathroom area as soon as possible.

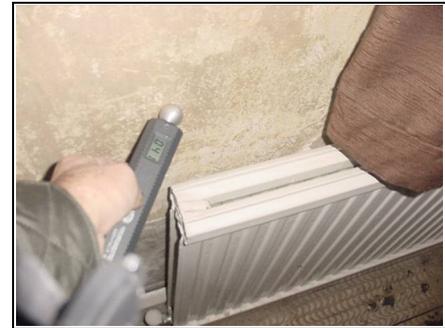
Lateral dampness detected via a damp meter

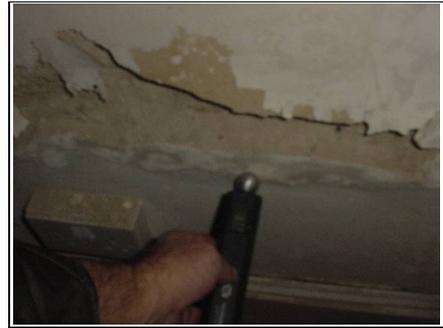
8) Rising damp and rot to joists

There is rising damp in the property throughout due to the generally high ground level around the property. Internally damp has got into the floor joist ends which are likely to be embedded into the walls.

ACTION REQUIRED: We believe this is caused by high ground levels and therefore a French Drain is recommend. We would recommend that you open up the floor as soon as possible and check the condition of the joist ends although there didn't seem to be that much deflection in the areas we were able to inspect (we didn't open up the floor). We do believe that it is likely given the age of the property that you will need to prop some of the floors and add additional timbers.

ANTICIPATED COST: A few hundred pounds unless there is an outbreak of woodworm or dry rot under the floor which is impossible to tell from an initial inspection of the top surface; quotations required.

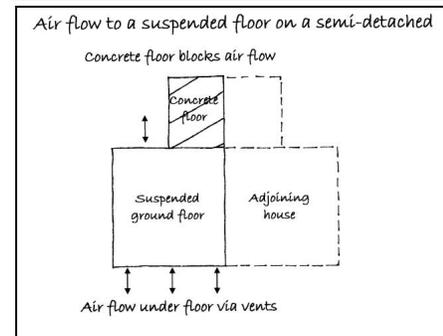
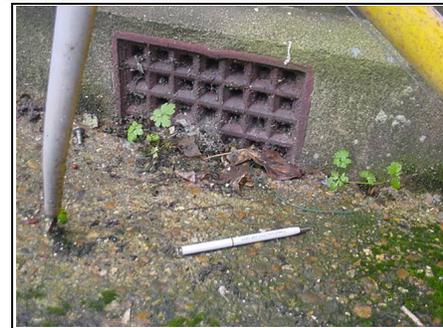
Airbrick acting as gutter

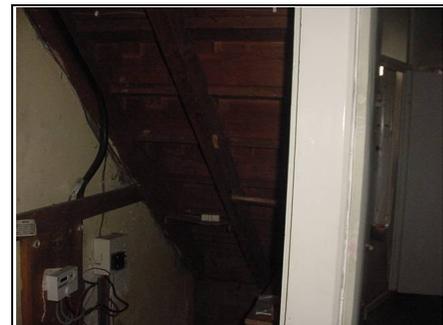
There isn't a fire lining to the staircase which is important in a worst case scenario of a fire as it gives some extra time to escape.

Underside of stairs needs lining

ACTION REQUIRED: We would recommend that this is added as it does mean that the upstairs occupants have extra time to escape should there be a fire.

ANTICIPATED COST: A shared cost with the occupiers above of a few hundred pounds to add a plasterboard or timber lining. We would recommended an hour fire resistance; quotations required.

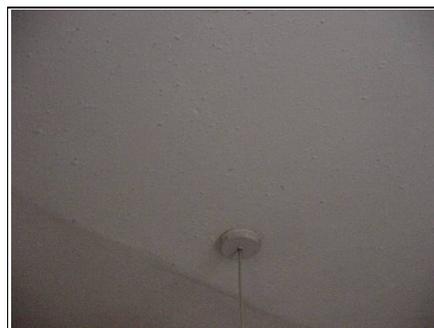
From the look of the artex we believe it is asbestos based. We therefore recommend that you use a plaster to smooth over this rough surface and also seal in the asbestos. You obviously should not sand it, cut into it, etc.

Asbestos ceiling

ACTION REQUIRED: If you do wish to remove it then it may require asbestos removals. We would recommend that you contact your Local Authority to obtain an approved inspector and company. We would advise that we are not asbestos surveyors.

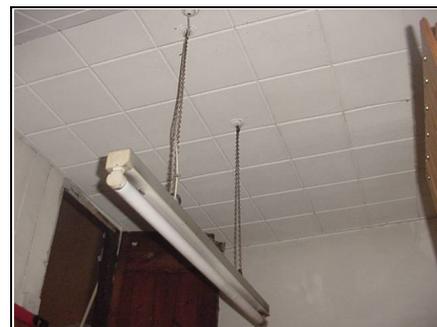
There are polystyrene tiles in some areas. These in a fire can drip and therefore are not generally recommended or approved.

Polystyrene ceiling

ACTION REQUIRED: Remove and replace with a new ceiling. They are often used where there is a poor ceiling underneath so be prepared for some work.

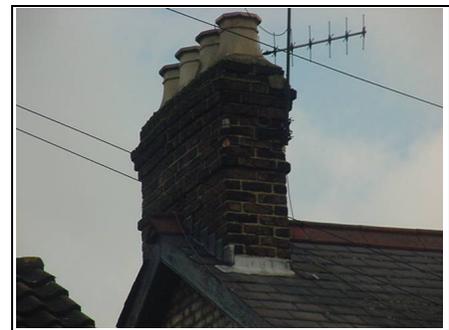
Chimney one

Unfortunately we were unable to see the very top of the chimney known as the flaunching, we therefore cannot comment upon it.

ACTION REQUIRED: We recommend a close inspection of this chimney within the year and that work is carried out to it as soon as possible. There may possibly need some rebuilding of the chimney.

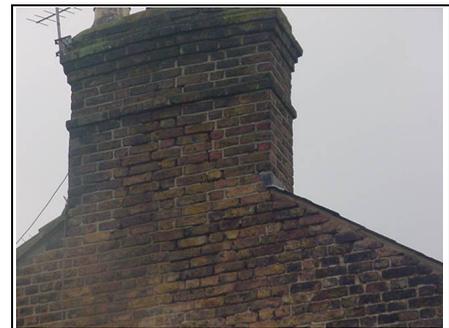
This is a large chimney built to the rear of the property shared with the neighbour. We can see a small amount of flashing which we believe is lead. The main issue here is the lack of repointing to the chimney and partly to the

Chimney two – in need of 27
repointing

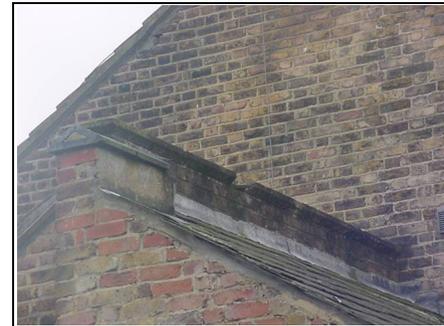
We would term the parapet wall as below average condition. Please see our comments in the Executive Summary where we believe dampness has got in through this parapet wall over the years.

Defective rear parapet wall

ACTION REQUIRED: You need to carry out general maintenance including repair of the coping stone. This should be a shared cost with your neighbour.

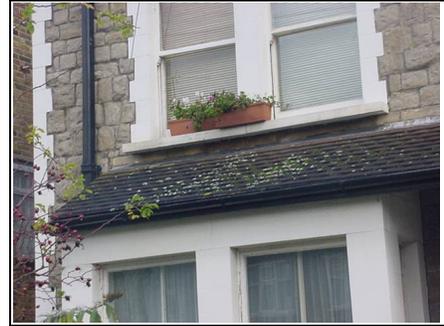
This has a small concrete tile on it. It has a lot of moss sitting on it as is common with this type of roof. Our concern is the flashing where it meets the main building where we would much prefer to see a lead flashing than the flashband that is being used. It does indicate that there has been a leak in this area at some point in time although there was no obvious visual signs internally.

Bay window roof

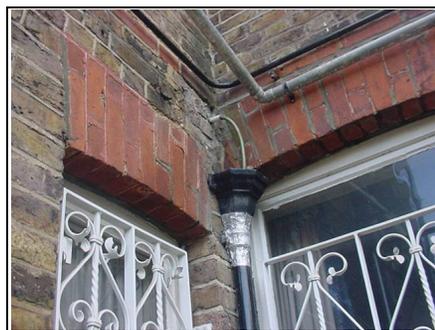
From ground level the gutters and downpipes are cast iron. With this age of Cast Iron, you can expect rusting and cracking as is the case in this instance where there have been some “interesting” amateur/DIY type repairs. You will have to carry out a fair amount of maintenance and various repairs.

Repairs to gutters and downpipes

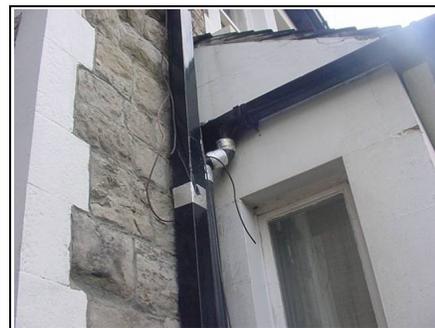
If Cast Iron is look after and maintained, it can last a considerable time; unfortunately sadly it's usually not maintained as in this case.

Leaking gutter and downpipe

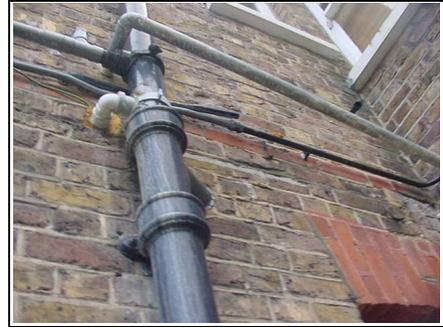
The original cast iron soil and vent pipe has been cut into many times and altered and adapted to accommodate the waste from the first floor apartment. There is a particularly unusual one that goes all the way to the water butt. It looks like someone is using waste sink water to water plants, etc.

Cast iron soil and vent pipe

ACTION REQUIRED: We suggest you have a chat to find a more conventional way of doing this such as running it straight down the wall into several water butts that you share.

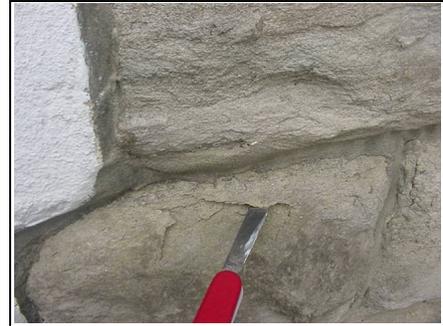
There is coursed stonework to the front of the property. It originally was bedded in lime mortar we believe; now we can see a cement mortar has been used. Unfortunately this is causing spalling to the stonework at the front as you can see in the adjacent photo.

Stonework

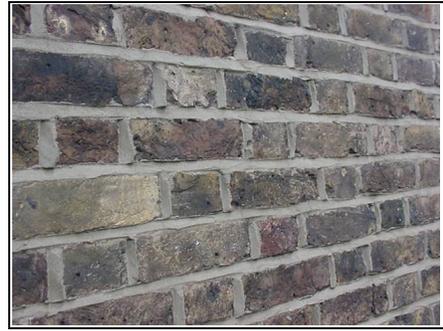
Cement pointing on brickwork

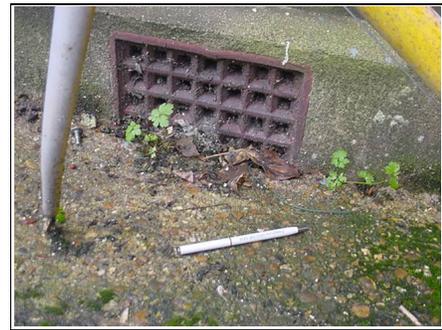
Airbrick acting as gully

ACTION REQUIRED: We recommend bricks are bedded around the air bricks to stop water getting into them.

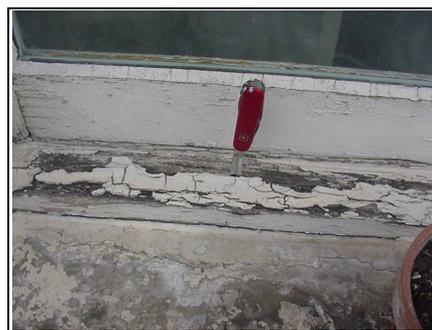
Windows in need of repair

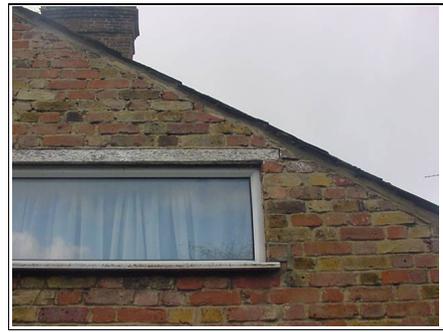
Plastic window with timber lintel

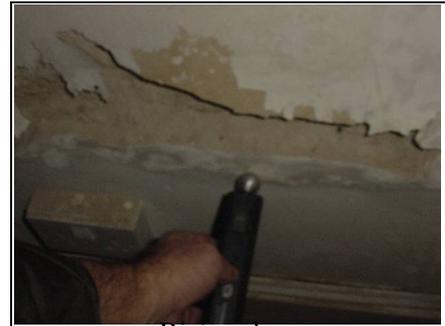
The readings we obtained indicated that there is some dampness in the property particularly to the front of the property. We believe this relates to high ground levels around the property as well as possibly a bridged damp proof course by the render.

Rising damp

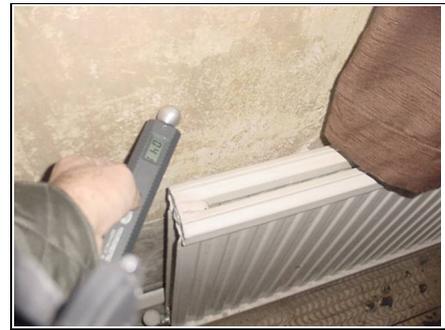
We have carried out checks at high level and found lateral dampness, this is likely to be from leaking gutters and the use of cement repointing is holding dampness in the property. Please see also the gutters and downpipe sections.

Lateral dampness

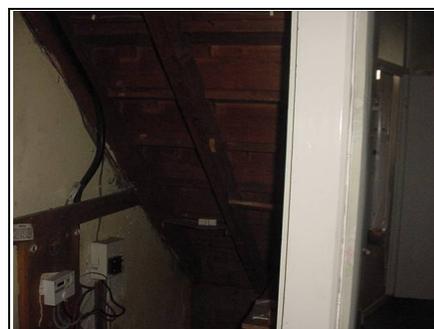
Underside of stairs needs lining

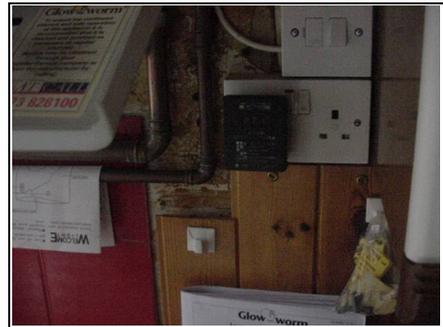
Earth test in kitchen failed

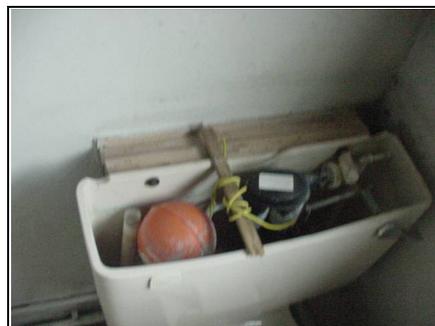
Problems with water cistern in bathroom

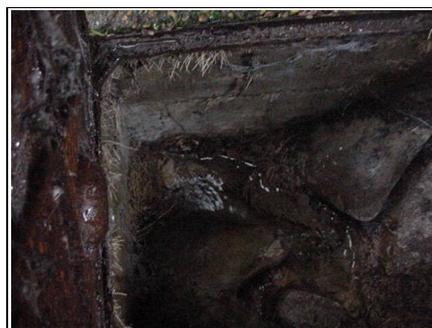
Roots in Manhole 1
