RESIDENTIAL BUILDING SURVEY

Beckenham
BR3

FOR

Mrs S

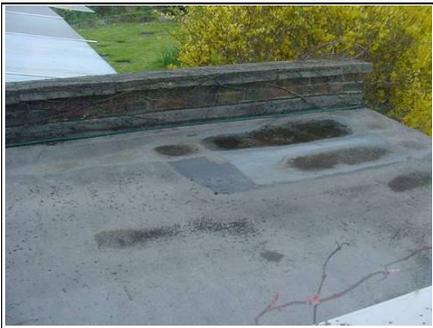
The flat roof is asphalt covered which has been patch repaired and is in need of a proper asphalt repair and a check to the flashings and parapet walls.

General view of flat roof

ACTION REQUIRED: Have a roofer for one to three days carry out proper asphalt repairs on the felt roof.

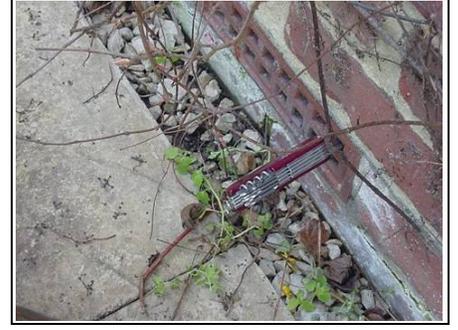
Air brick to rear blocked

ACTION REQUIRED: Reduce the ground level around the property. Ideally an area of the flooring should be opened up to check the condition of the floors beneath.

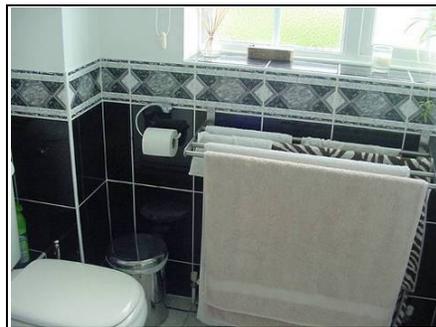
During the course of the survey the property was relatively humid. This may just be due to the size of the family but we did not meet anyone because the property was empty. We did however note that there were no extract fans within the kitchen and the bathroom.

Drying of clothes on radiators causing humidity

ACTION REQUIRED: We would recommend large humidity controlled extracts fans are added to the kitchen and bathroom (by large we mean at least 150mm/6” extract fan).

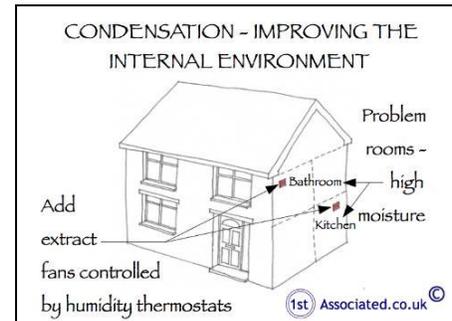
Condensation

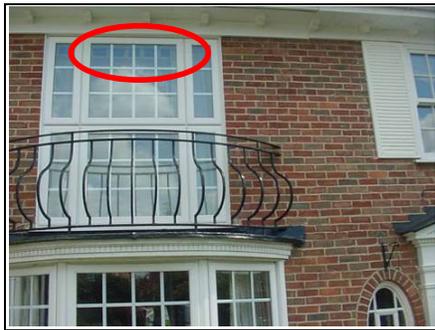
We also noted that the windows do not have any visible trickle vents. These help air circulation within a property.

No trickle vents in windows

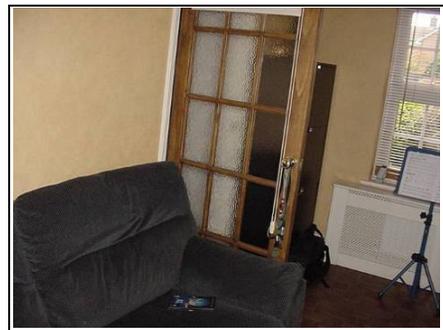
Glazed door has no kite mark

ACTION REQUIRED: Unless the owners can produce evidence to show that safety glass has been used we would recommend replacing the doors if you have young children, informed or elderly, less able people, etc.

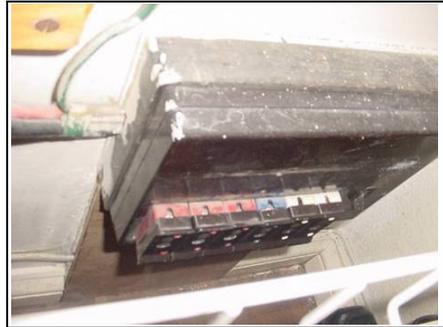
There is an old electric fuseboard which we recommend is replaced.

Old electric fuseboard

ACTION REQUIRED: Replace fuseboard. We recommend an IEE (Institute of Electrical Engineers) test and report by an NICEIC registered and approved electrical contractor or equivalent.

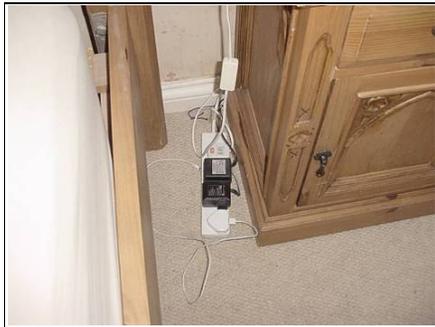
Another reason why we are recommending this is that we noted extension cables and overloaded socket points which normally indicate more electric points are required, as things can possibly start to become unsafe with overloaded points.

Need more electric points

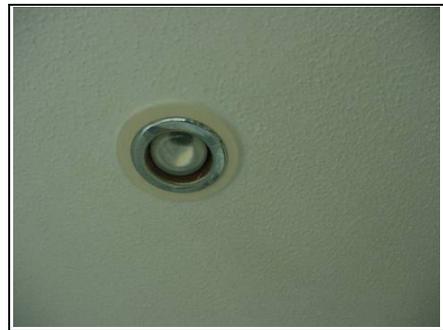
The property has old electric lights to the ceiling. In some instances these can cause problems as the heat given off has in some cases lead to outbreaks of fire; these tend to be in the older type of ceiling lights.

Older style ceiling light

ACTION REQUIRED: We recommend replacing this with a low energy bulb.

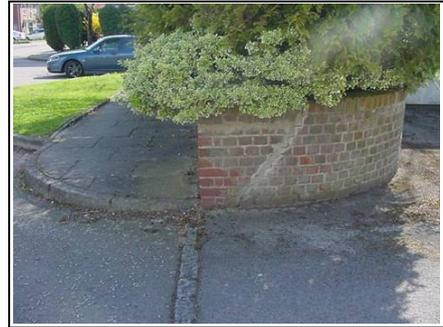
There are areas of work around the garage block and often you have shared costs with regard to these. For example, regarding the crack in the wall adjacent to the garage block you would have a shared cost and shared liability should there be a problem.

Crack to wall

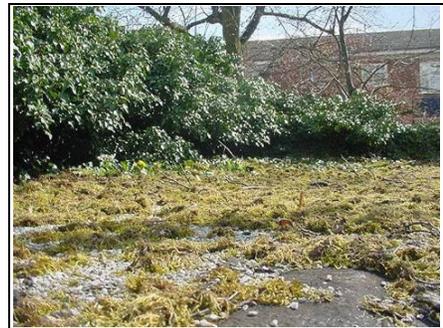
The garage roof is in poor condition and will need renewing within the next few years.

Garage roof in poor condition

ACTION REQUIRED: Clear roof and check condition. Most people patch repair garage roofs unless they have a very expensive car or something perishable they wish to keep in the garage, which obviously is not ideal as the garage is away from the house.

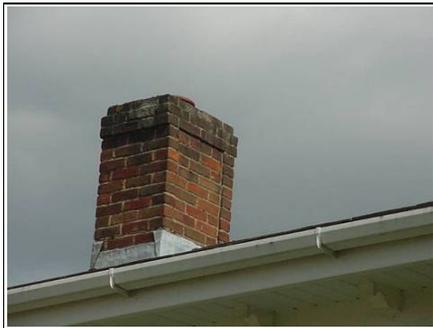
This chimney is brick finished with a lead flashing and one chimney pot. From what we could see from ground level it looked in average condition, but slightly weathered considering its age, type and style.

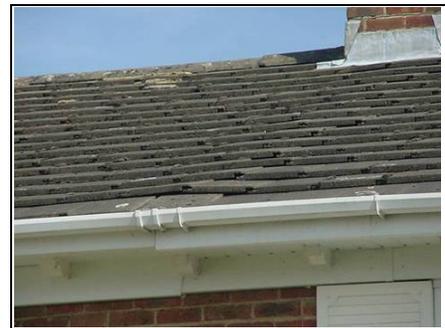
The main roof is shallow pitched and clad with interlocking concrete tiles, and, from ground level, this looks in average condition considering the roofs age type and style.

Where there is cement mortar to the end of the tiles we can sometimes see adverse effects and cracking, however again this is in average condition, particularly considering it looks to have been covered with ivy in the not too distant past.

ACTION REQUIRED: Carry out periodic inspections and maintenance of the roof, as required.

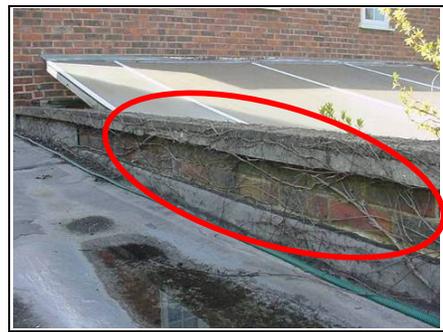
The property has flat roofs to the side. These are parapet walls build from brick with a coping stone of concrete which look in average condition with the exception of where the ivy has taken over in years gone by.

ACTION REQUIRED: We recommend the ivy is cut back further. We were pleased to see that there was an asphalt flashing on the parapet wall.

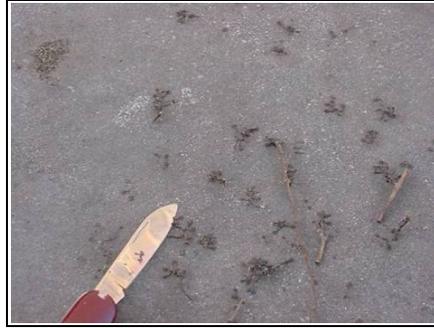
Ivy has damaged flat roof

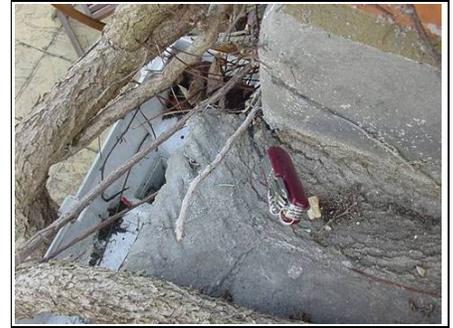
Asphalt breaking up

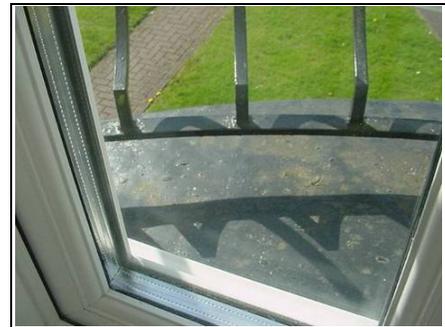
This is a small front roof without a gutter and looks in average condition for its age, type and style.

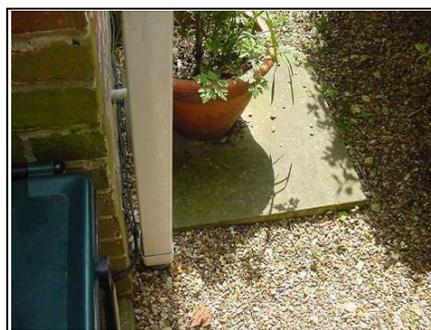
The property has plastic gutters and downpipes. We noted that the rainwater goods discharge directly into the ground, a practice that we are not keen on as they are often prone to blockages. Ideally, they should be changed to a gully system.

There may be some minor leaks but most people would be happy to live with these providing repairs are carried out within the next six to twelve months.

We also recommend that the gutters and downpipes are cleaned out, the joints are checked and the alignment checked to ensure that the gutters fall towards the downpipes.

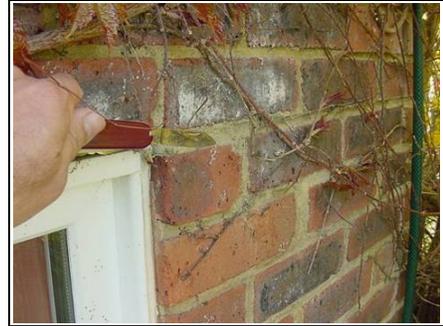
Pointing deteriorating

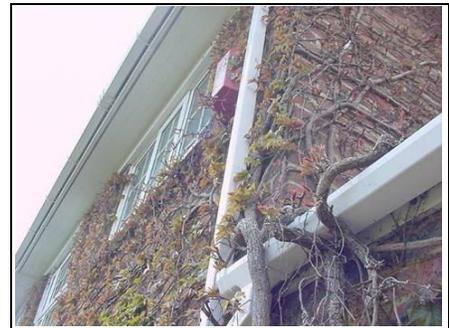
Please note our comments with regard to ideally putting a trellis work between the walls and the ivy to stop damage.

Ivy

ACTION REQUIRED: Please see our comments in the Executive Summary.

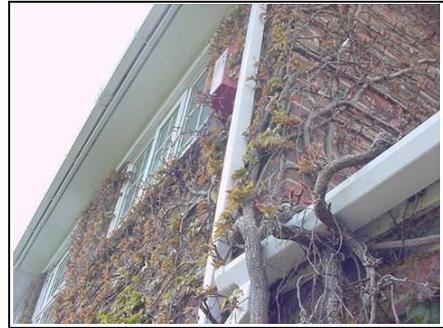
We can see that the ivy looks has been cut back fairly drastically and you can still see where it has caused marks to the brickwork and the flat roof and also the plastic fascias and soffits.

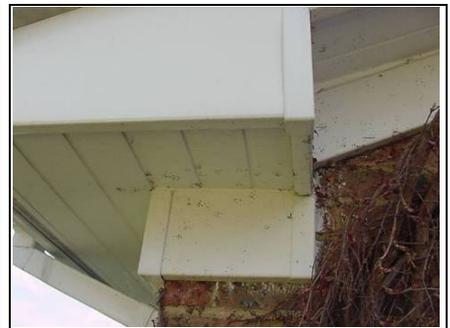
The fascias and soffits are plastic with vents. We would comment they are in average condition for their age, type and style and have suffered damage from the ivy (please see our comments about ivy elsewhere within this report).

Ivy damage to fascias and soffits

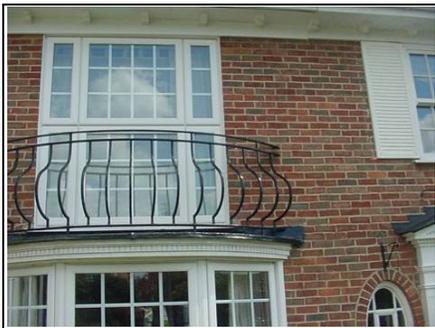
The property has plastic double glazed windows without trickle vents, which generally look to be of an average quality. We would draw your attention to the fact that sealed double glazed units can fail, particularly as a result of poor workmanship during installation. Failure of the seal leads to condensation between the two panes of glass and simply replacing the affected units may not provide a satisfactory long-term solution.

Windows without trickle vents

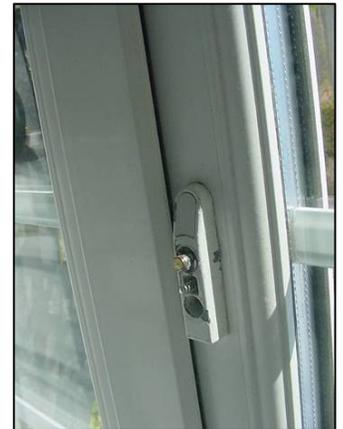
Broken catch to front bay window

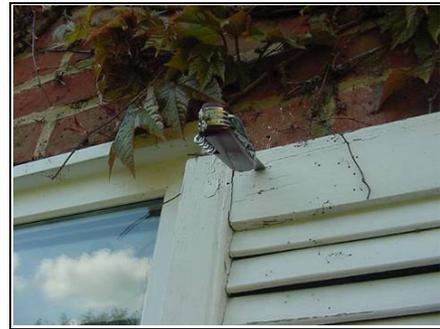
Rot to shutters

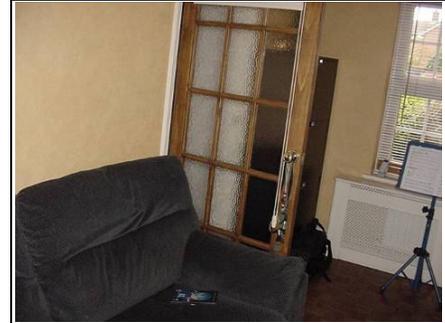
We noted that the glazed doors do not have the British Standards safety kite mark.

Glazed door has no kite mark

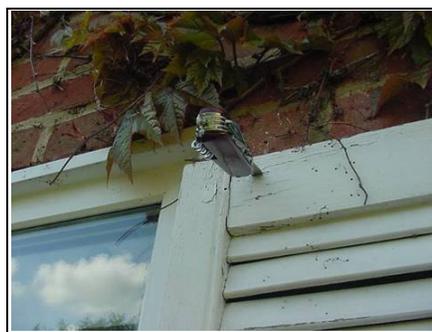
Rot to shutters

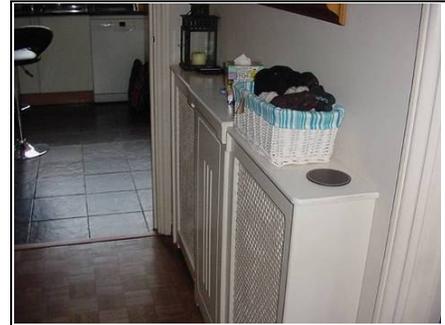
Radiators are boxed in which does limit the amount of heating coming out

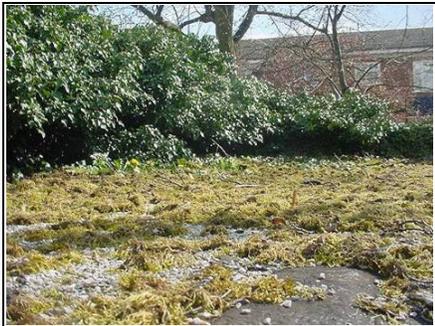
The property has a garage in an adjacent block of garages (corner garage). The flat roof is not in the best of conditions and will need replacing over the next few years. The garage looks quite small and you need to check you can get your car inside it.

Garage roof in poor condition
