RESIDENTIAL BUILDING SURVEY
OF
Bedford, MK41

FOR
Mr G
Prepared by:

INDEPENDENT CHARTERED SURVEYORS

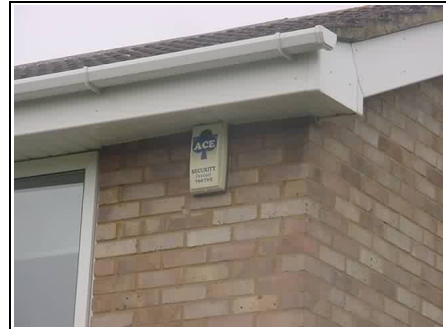
1) Overcladding – (this was found after you left the survey)

The fascia and soffits boards have been overclad. This is usually carried out in this age of property when timber is deteriorating. Unfortunately the overcladding is often stuck on and comes away as the fascias and soffits deteriorate further. In a worst case scenario this can lead to rot in the rafters.

We are advised this was carried out over the years, the last bit being last year.

ACTION REQUIRED: You need to remove a section to check the condition of the timber underneath. Ideally, all the fascias and soffits should be replaced with a timber or solid core plastic.

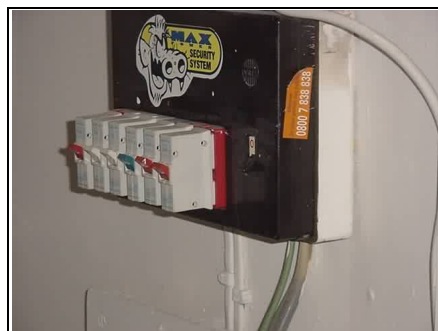
The electric fuseboard is dated. We would recommend that it be replaced. We also noted lighting in the garden to the side of the garage, which although we think is a good idea would not meet current Institute of Electrical Engineers standards from what we could see of it above ground level.

ACTION REQUIRED: Replace fuseboard and have NICEIC approved electrician carry out a report and inspection.

ANTICIPATED COST: £250 - £500

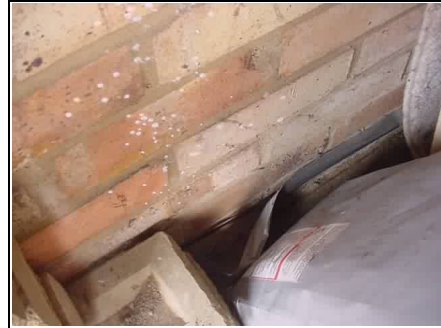
Wiring to Electric Lights in garage

ACTION REQUIRED: As the property is changing occupancy the Institute of Electrical Engineers (IEE) recommend an NICEIC registered and approved electrical contractor carry out an inspection, test and report.

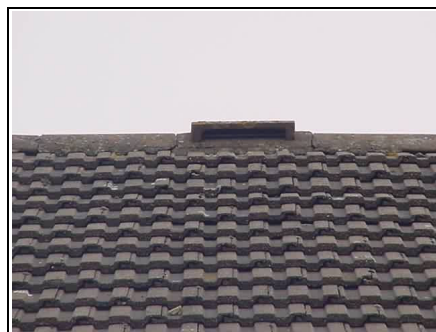
This roof is shallow pitched, clad with concrete tiles. This type of roof was popular in the 1960/70s. Taking account of the roof's age we consider it to be in average condition.

Typical problems are wind blown/driven rain getting under the tiles and rotting the battens. In this instance we were unable to lift the tiles to check. Also moss can build up on the concrete tiles and needs clearing from time to time.

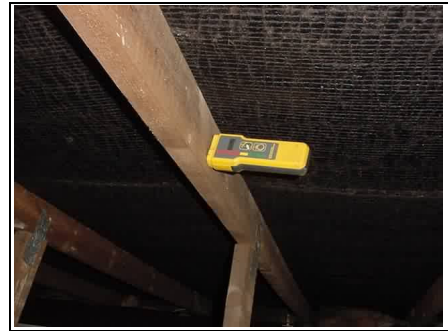
When we inspected the loft space we found a Hessian base Bitumen membrane. This type of membrane has been used since the 1960s. We generally found it to be in average condition, its damaged in a few more places than we normally find.

This photo shows the common rafters (the ones that form the pitch of the roof) and the dark area between is the underlayer.

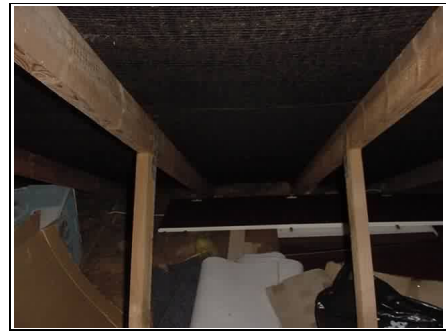
We found the timbers in average condition, our examination was restricted by the general configuration of the roof, the insulation and stored items. What we could see we found in generally average condition, with some minor condensation and damp.

ACTION REQUIRED: The only way to be 100 per cent certain is to have the roof cleared and checked.

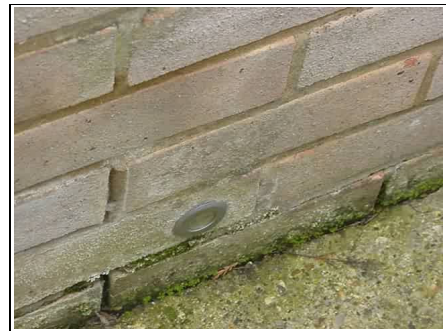
Lighting to the garage

ACTION REQUIRED: Ask the Owner if he has an electrician electrical certificate for the wiring to the garage. If not you should get an NICEIC approved contractor to carry out an Institute of Electrical Engineers report, as already mentioned.

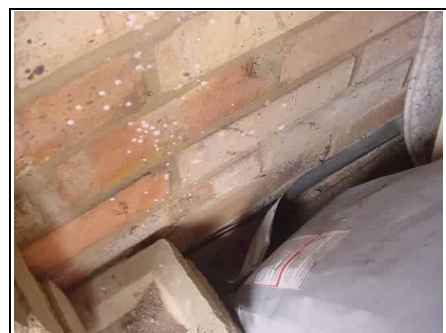
Wiring to the garage

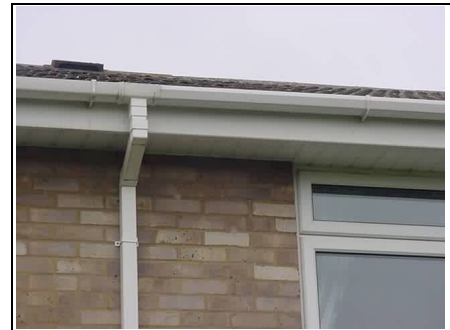
The property plastic profile gutters and downpipes, the profile is square. What we found was in average condition all things considered; we can see areas where there are leaks but we feel most people could live with these.

ACTION REQUIRED: We would always recommend that the gutters and downpipes are cleaned out, the joints are checked and the alignment checked to ensure that the gutters fall towards the downpipes.

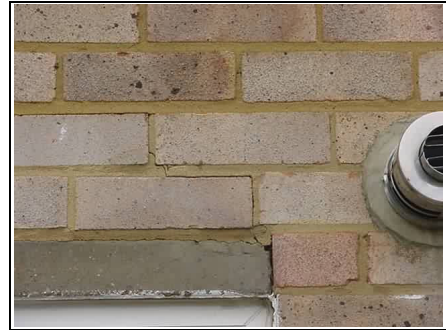
The brickwork has some minor hairline cracking, for example over the window areas, particularly to the rear boot lintel that can be seen in the photograph.

Minor cracking above "boot" lintel. Boot is the name given to this type of lintel

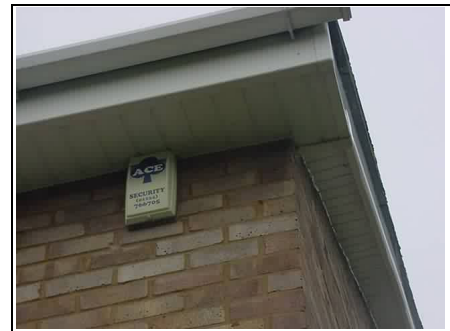
We noted that the property has plastic fascias, soffits and we think that these over clad the original timber fascias, soffits and bargeboards. This is a system used by what we can only term ‘cowboy builders’ to look as if the fascias, soffits and bargeboards have been carried out in plastic. The plastic is usually stuck on and, as there is no ventilation in this area, rot can occur.

ACTION REQUIRED: Carry out a sample by drilling into the fascia to see if wood is below. If wood is present, strip off the over cladding and check the condition of the timber beneath. Ideally you should add a vent to the soffit and repair and redecorate as necessary.

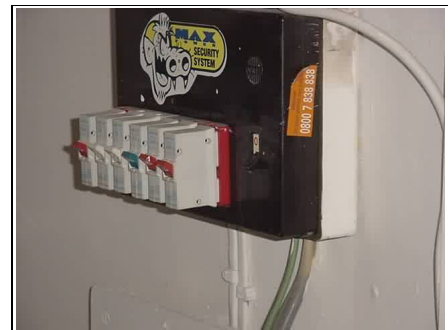
The electric fuses and consumer units were located entrance hall. We would date the fuseboard as being original. We would recommend replacement.

ACTION REQUIRED: We recommend the fuseboard is updated and a full test of the electrics is carried out, unless recent test certificates are available - less than five years old.

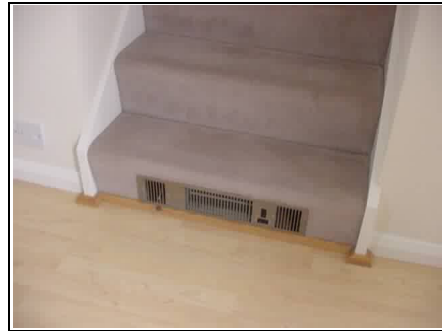
Originally this property had a warm air heating system which was popular in the 1970s. The warm was passed round the house by ducts the ducts may incorporate asbestos. As in this case many people over the years converted to more traditional central heating.

ACTION REQUIRED: Your solicitor should specifically request if the duct work has been removed and if not they should specifically ask if it is asbestos.
