RESIDENTIAL BUILDING SURVEY

Queens Park
Bedford, Bedfordshire MK40

FOR

Mr C

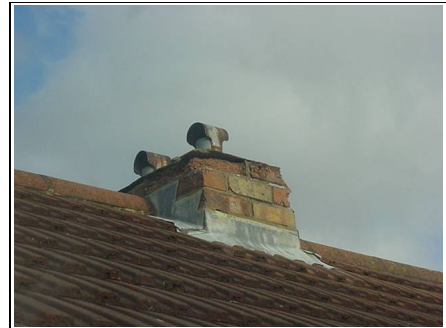
Rear chimney

ACTION REQUIRED: If any high level work takes place the opportunity for a close inspection should be taken.

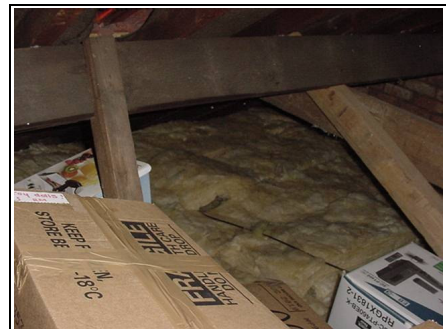
The roof has been fully insulated. Whilst this roof has some ventilation we have found, in our experience, bearing in mind the other issues, such as the internal radiators and lack of trickle vents to the windows (which we discuss later in this section), these can all promote condensation.

Roof insulation, and stored items

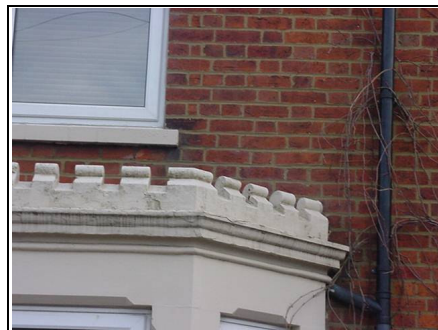
Flat roofs to a bay window are always risk areas for future leaks.

Flat roof to bay window

ACTION REQUIRED: You need to make sure this area is maintained and that the outlet gully on the right hand side (all directions given as you face the property) is kept unblocked.

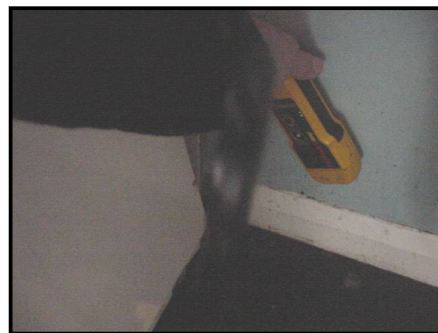
We found rising damp to the front of the property and also to areas at the rear. It is quite complex as to why there are problems: a combination of lack of ventilation under the floor and a cement pointing, together with gypsum plaster internally when previous “damp proofing” work has been carried out.

Finding rising damp –
front bay window

ACTION REQUIRED: We would recommend, in the first instance, that additional air bricks are added to the bay windows at the front of the property, and that a French gully is put around the property to the front and rear to lower the ground level, as well as moving the water away from the ground level.

ANTICIPATED COST: In the region of £1,000 to £2,000. Please obtain quotations.

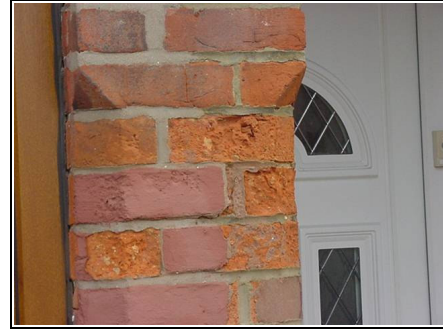
The property has been re-pointed. As with most properties of this age it has been incorrectly re-pointed with a cement mortar. This in turn causes spalling to the brickwork, as can be seen in some isolated areas. This will increase over the years.

Spalling brickwork

ACTION REQUIRED: Any cement pointing that comes away should be re-pointed in a lime mortar. From the condition of the bricks that we have seen we would leave them and not repair them and we certainly would not repair them with cement mortar, as we often see.

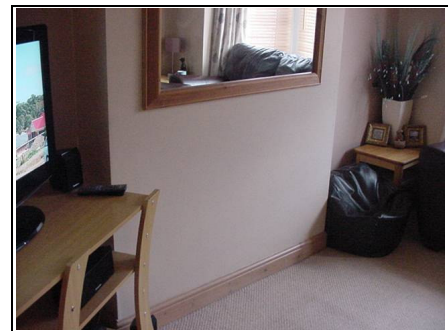
Chimneys need venting to stop sulphate attacks and dampness. We noted the front chimney was unvented.

Front chimney breast – we recommend the adding of a vent

ANTICIPATED COST: In the region of a few hundred pounds, plus. Please obtain quotations.

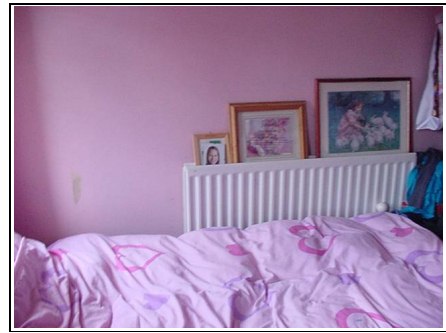
The best place for radiators are underneath windows, as this allows, as the heat rises, air circulation as it hits the colder air from the window area. Internal radiators were noted in this property, which increases the chances of condensation. When we spoke to the owner about this they advised that they had had condensation problems.

Internal radiator

ACTION REQUIRED: We recommend that you improve air circulation, particularly in high, humid and moist areas, such as the kitchen and bathroom, by the addition of a mechanical extract fan.

We would also recommend the opening of windows to air the property on a regular basis and possibly the moving of the radiators.

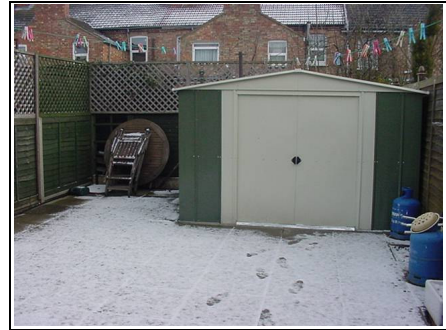
The rear garden is paved, which does mean during heavy down falls of rain you can get a large amount of water coming towards the property, which can cause some dampness.

Paved rear garden

ACTION REQUIRED: The best way to help this is to add a French gully, which we have mentioned earlier.

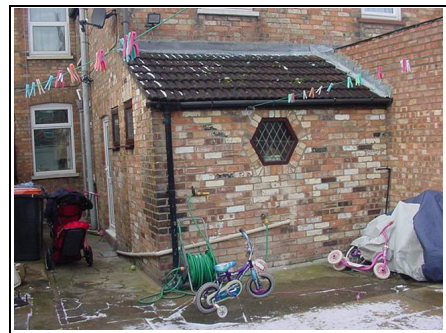
We believe that the rear of the kitchen is a single skin structure; being a single skin of brickwork. We believe this used to be the coal shed area and, as such, is not officially a habitable area, albeit that it could be argued that a kitchen does not need to be. This does not strictly speaking meet the Building Regulations.

Kitchen to rear

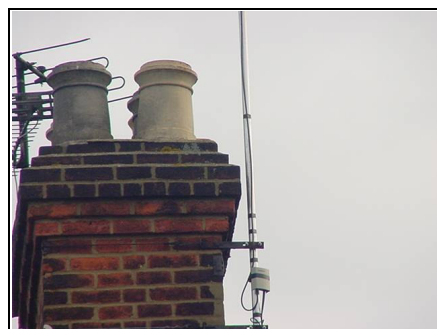
This chimney is brick finished with numerous chimney pots with lead flashings. From what we could see the chimney looks in average condition. Unfortunately we were unable to see the top of the chimney known as the flaunchings we therefore cannot comment upon them.

Close up of top of front chimney

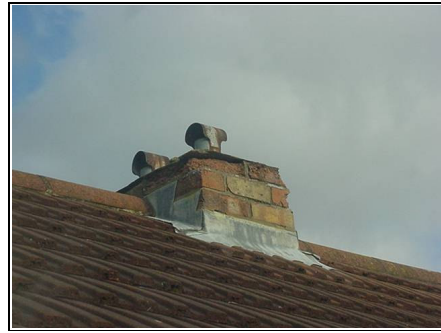
Chimney breast size reduced

ACTION REQUIRED: Please see our comments in the Executive Summary.

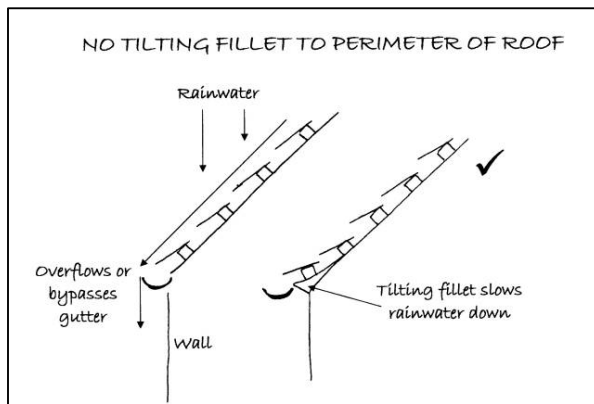
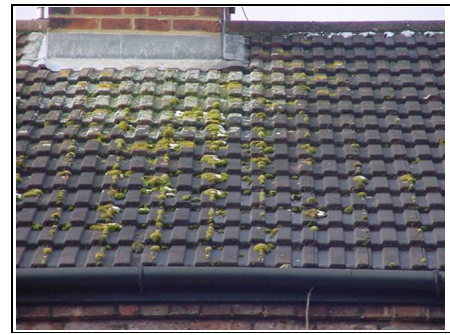
Lack of tilting fillet to main roof

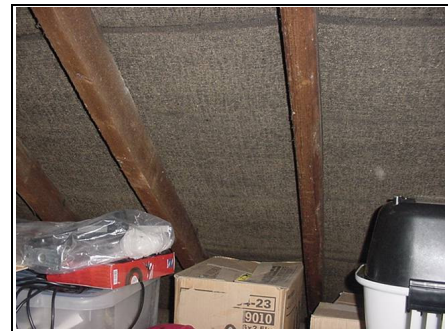
When we inspected the loft space we found a Hessian base Bitumen membrane. This type of membrane has been used since the 1960s. We generally found it to be in average condition, its damaged in a few more places than we normally find.

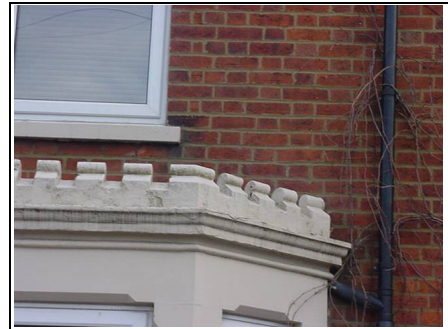
The bay window roof is flat. Flat roofs to a bay window are always risk areas for future leaks.

Flat roof to bay window

ACTION REQUIRED: Please see our comments in the Executive Summary.

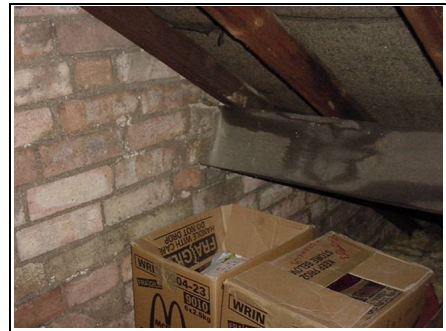
Dampness in purlin

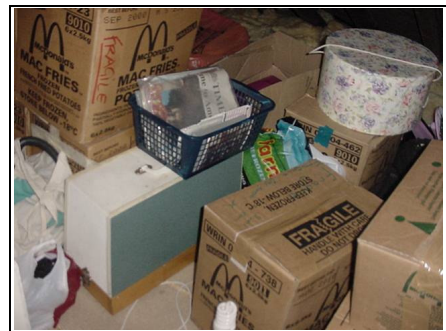
Our examination was limited by the general configuration of the roof, the insulation and stored items. As mentioned what we could see was generally found to be in average condition considering its age. Due to the amount of stored items in the roof, including a mass of insulation, it is feasible there are problems in the roof that are hidden, typically woodworm.

Mass of stored items in roof

ACTION REQUIRED: The only way to be 100 per cent certain is to have the roof cleared and checked.

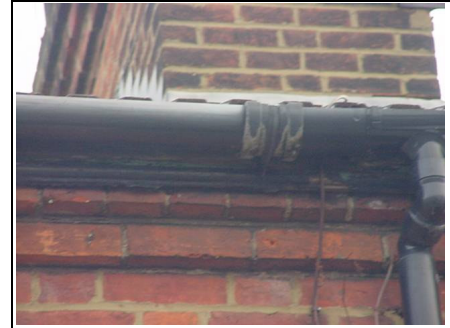
The property has a mixture of the original cast iron gutters and downpipes and the more modern replacement plastic gutters and downpipes. What we found were in typical condition for this mixture of materials. There are some leaks and there is some corrosion of the cast iron, however we feel that most people could live with this.

Specific examples are the leaking gutter to the front and the corroding hopper head to the rear as can be seen in the photos.

Leaking gutter to front

ACTION REQUIRED: We would always recommend that the gutters and downpipes are cleaned out, the joints are checked and the alignment checked to ensure that the gutters fall towards the downpipes.

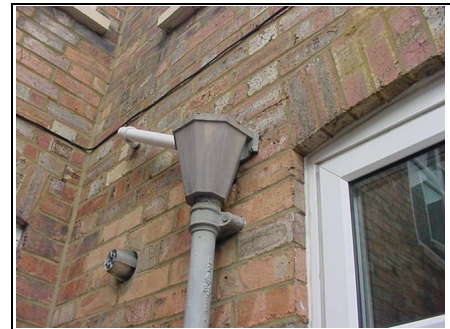
Old cast iron hopper head to rear

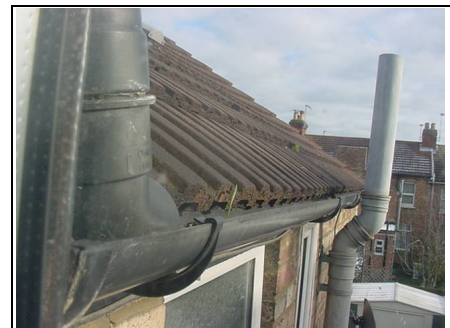
Rear gutter - this is a gutter that is likely to overflow. We noticed some grass growing from it - if you look closely

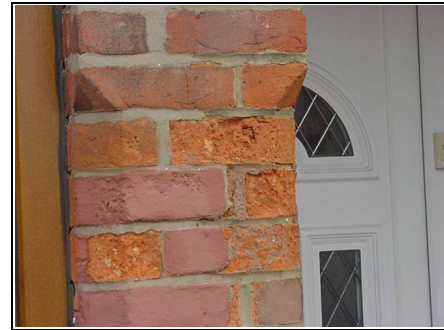
Spalling brickwork

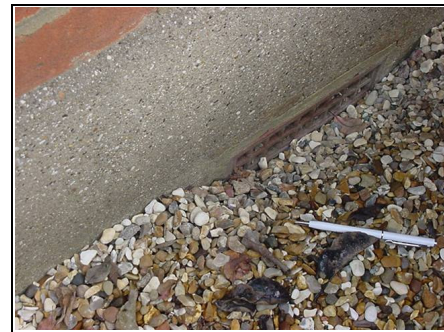
Open up air bricks to allow free flow of air

ACTION REQUIRED: Add air bricks to the front and rear, but mainly note our comments with regard to the adding of a French gully. Please see the Executive Summary.

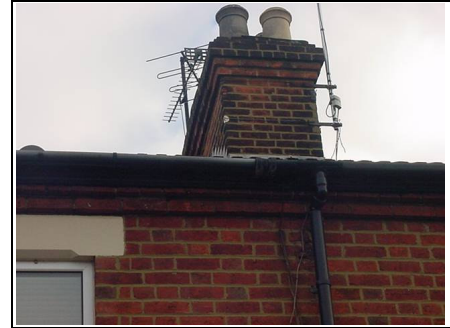
The property has painted timber fascias and soffits and these are in average condition, (which means there is likely to be some rot) although much of the fascia is mainly hidden by the guttering, as you can see in the attached photo.

Fascias hidden by guttering

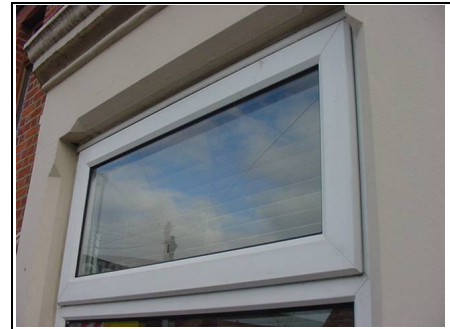
Double glazed window –
no trickle vent

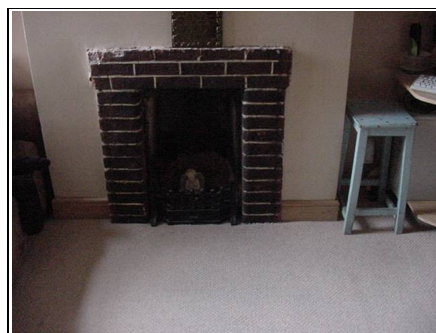
This has been removed in part at the top and also at the bottom. Without opening up the structure unfortunately we cannot comment further, but there are no obvious tell tale signs, such as cracking in the associated area at the time of the survey to indicate any problems.

Rear chimney breast

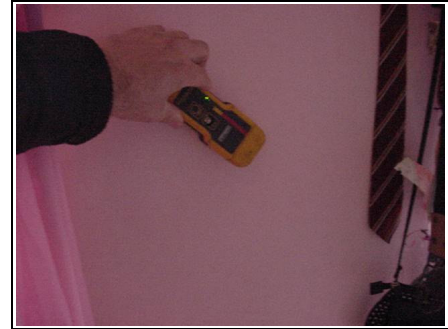
Again, tests were taken with a damp meter. No significant penetrating/lateral dampness was found. We did note areas of blown plaster, usually due to age. This is probably why it has been re-plastered in part.

Checking for lateral dampness

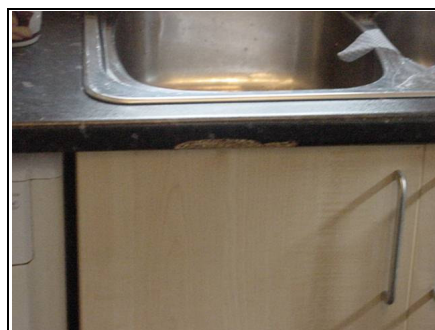
This are from the cheaper end of the market, as the owner was aware when we discussed this. From our cursory visual inspection the kitchen looked to be in basic condition, with damage to the front underneath the sink, which we believe there is a claim about.

ACTION REQUIRED: Ensure the claim is resolved before you purchase the property.

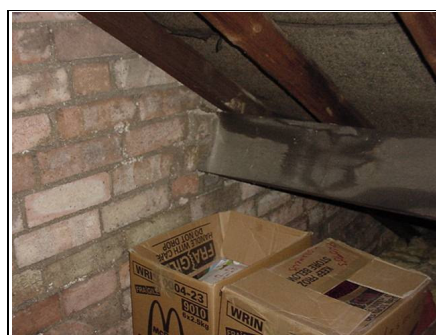
Dampness in rear purlin

ACTION REQUIRED: When the roof is empty you need to check the amount of dampness in this area. It may be necessary to have a roof repair. Please see our comments in the Executive Summary.

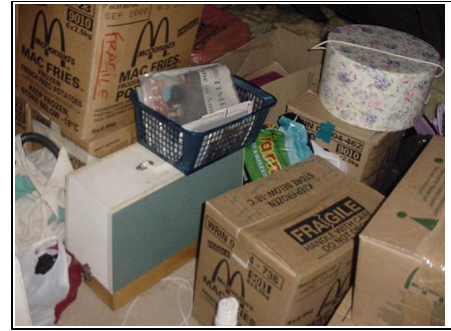
Roof full of stored items
